**UNITED STATES BANKRUPTCY COURT
SOUTHERN DISTRICT OF NEW YORK**

MOTORS LIQUIDATION COMPANY, f/k/a
GENERAL MOTORS CORPORATION, *et al.*,

Plaintiff's Representative Assets Appendix

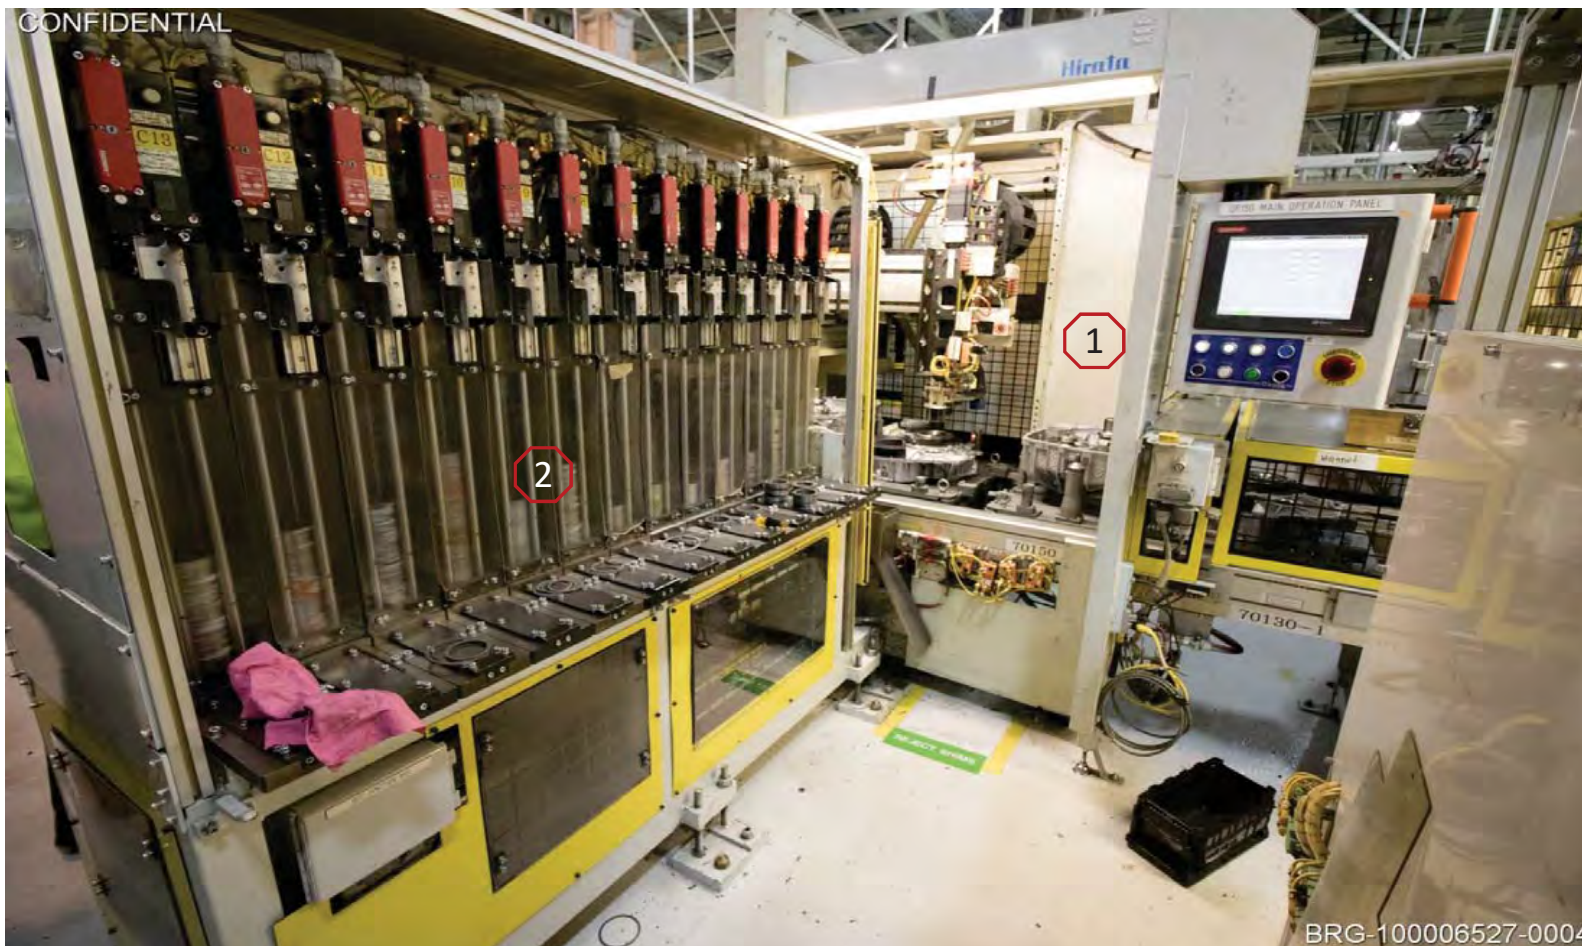
Picture 100006527-2 - Shim Select and Placement Machine

Shim Dispenser

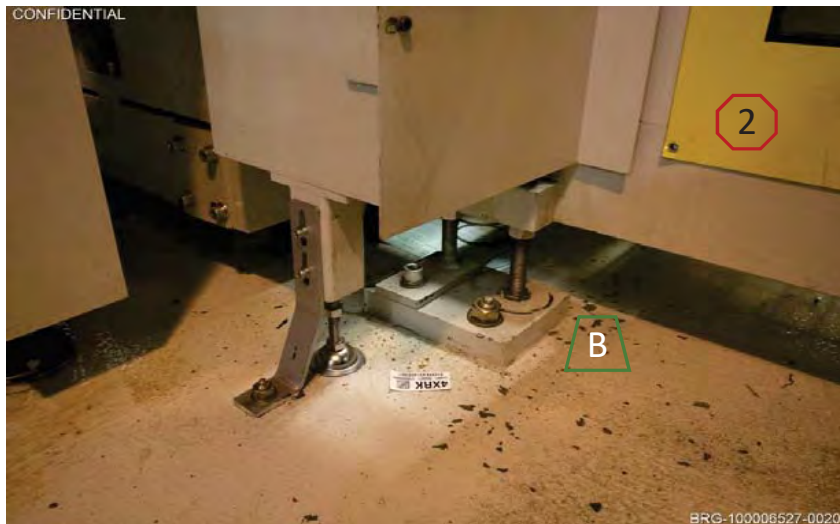
Picture 100006527-3 - Shim Dispenser (Attachment)

Shim Dispenser

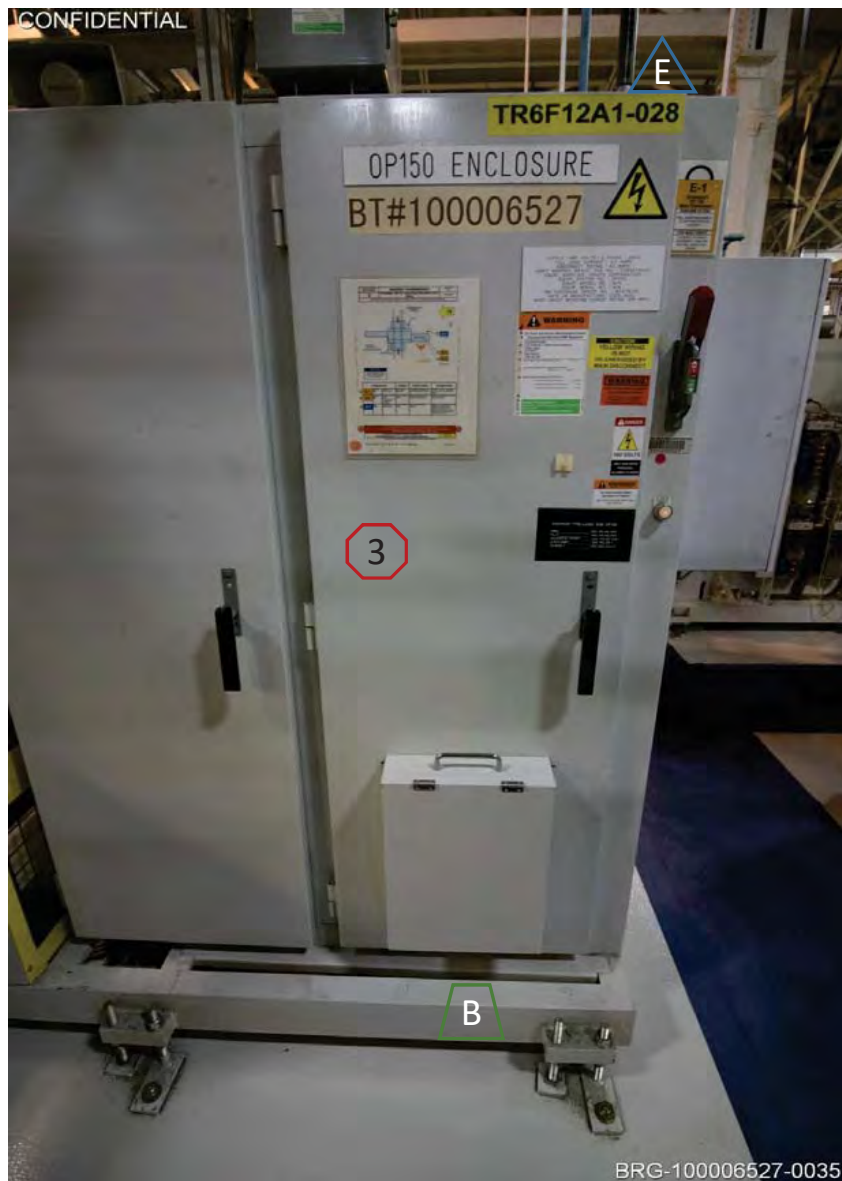
Picture 100006527-5 - Control Panel

1 Automated Placement Machine

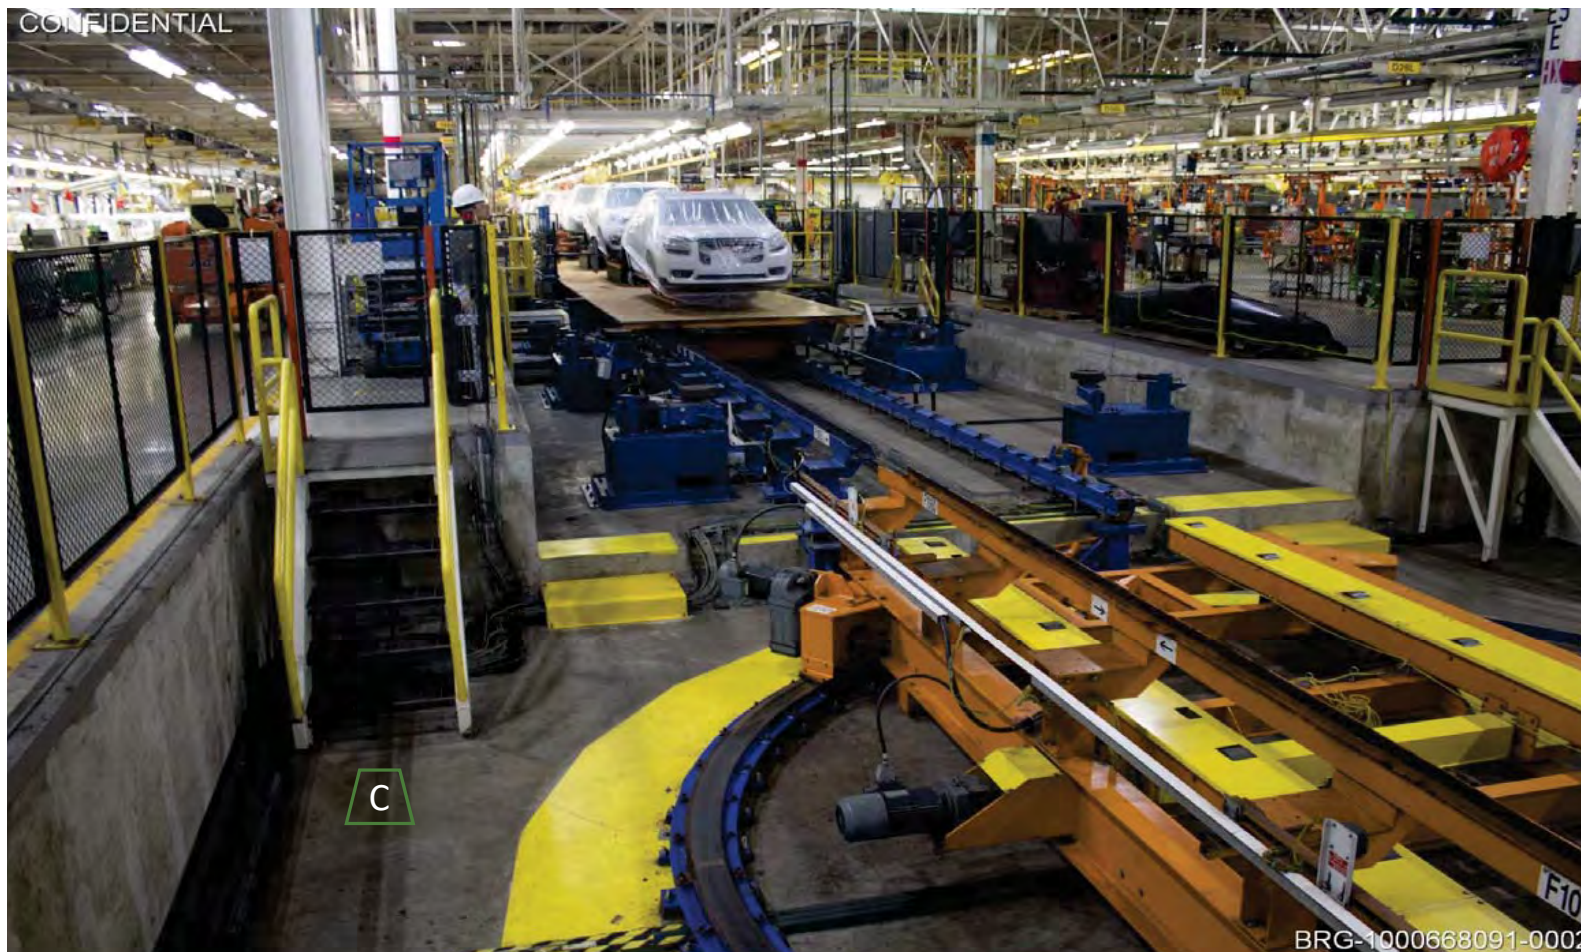
Picture 100017544-1 - Example Pit within General Assembly

Asset ID 100017544 consists of various pits and trenches (the "Pits and Trenches") in the general assembly building at GM's Lansing Delta Township Assembly plant. Based on a floor plan and list provided by NewGM, the Pits and Trenches include those constructed for the final assembly line skillet conveyors, the trim line skillet conveyors, and the Care Line skillet conveyors. The Pits and Trenches vary in their dimensions but are generally constructed by excavating a particular area and pouring a concrete foundation such that a void is created in the floor allowing for below grade drainage or equipment installation. The pits and trenches are physically integrated into the building foundation in a way that does not allow them to operate or remain intact when separated from the building.

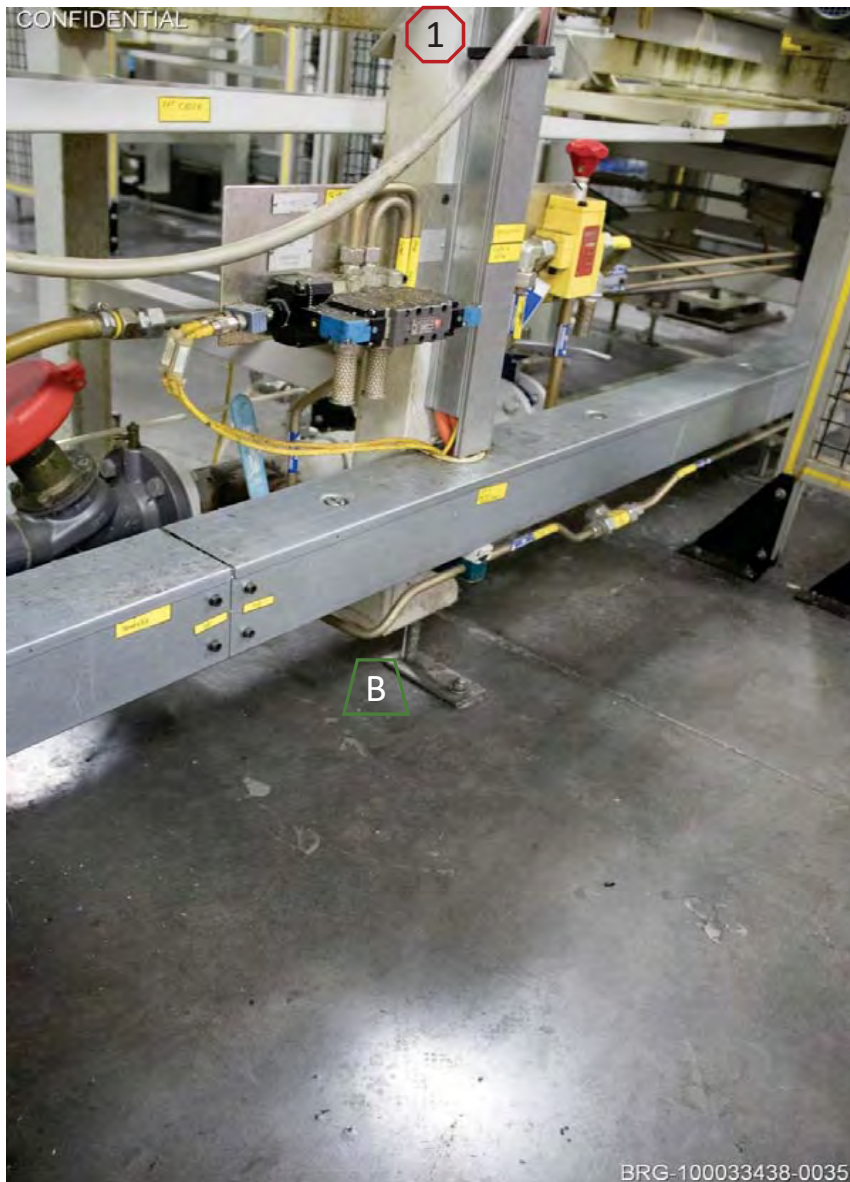
Picture 100033438-3 - Roller Conveyor

Powered Roller Conveyor

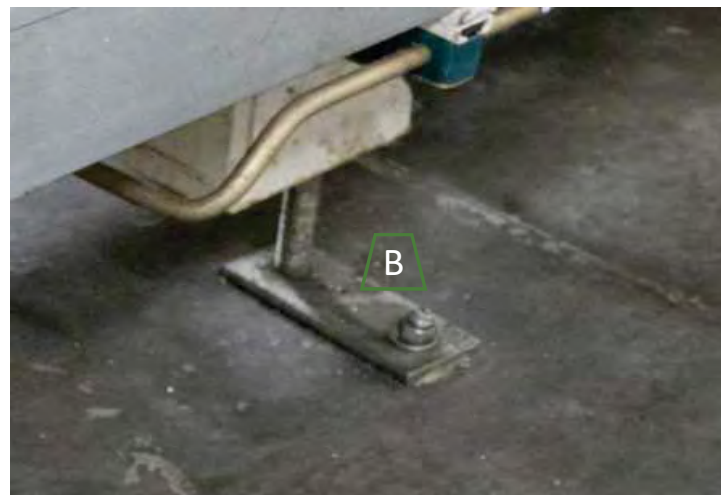
Picture 100033438-4 - Enlargement of Support Attachment

Powered Roller Conveyor

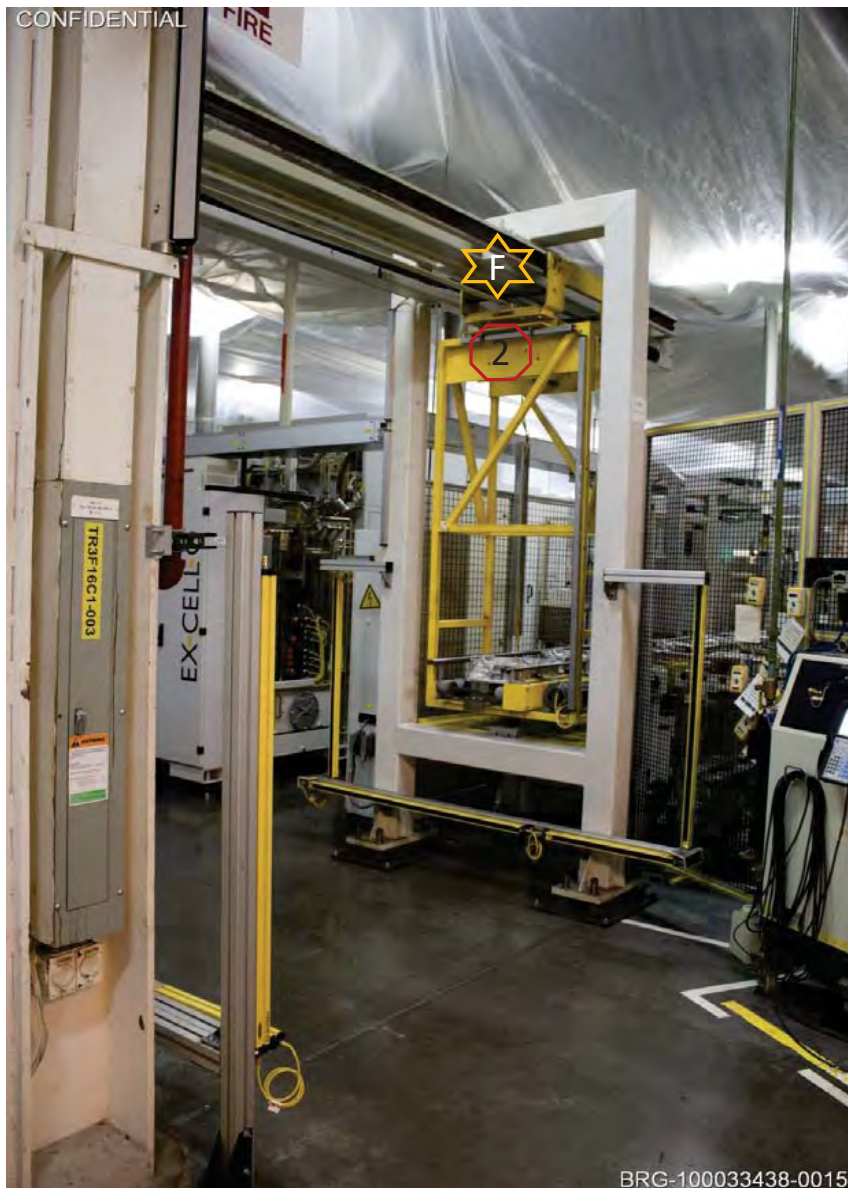
Picture 100033438-5 - Overhead Gantry Transfer Section

Overhead Gantry Transfer Sections (3 access points to machine tools)

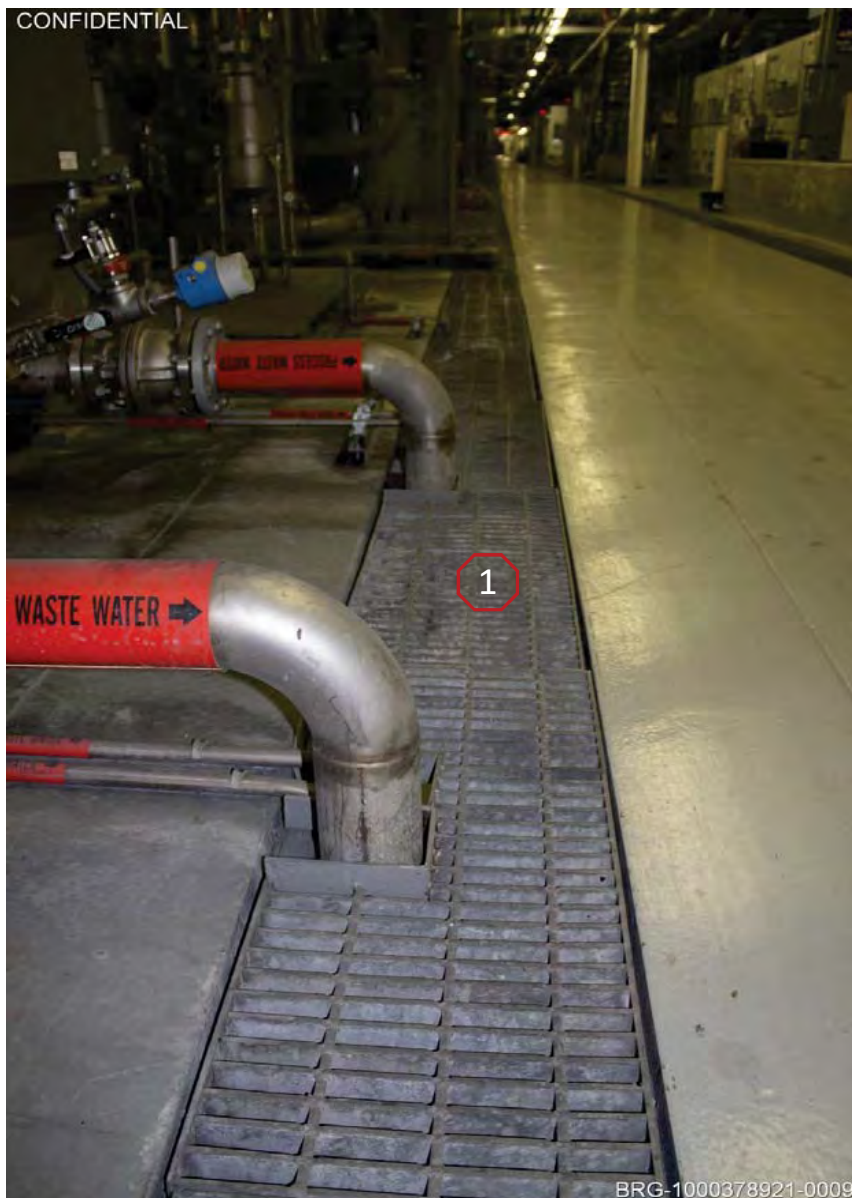
Picture 100037892-1 - Trench Example

The trench is constructed of concrete and is embedded in the building floor/foundation.

Asset ID 100037892 consists of process waste trenches, piping, and pumps from the electrophoretic deposition coating line (the "ELPO Process Waste Lines") at GM's Lansing Delta Township assembly plant. The ELPO Process Waste Lines are used to transport liquid waste from the ELPO process to the waste treatment facility. The ELPO Process Waste Lines consist of two trenches, a sump pit, two pumps, and piping. A significant portion of the ELPO Process Waste Lines – the trenches and sump pit - are physically integrated into the building floor and foundation system such that they would not remain intact if removed from the building. In addition, removing the trenches and sump pit would significantly impair the realty, leaving open, unlined holes in the floor of the building. While the pumps could be removed and used elsewhere, they are estimated to comprise less than 10% of the original cost of the asset.

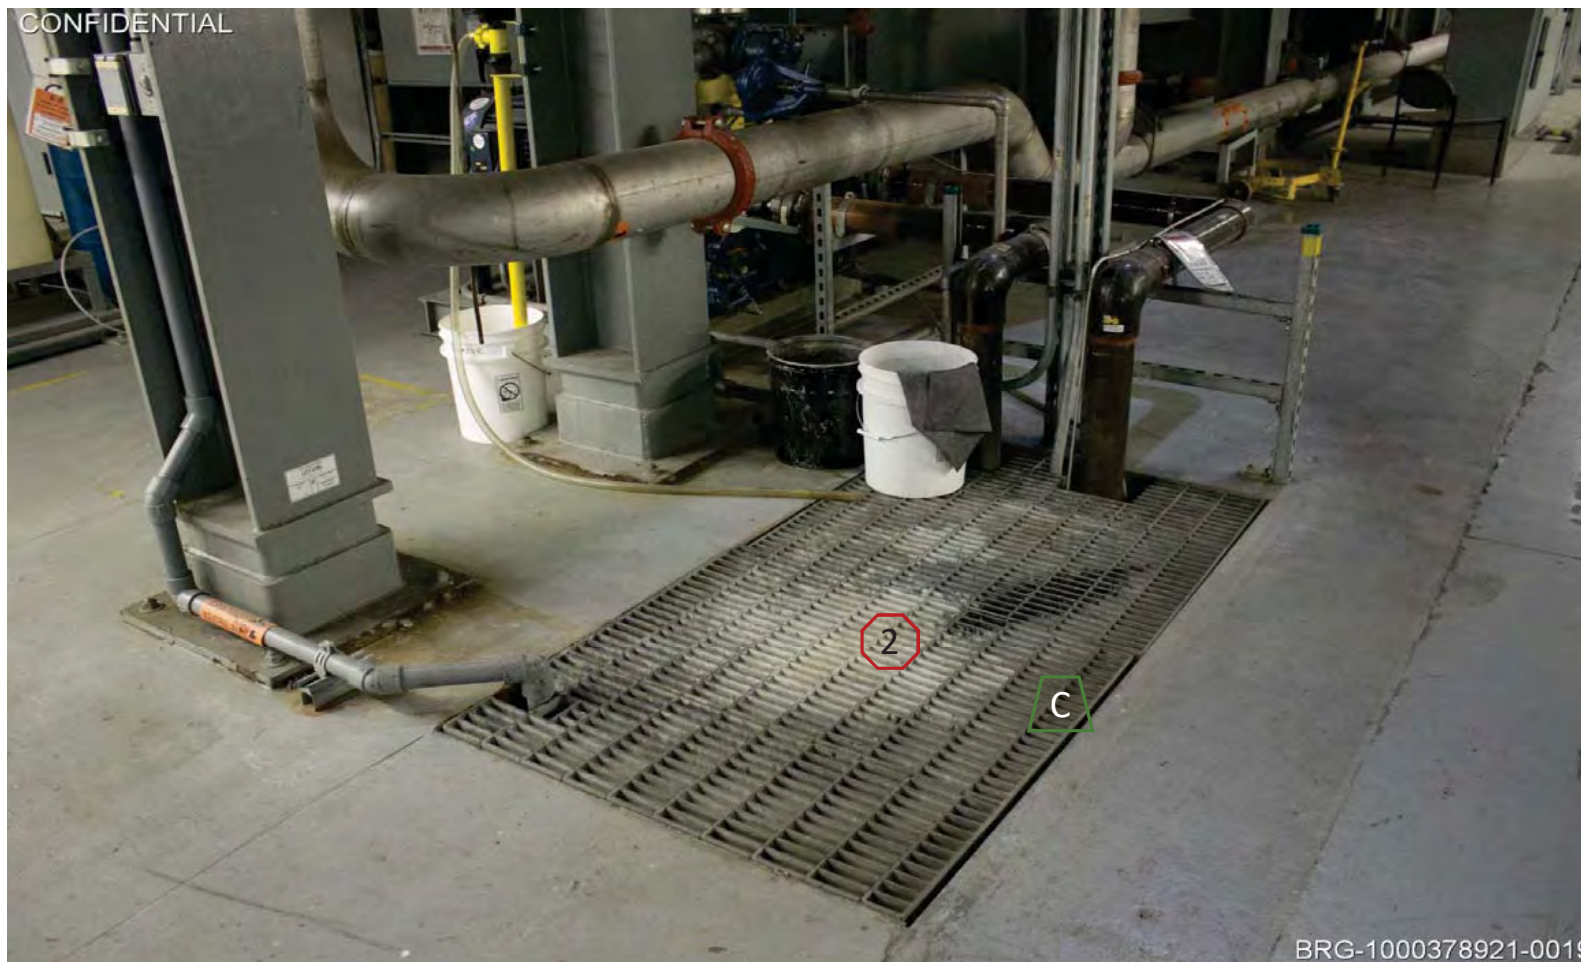
Picture 100037892-3 - Sump Pit

The sump pit is constructed of concrete which is embedded in the building floor/foundation.

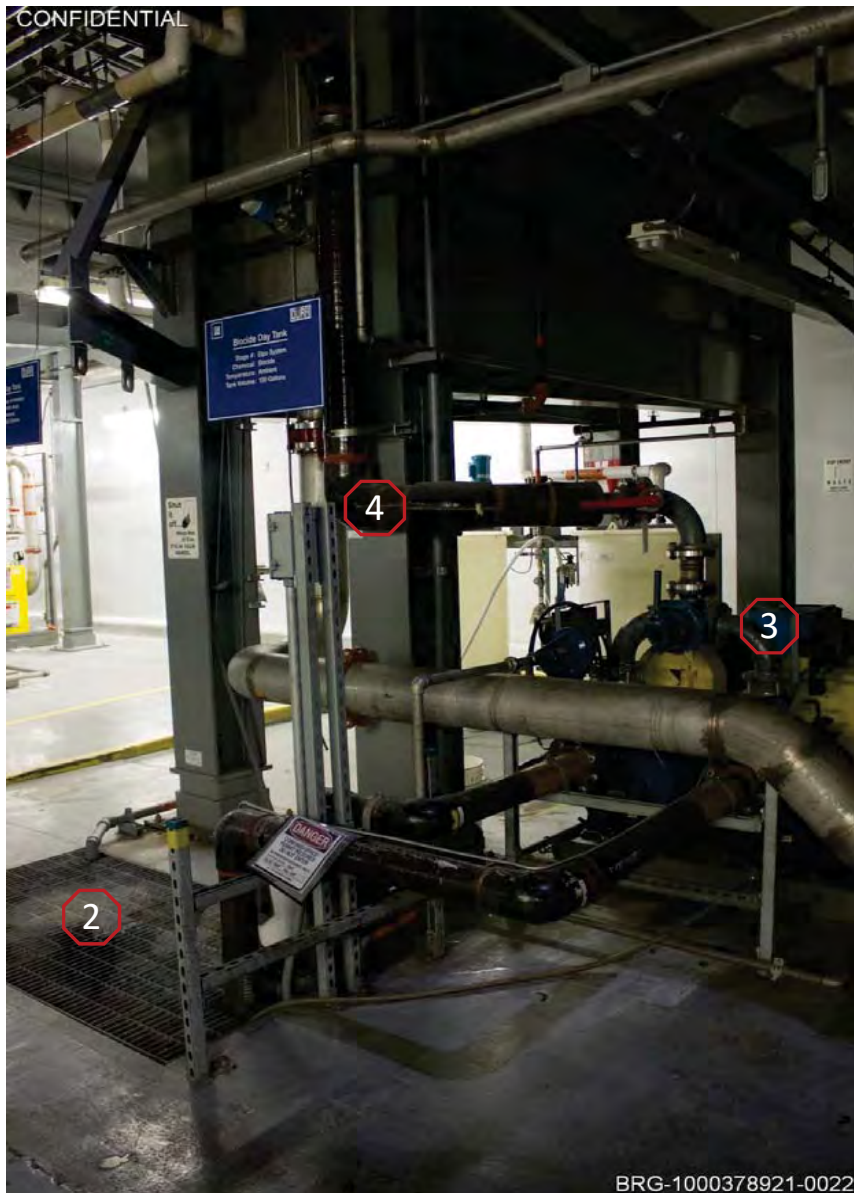
Picture 100037892-4 - Asset Components

- 2 Sump Pit
- 3 Pumps
- 4 Process Waste Piping

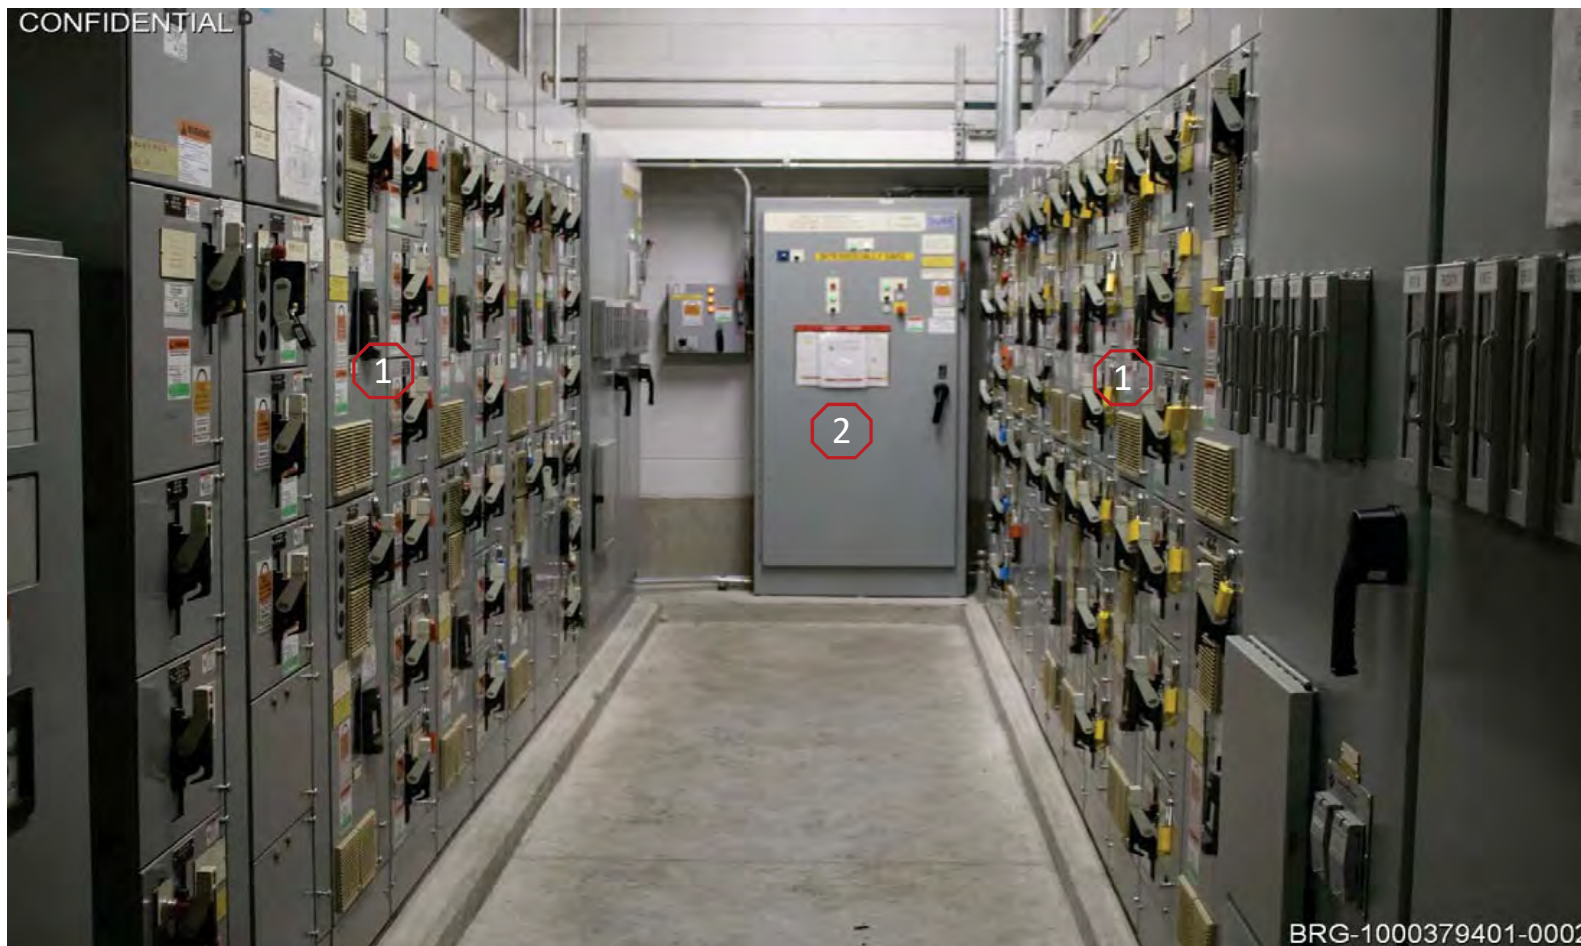
Picture 100037940-1 - Asset Components

Control Cabinet

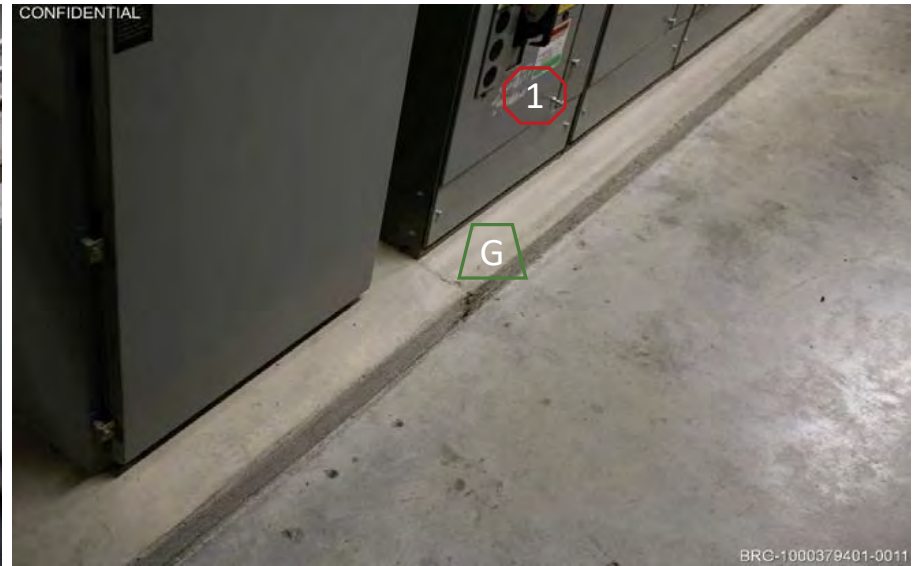
Picture 100037940-3 - MCC Cabinet (Attachment)

Motor Control Center Cabinets with switches

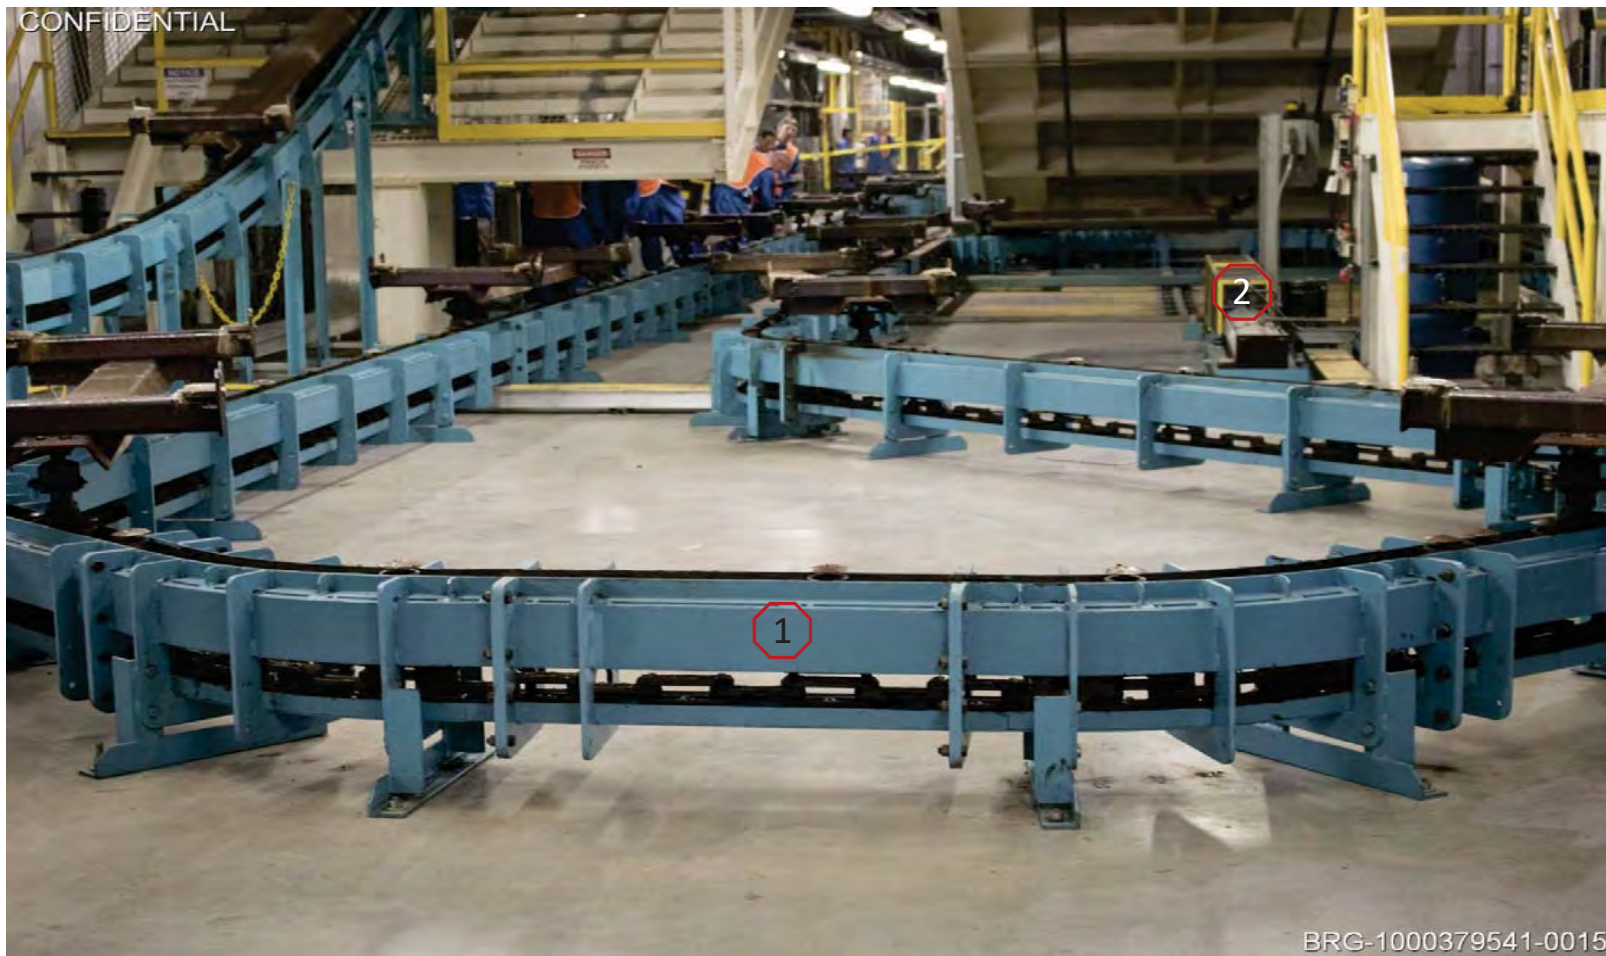
Picture 100037954-1 - ELPO IMC System

1 Inverted Monorail Conveyor ("IMC") track

B The individual track sections of the IMC are connected using eight nut and bolt fasteners.

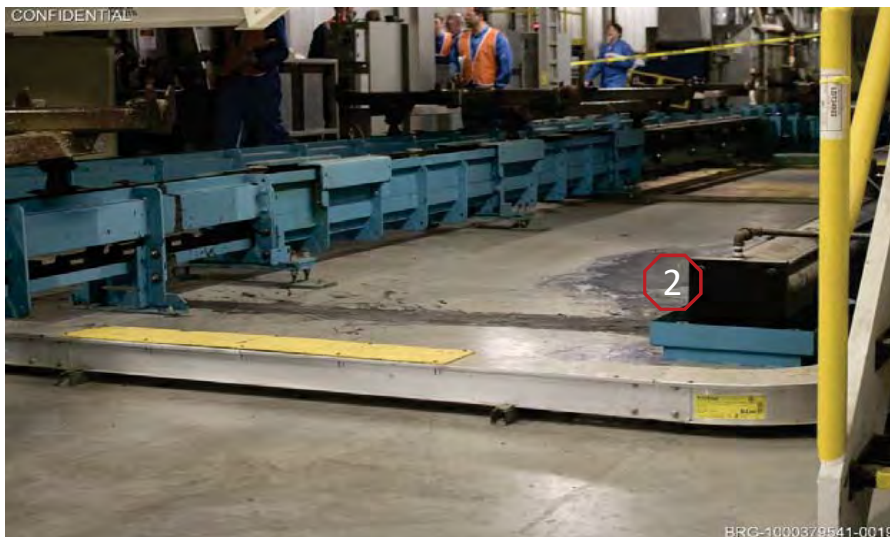
Picture 100037954-4 - Electric Drive

Electric Drive

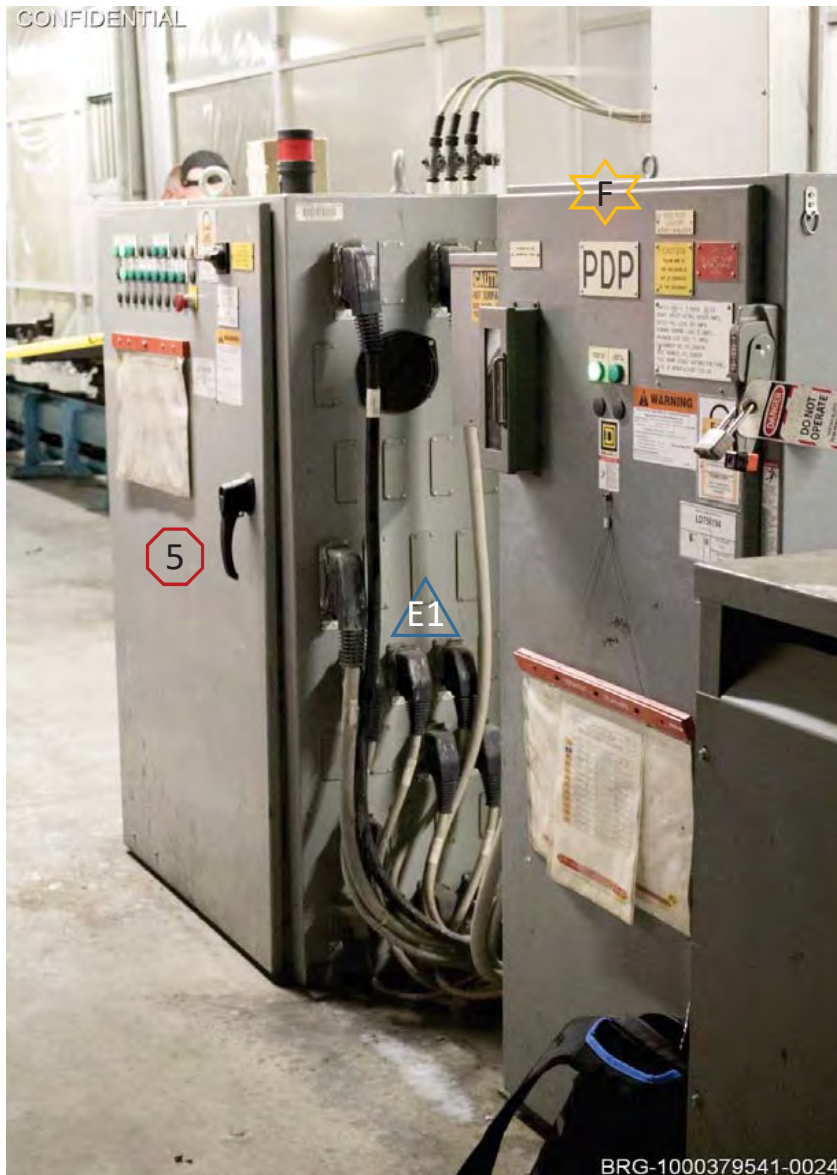
Picture 100037954-7 - Main Control Panel

The HMI control panel is attached to the building floor with lag bolts.

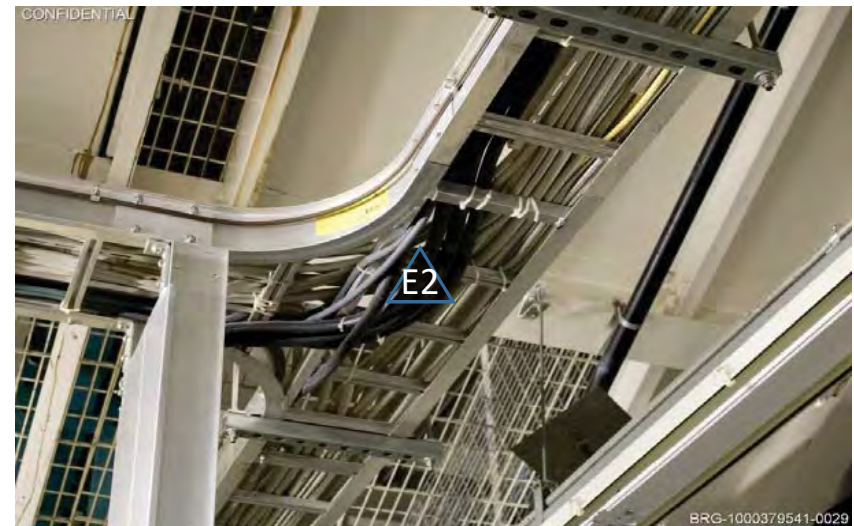
Picture 100037954-8 - Wiring

Electrical power and data are fed to the conveyor through loose wiring contained in reconfigurable metal cable trays.
-

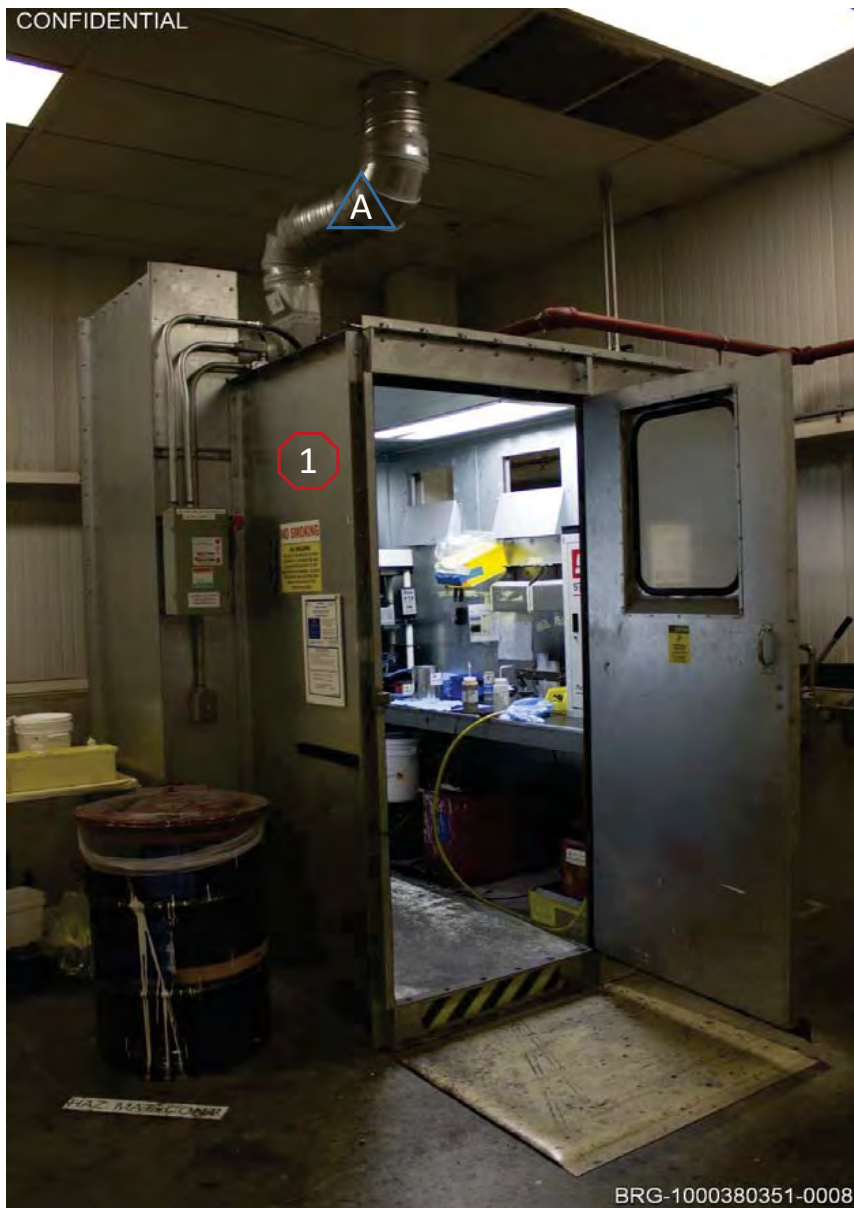
Picture 100038035-1 - Paint Mix Enclosure

Ventilation ducting is attached to the top of the paint mix enclosure.

Asset ID 100038035 consists of a small, self-contained paint mixing room (the "Paint Mix Room") located at GM's Lansing Delta Township assembly plant within the general assembly area. The Paint Mix Room is manufactured by Global Finishing Solutions and is used as a vented enclosure to mix small quantities of paint for minor paint repairs to vehicles at the end of the final assembly line. The asset is constructed from modular single skin panels utilizing nut and bolt fasteners and is attached to the building floor with lag bolts.

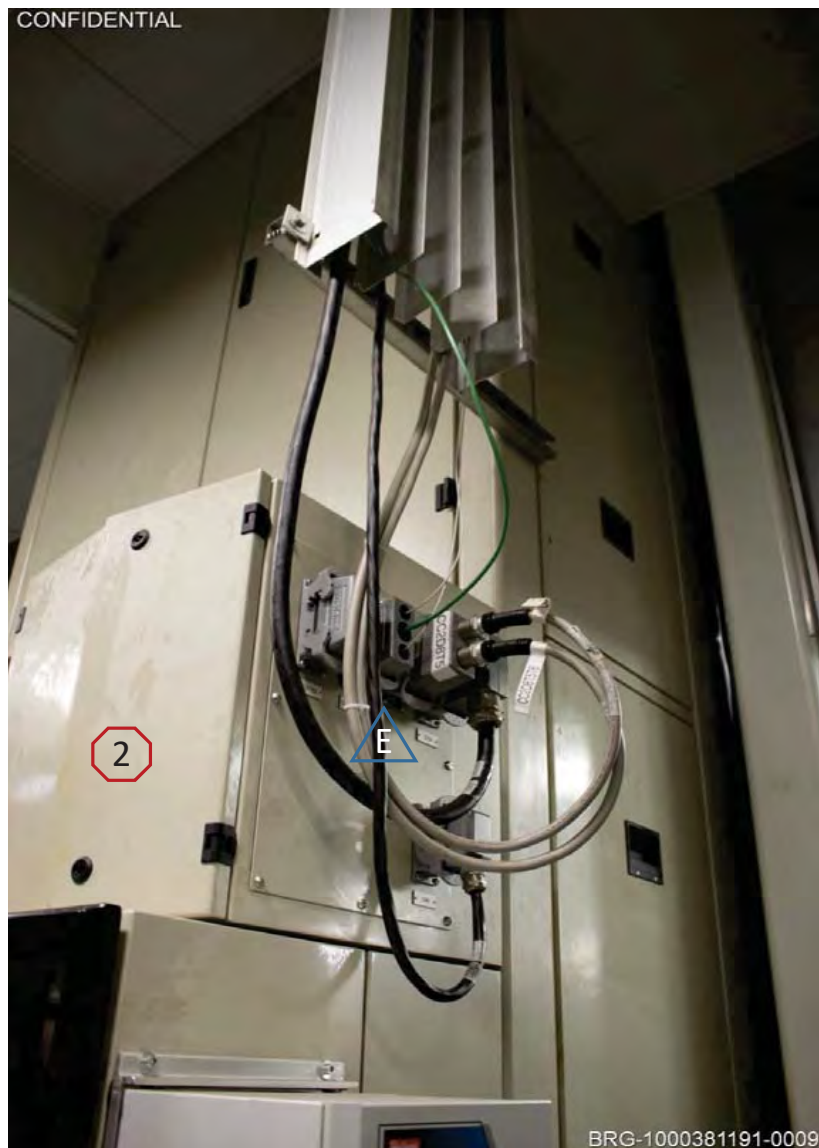
Picture 100038119-4 - Top Application Machine

Top Application Machine

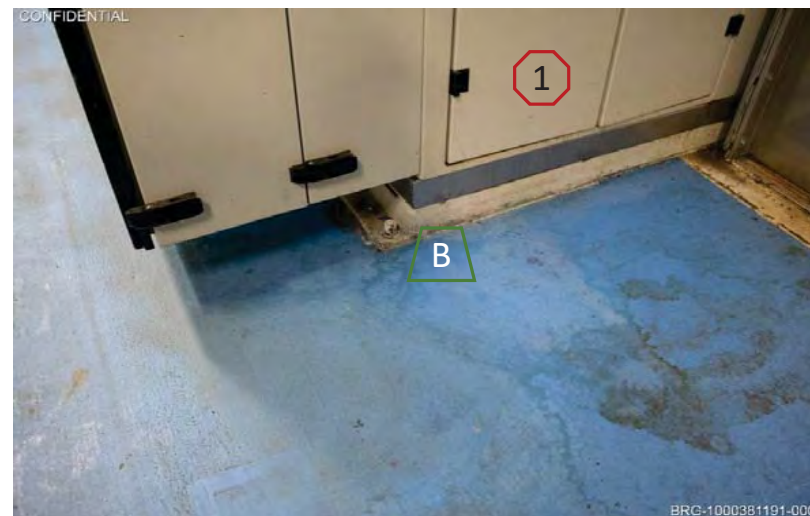
Picture 100038119-5 - Side Application Machine

The side application machines are installed through the booth walls. A flexible gasket/seal covered with a metal panel fits between the spray booth wall and the machine to prevent leakage of air from the booth.

E The data and control wiring is fed to the side application machines through loose wiring and is equipped with quick disconnect fittings for easy separation.

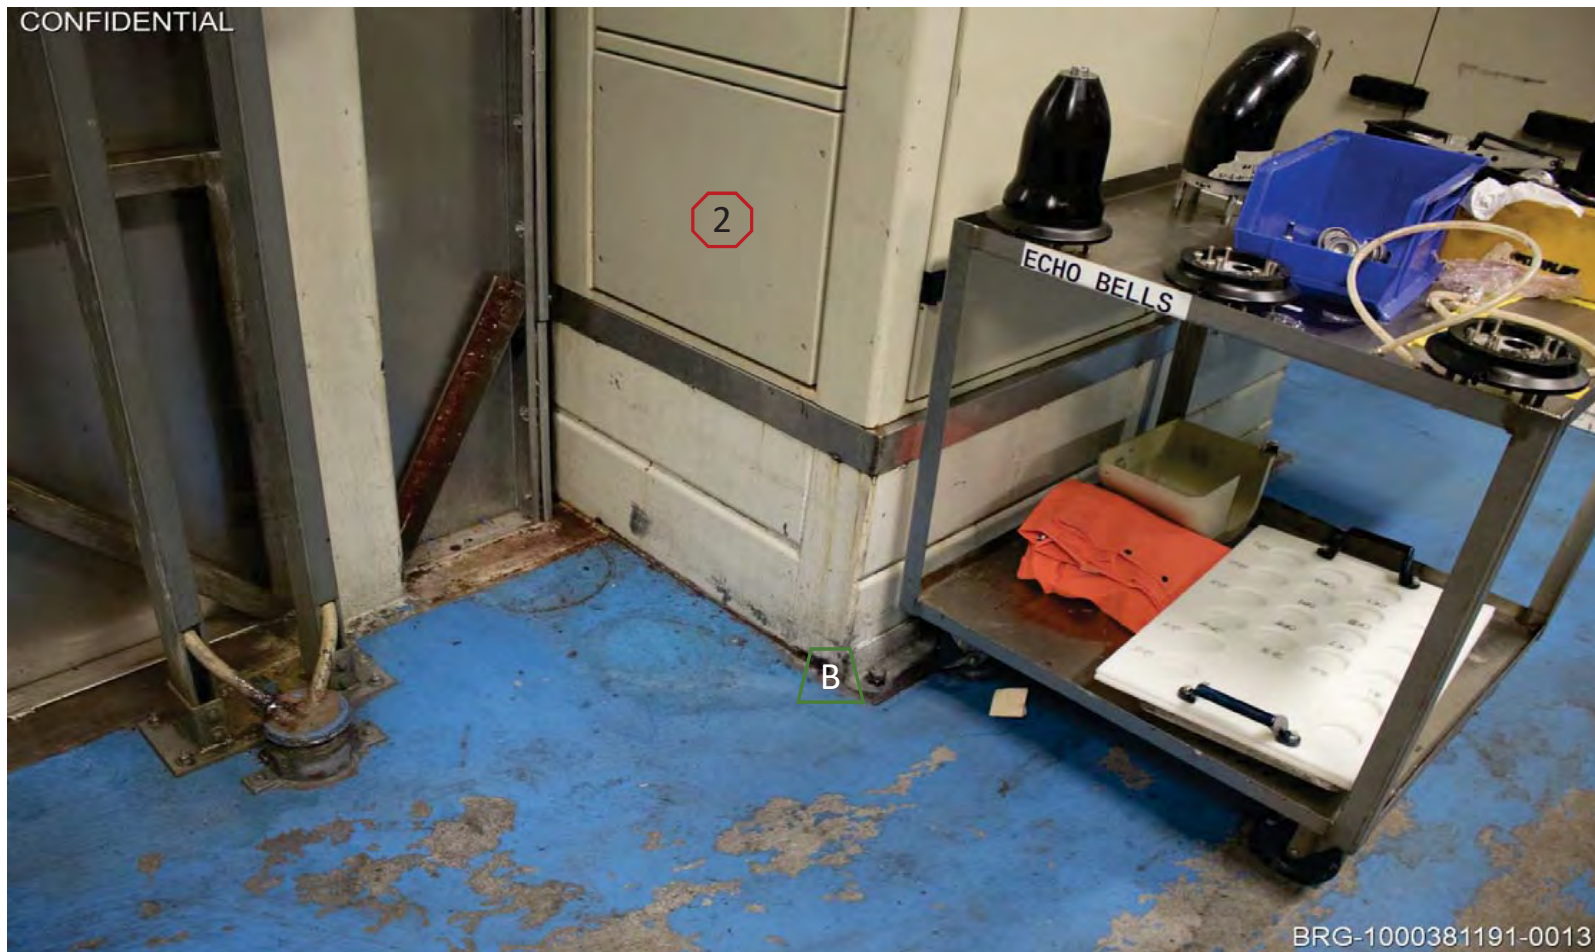
Picture 100038119-6 - Top Application Machine

2 Top Application Machine

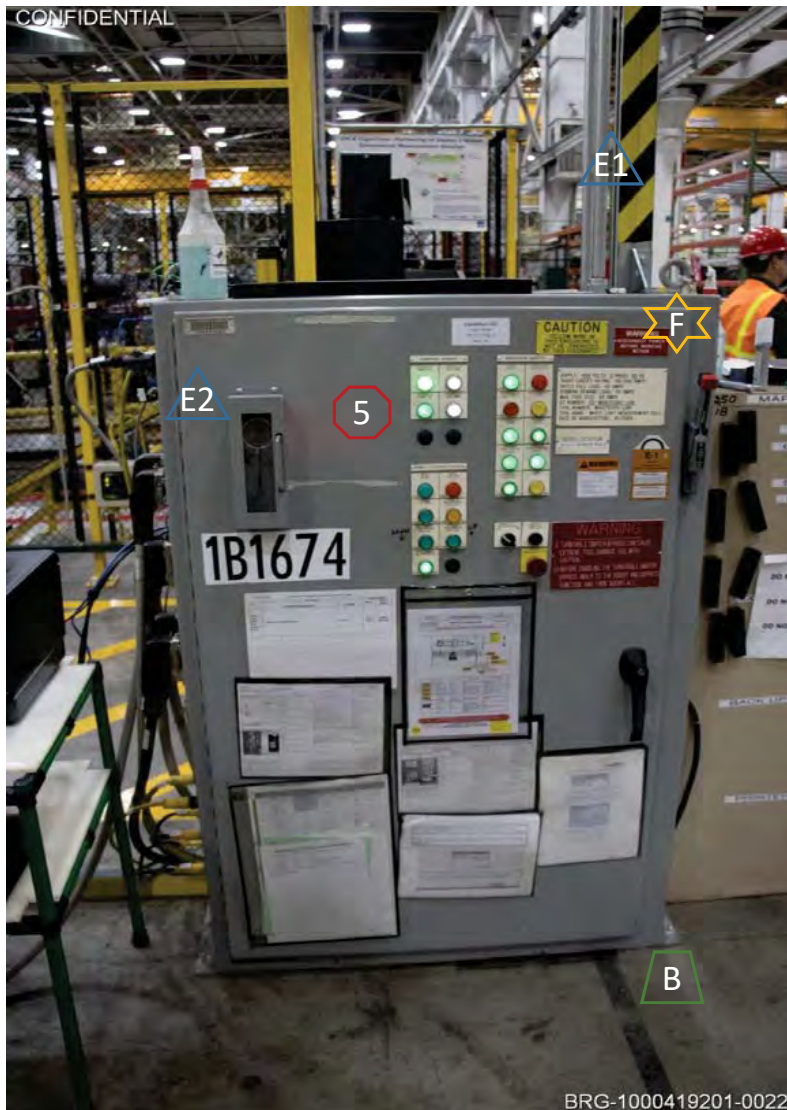
Picture 100041920-3 - Control

Eye bolts mounted on top of the control act as lift points.

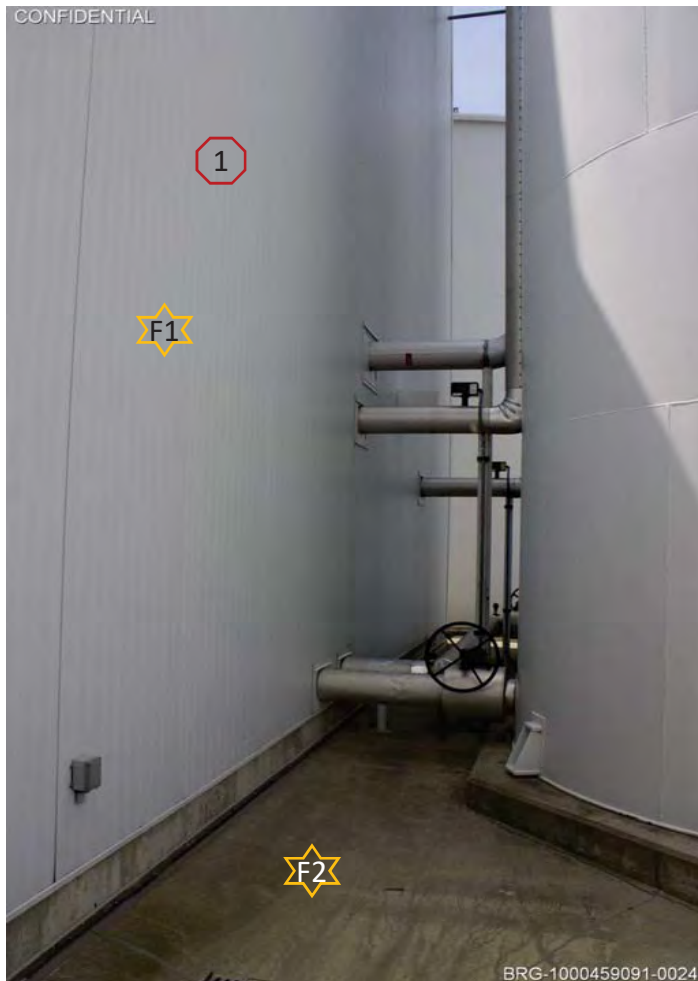
Picture 100045909-3 - CUC Building (Exterior)

The CUC building rests upon a concrete slab foundation.
- 1
