**UNITED STATES BANKRUPTCY COURT
SOUTHERN DISTRICT OF NEW YORK**

MOTORS LIQUIDATION COMPANY, f/k/a
GENERAL MOTORS CORPORATION, *et al.*,

Plaintiff's Representative Assets Appendix

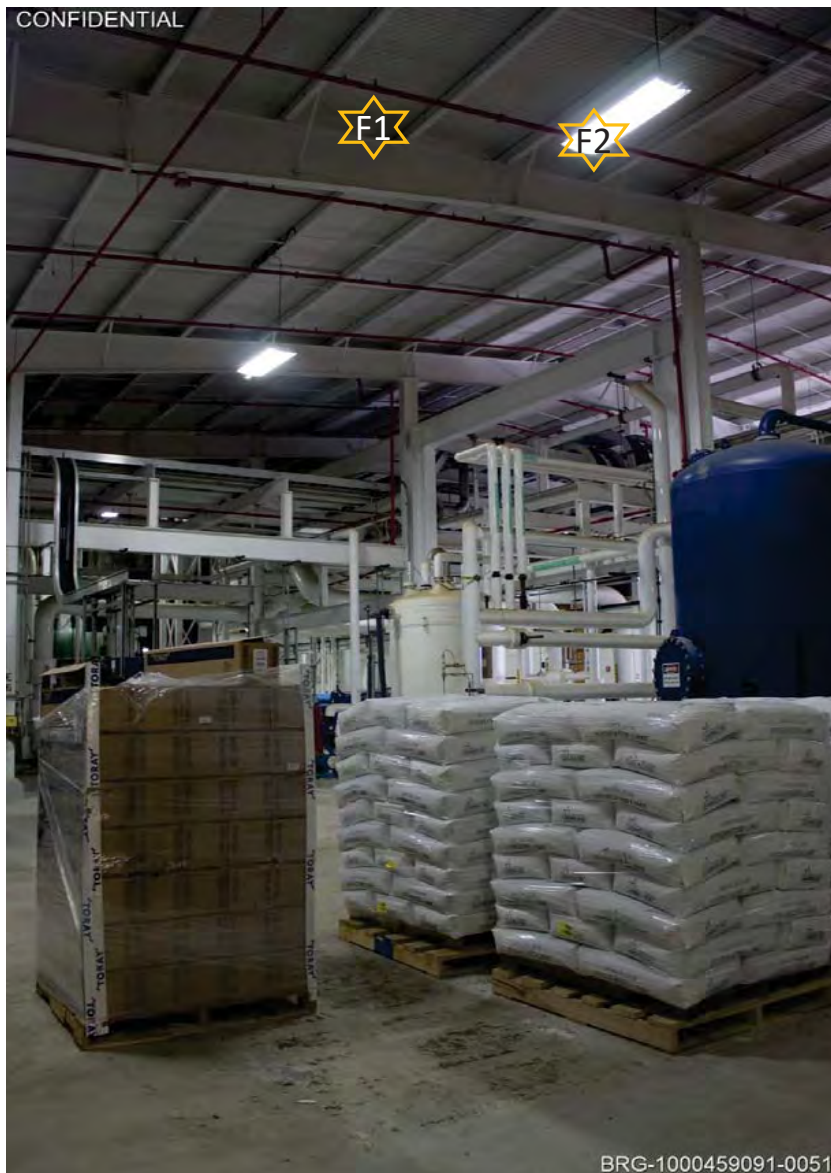
Picture 100045909-5 - CUC Building (Interior)

The CUC building rests upon a concrete slab foundation.
- W

The CUC building contains sprinkler systems for fire protection.

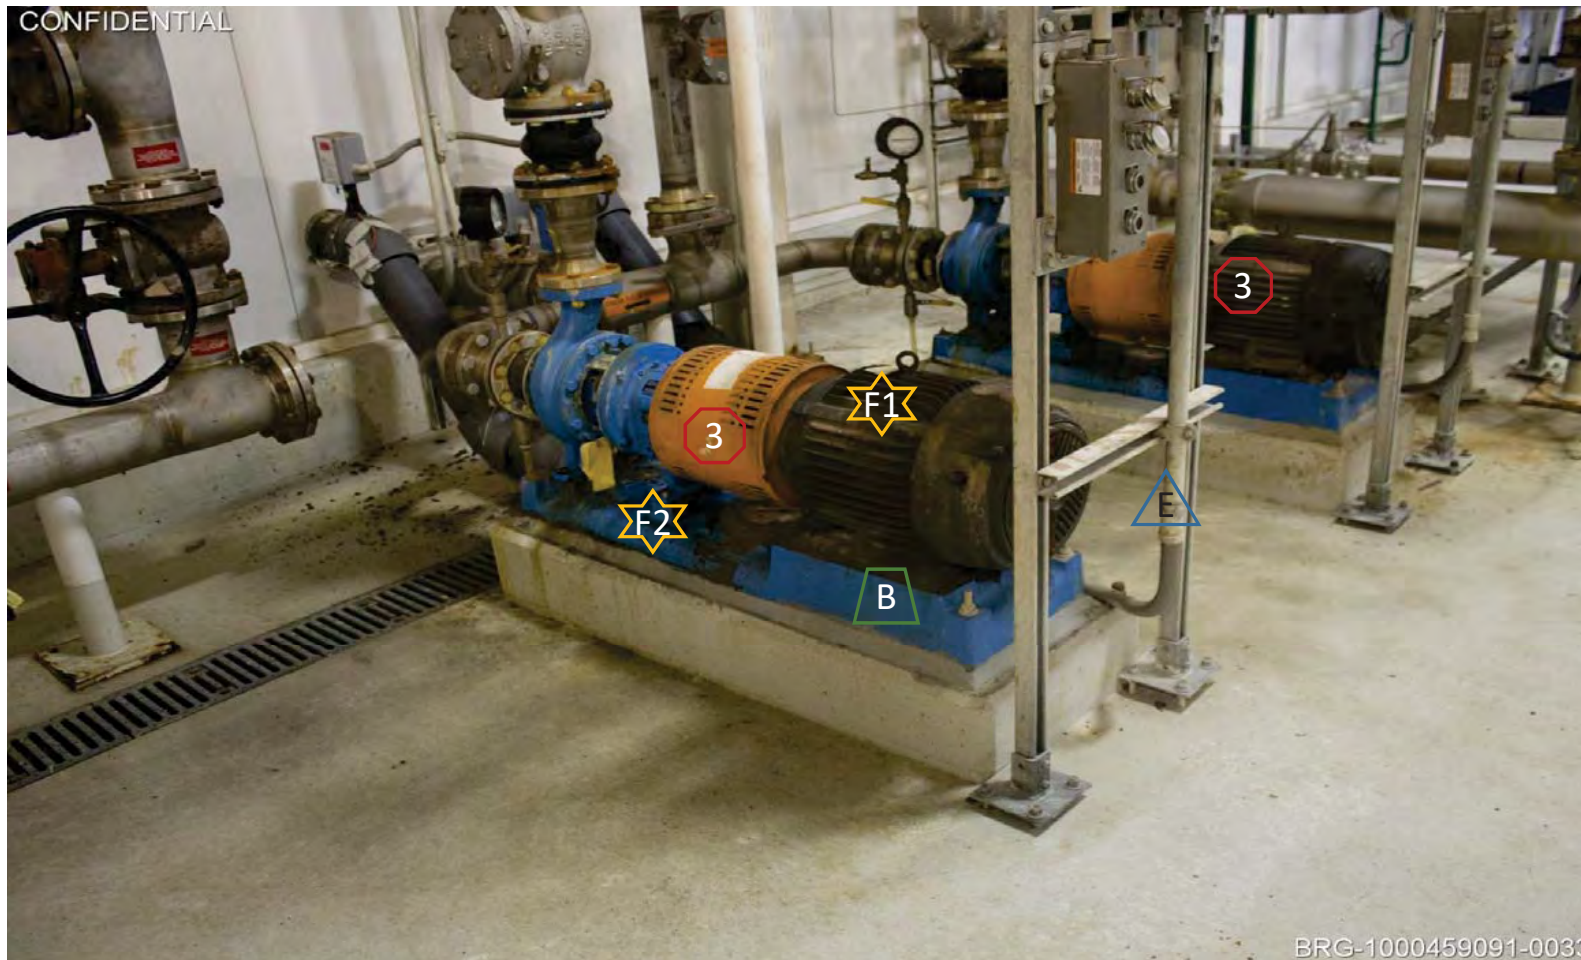
Picture 100045909-11 - CUC Pumps

3 CUC Pumps

The pumps are mounted on a steel skid. A thin layer of grout is applied around the skid to prevent liquid accumulation under the skid.

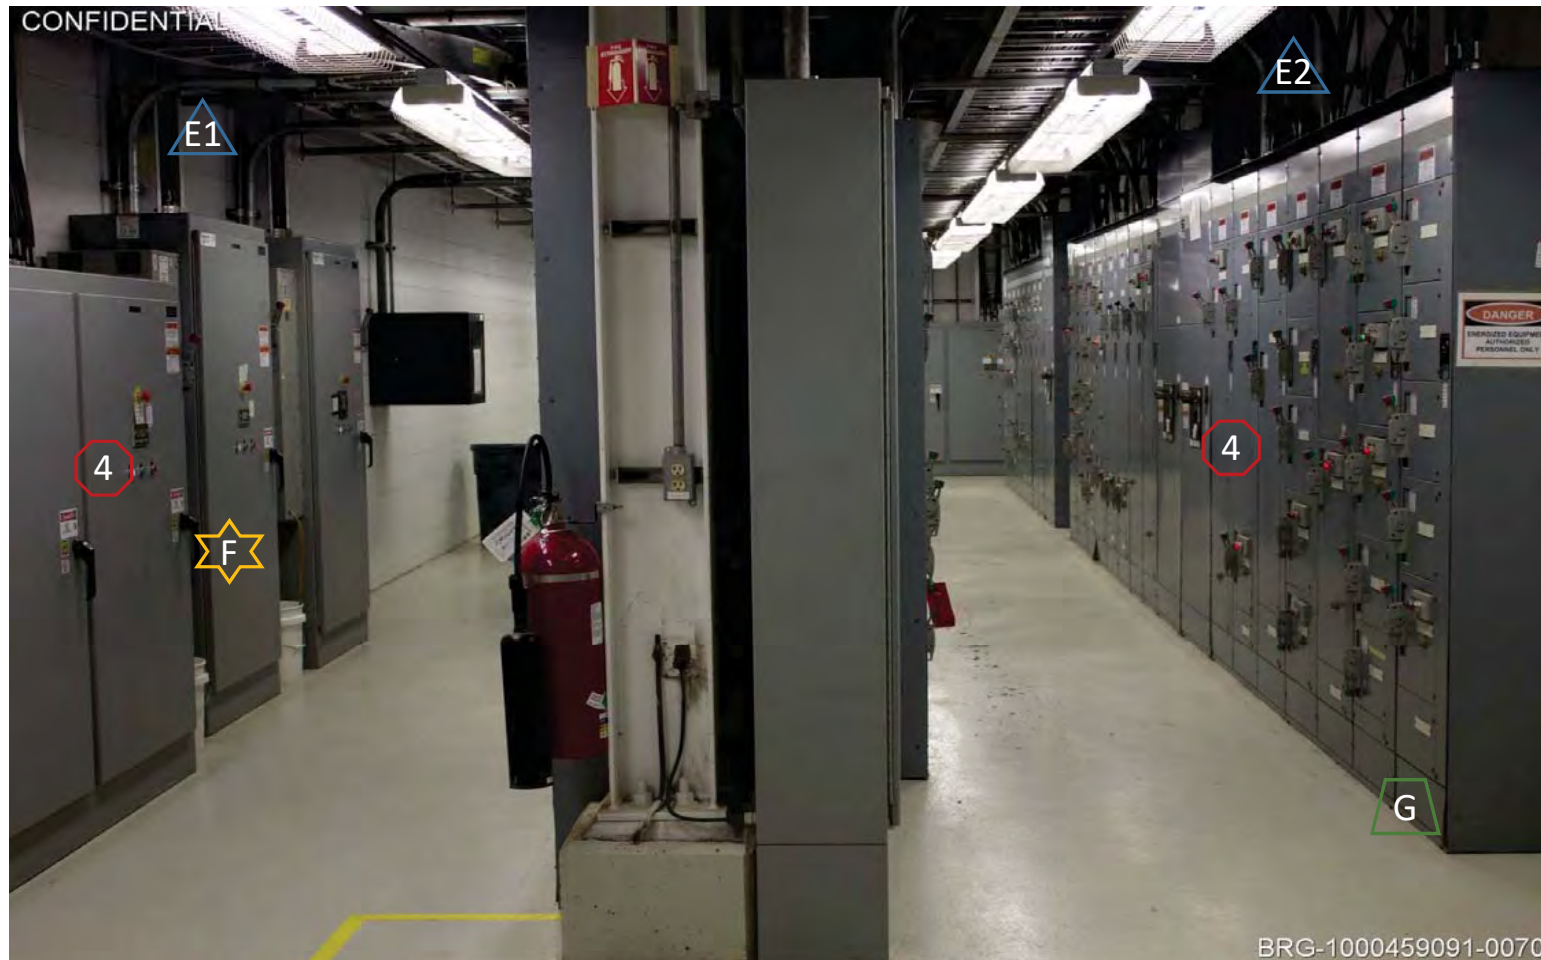
Picture 100045909-12 - Electrical Power Distribution

Electrical power is transmitted through loose cabling contained in reconfigurable metal cable trays.

Motor control cabinets, switchgear, and circuit breakers are typically self-contained and designed to enable movement after disconnection from utilities and the reality.

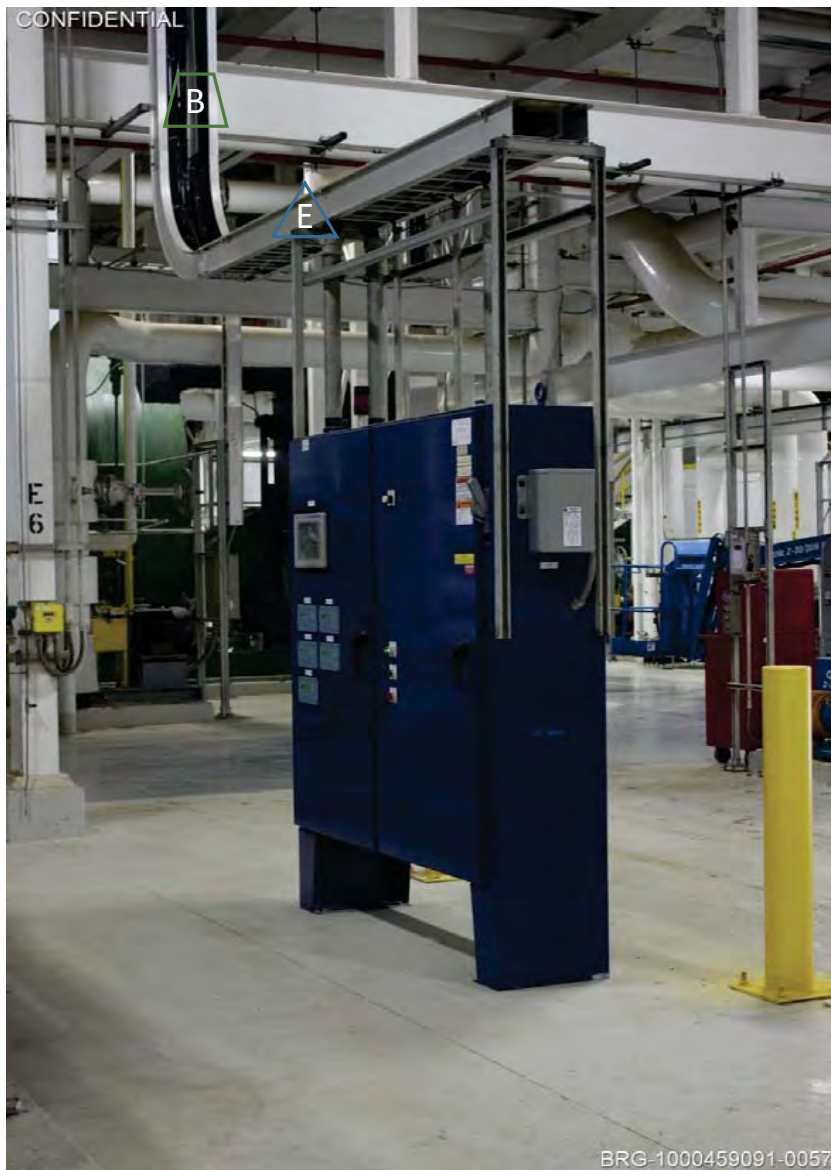
Picture 100045909-13 - Electrical Power Distribution (Wiring)

Electrical power is transmitted to assets within the CUC through loose cabling contained in reconfigurable metal cable trays.

The cable trays carrying the loose wiring are attached to beams in the building with bolted attachments.

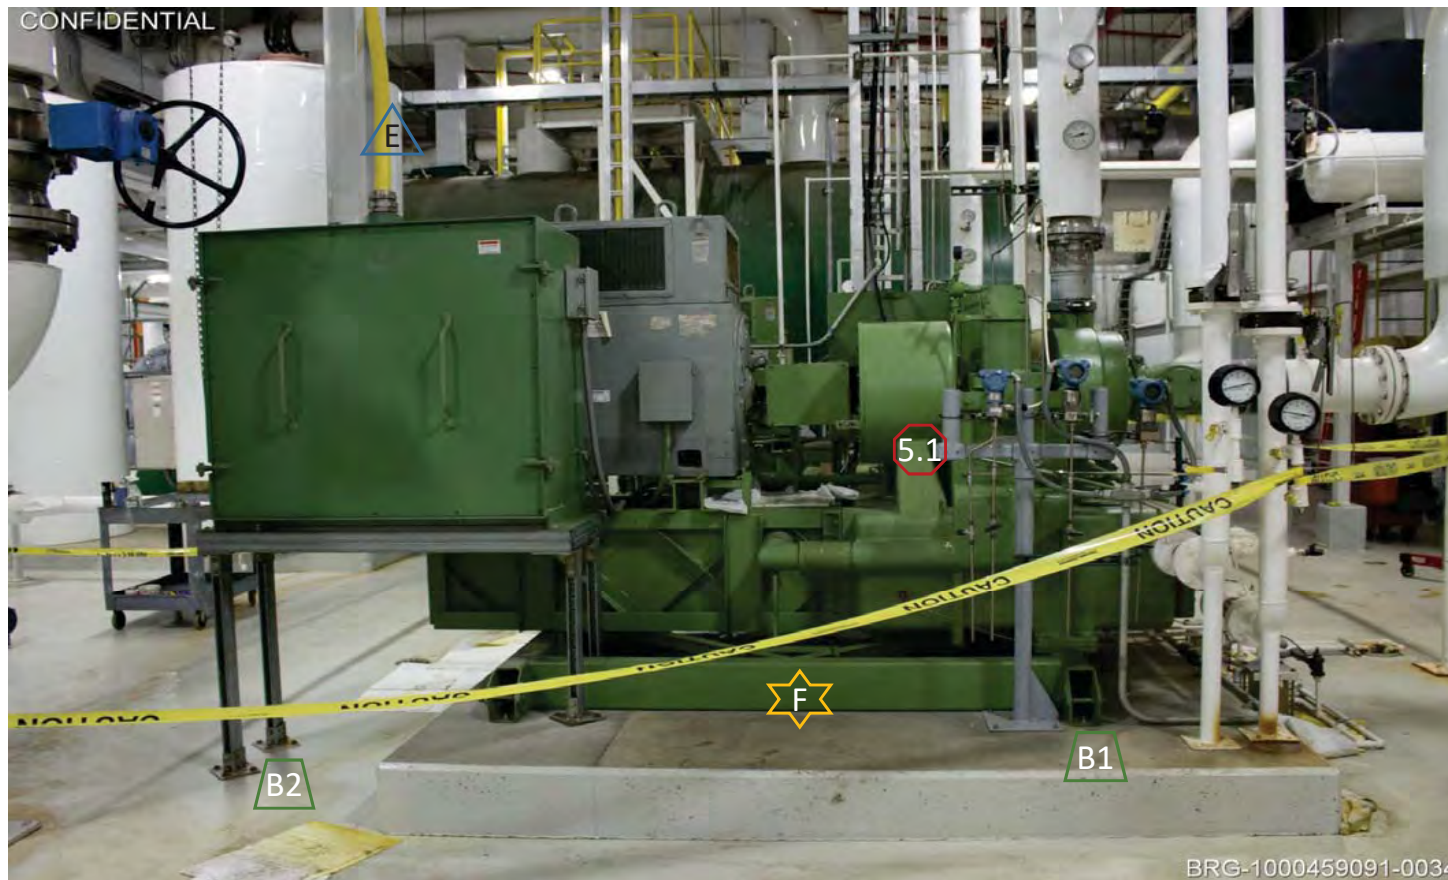
Picture 100045909-16 - Air Compressor

The air compressor is mounted on a steel skid with lift points at each corner of the skid.

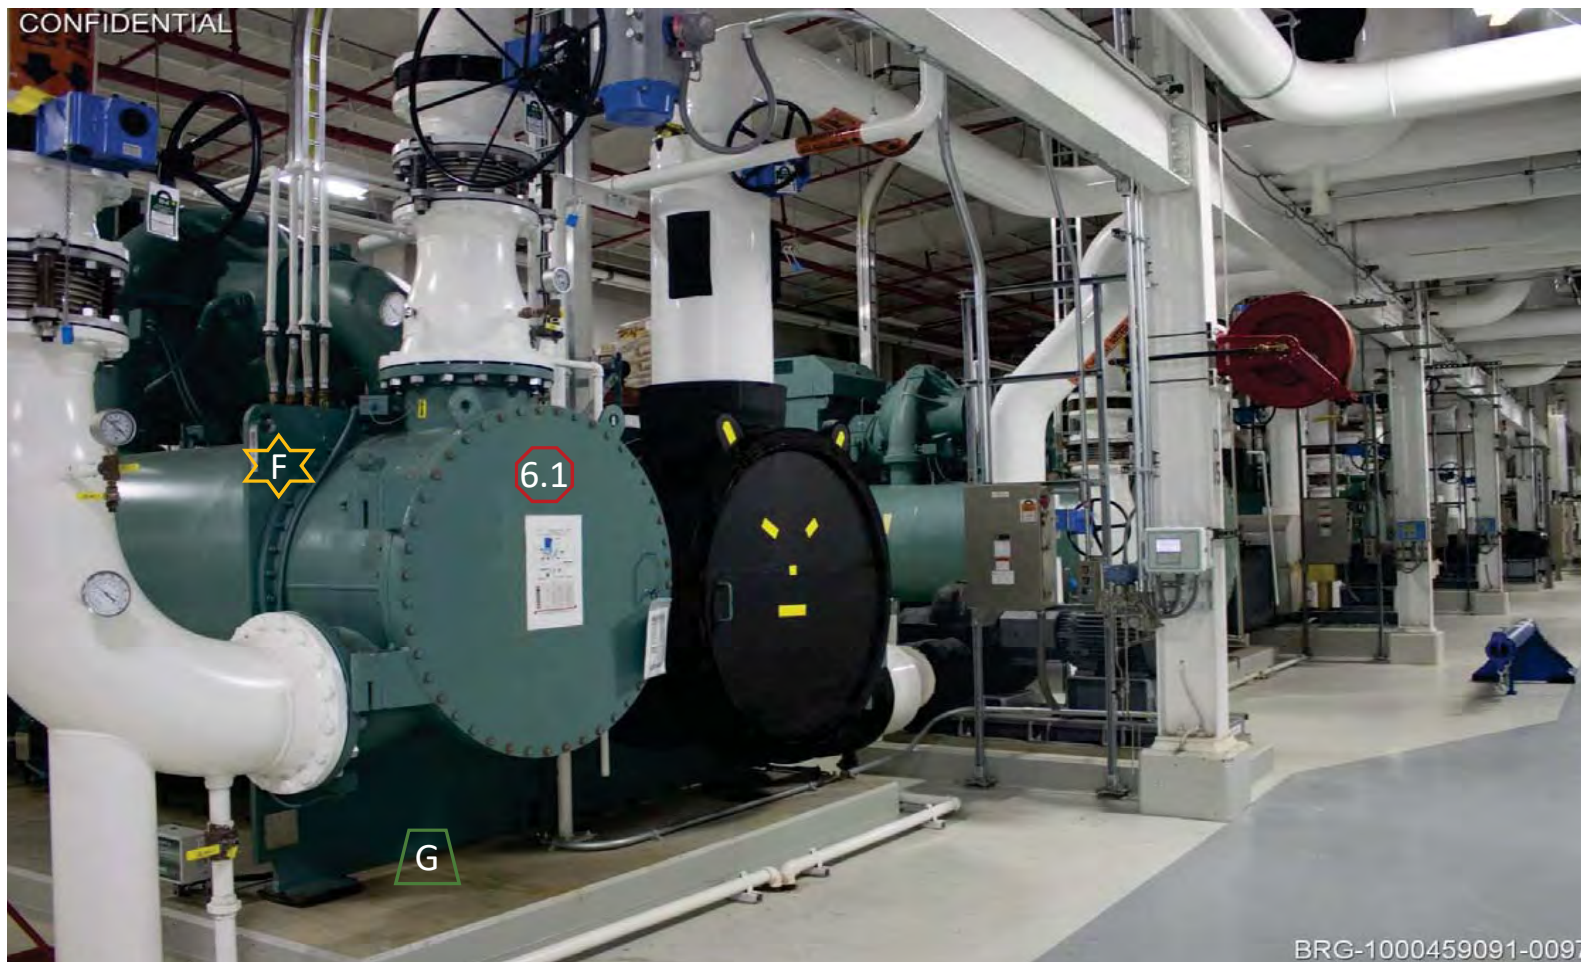
Picture 100045909-21 - Chillers

There are several lift points located on the chillers.

Centrifugal Chillers

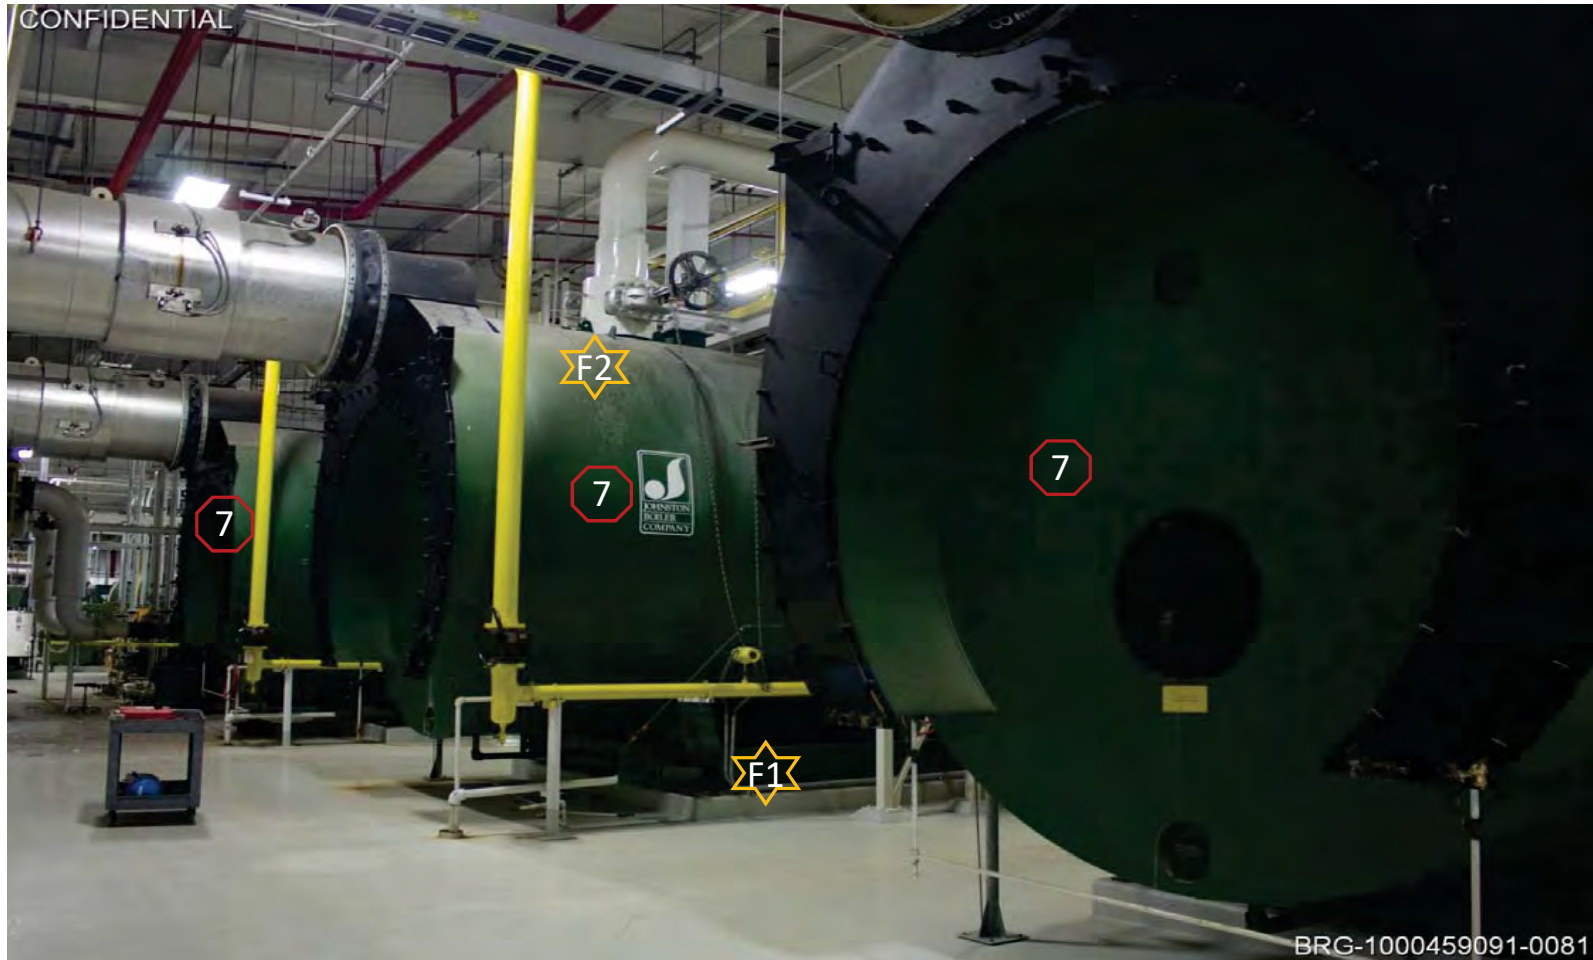
Picture 100045909-22 - Hot Water Boilers

The CUC boilers are mounted on steel skids that rest on 4 inch concrete pads without further attachment.

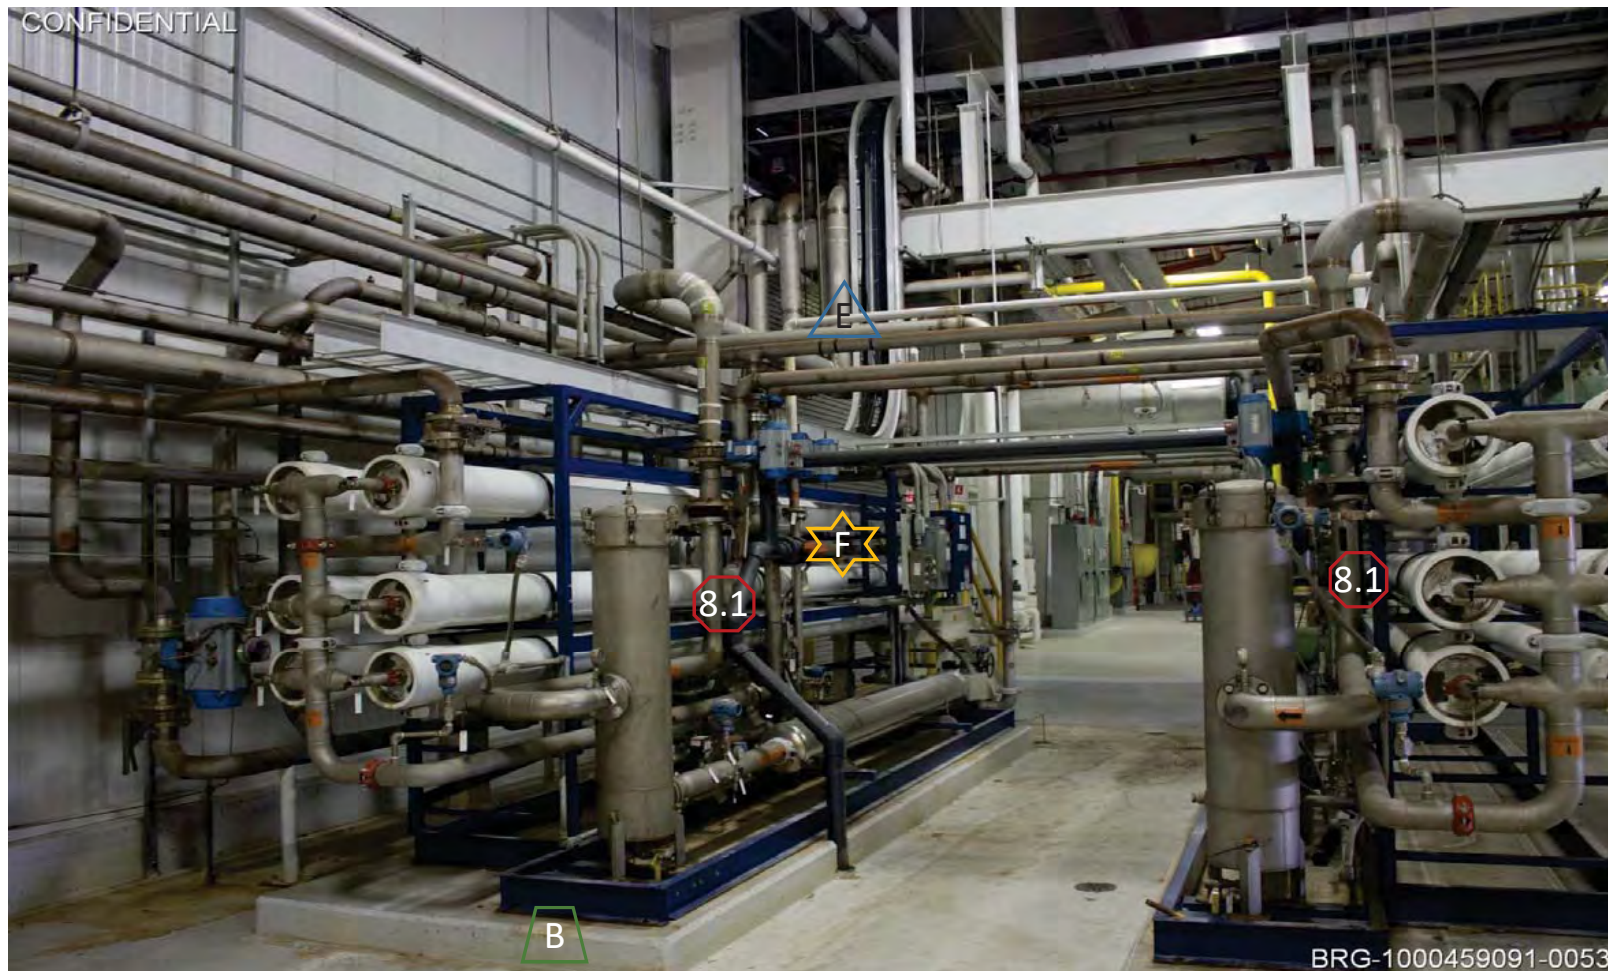
Picture 100045909-26 - Water Treatment System (Reverse Osmosis Units)

Reverse Osmosis Units

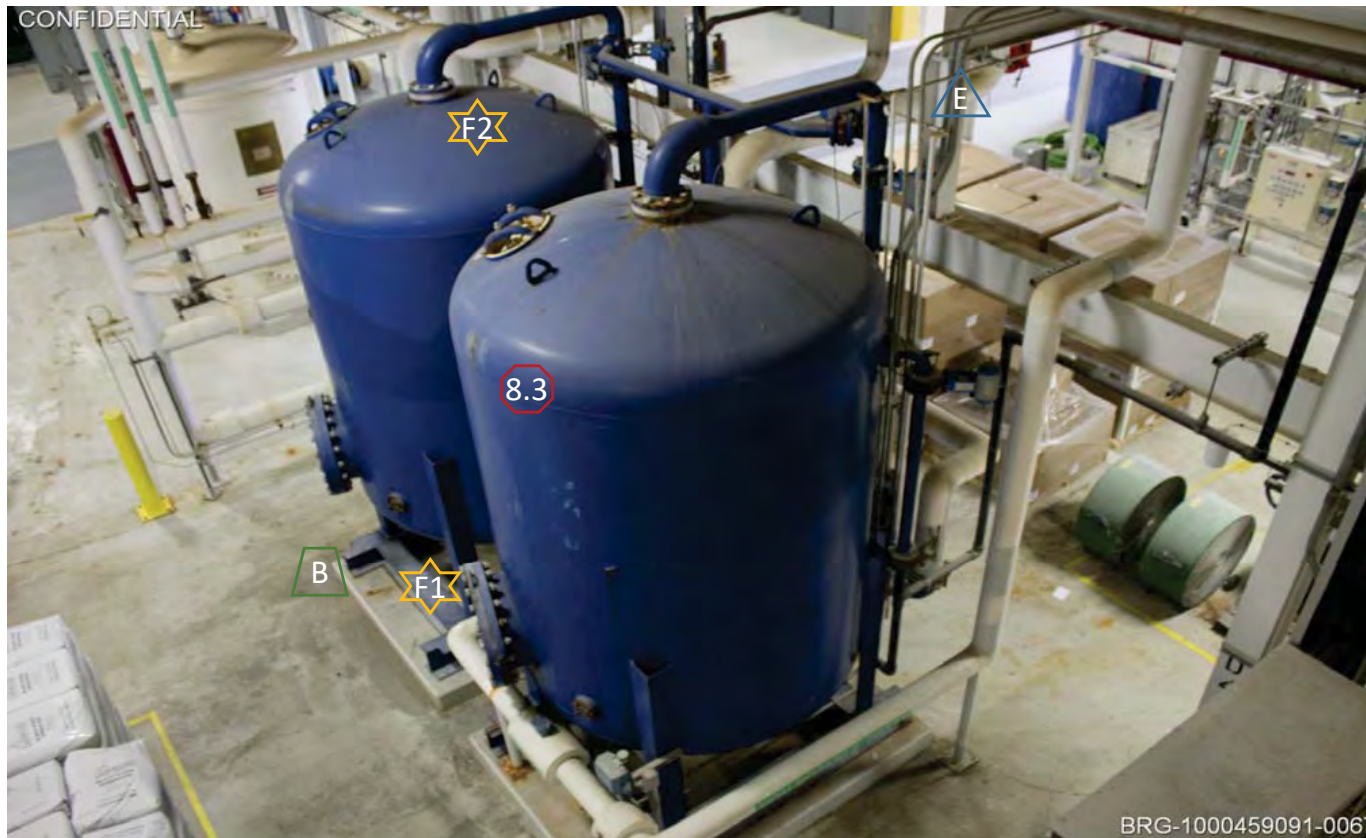
Picture 100045909-27 - Water Treatment System (Water Softening System)

Water Softening System

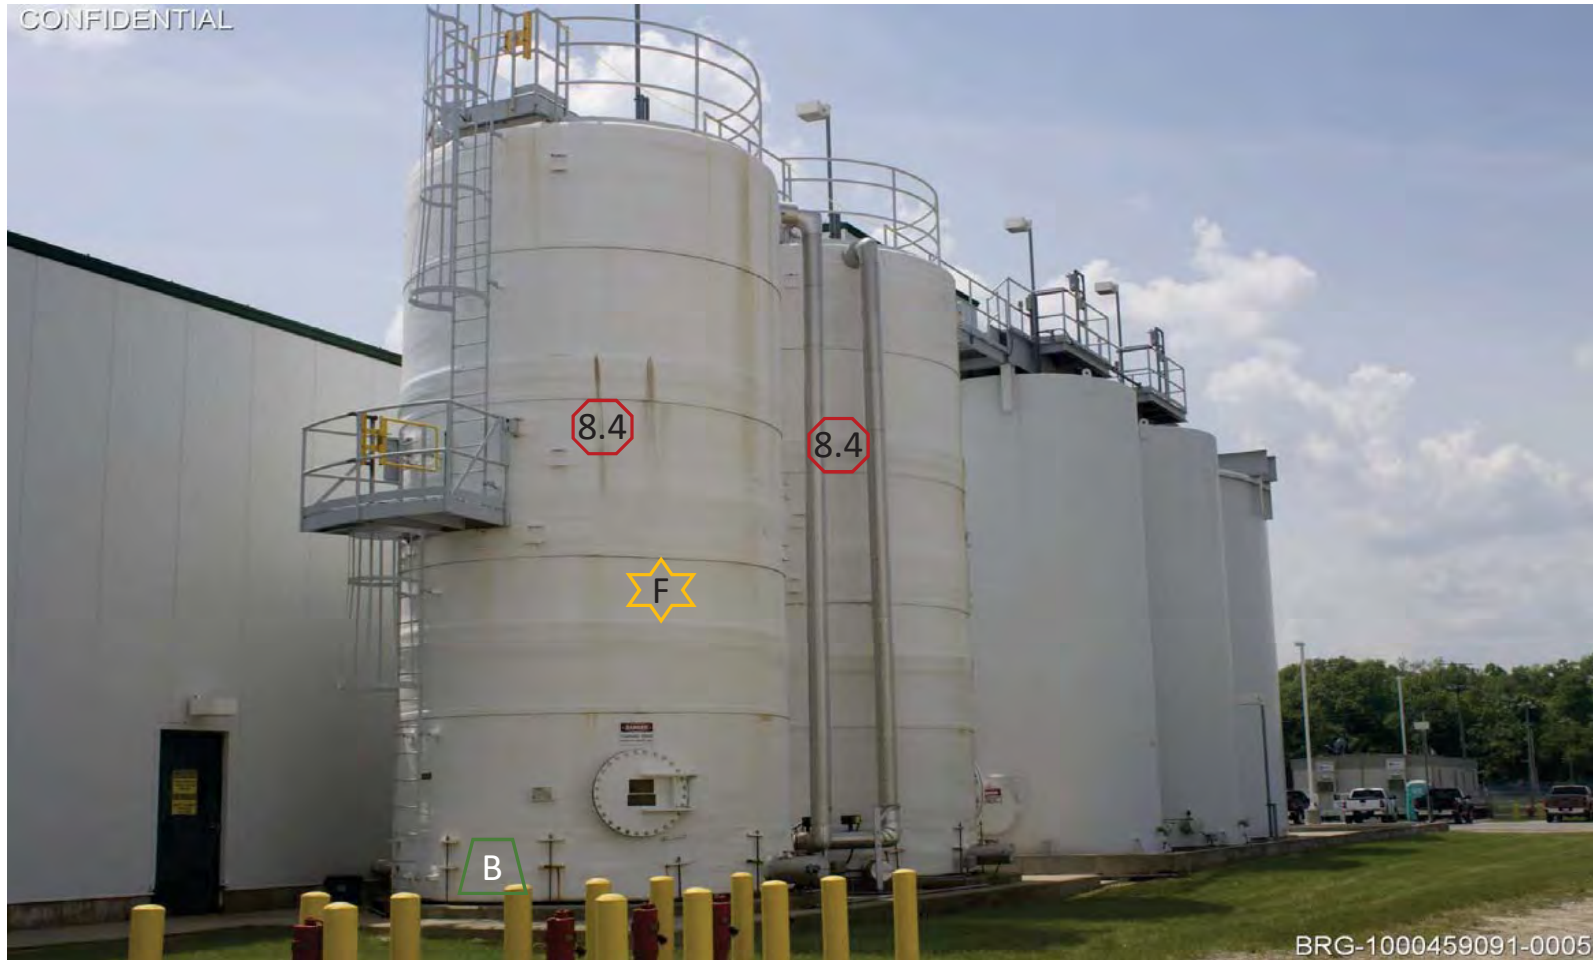
Picture 100045909-30 - Water Treatment System (Water Holding Tanks)

The water holding tanks are constructed of fiberglass.

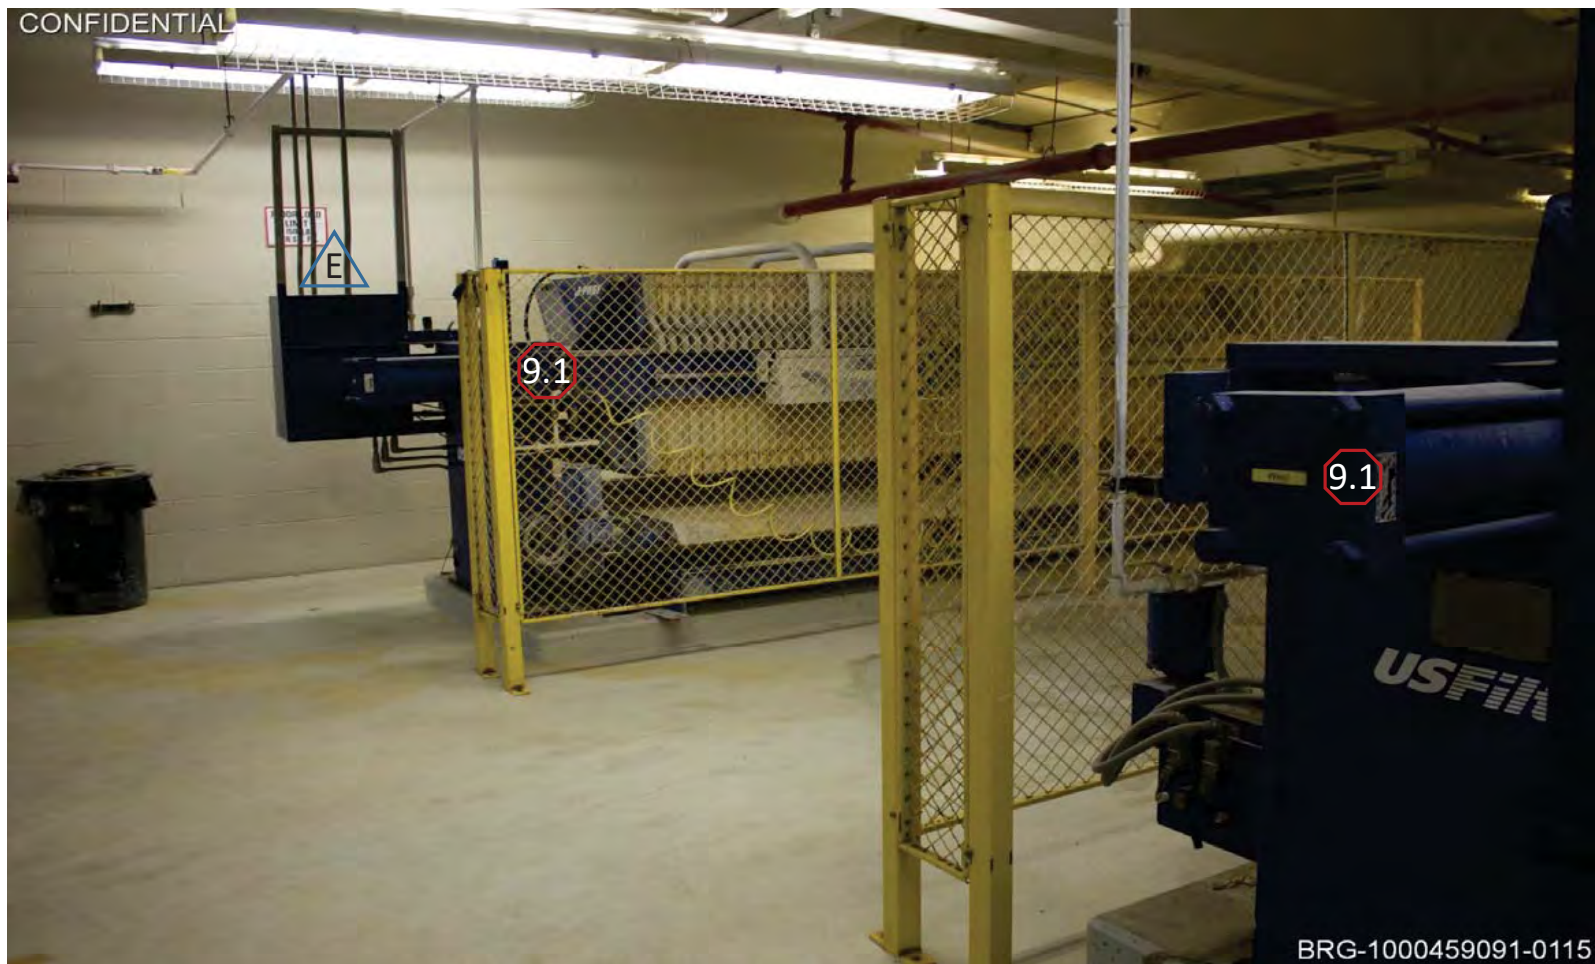
Picture 100045909-31 - Wastewater Treatment "WWT" (Filter Presses)

Incoming electrical power is delivered to the filter presses through wire in rigid conduit.

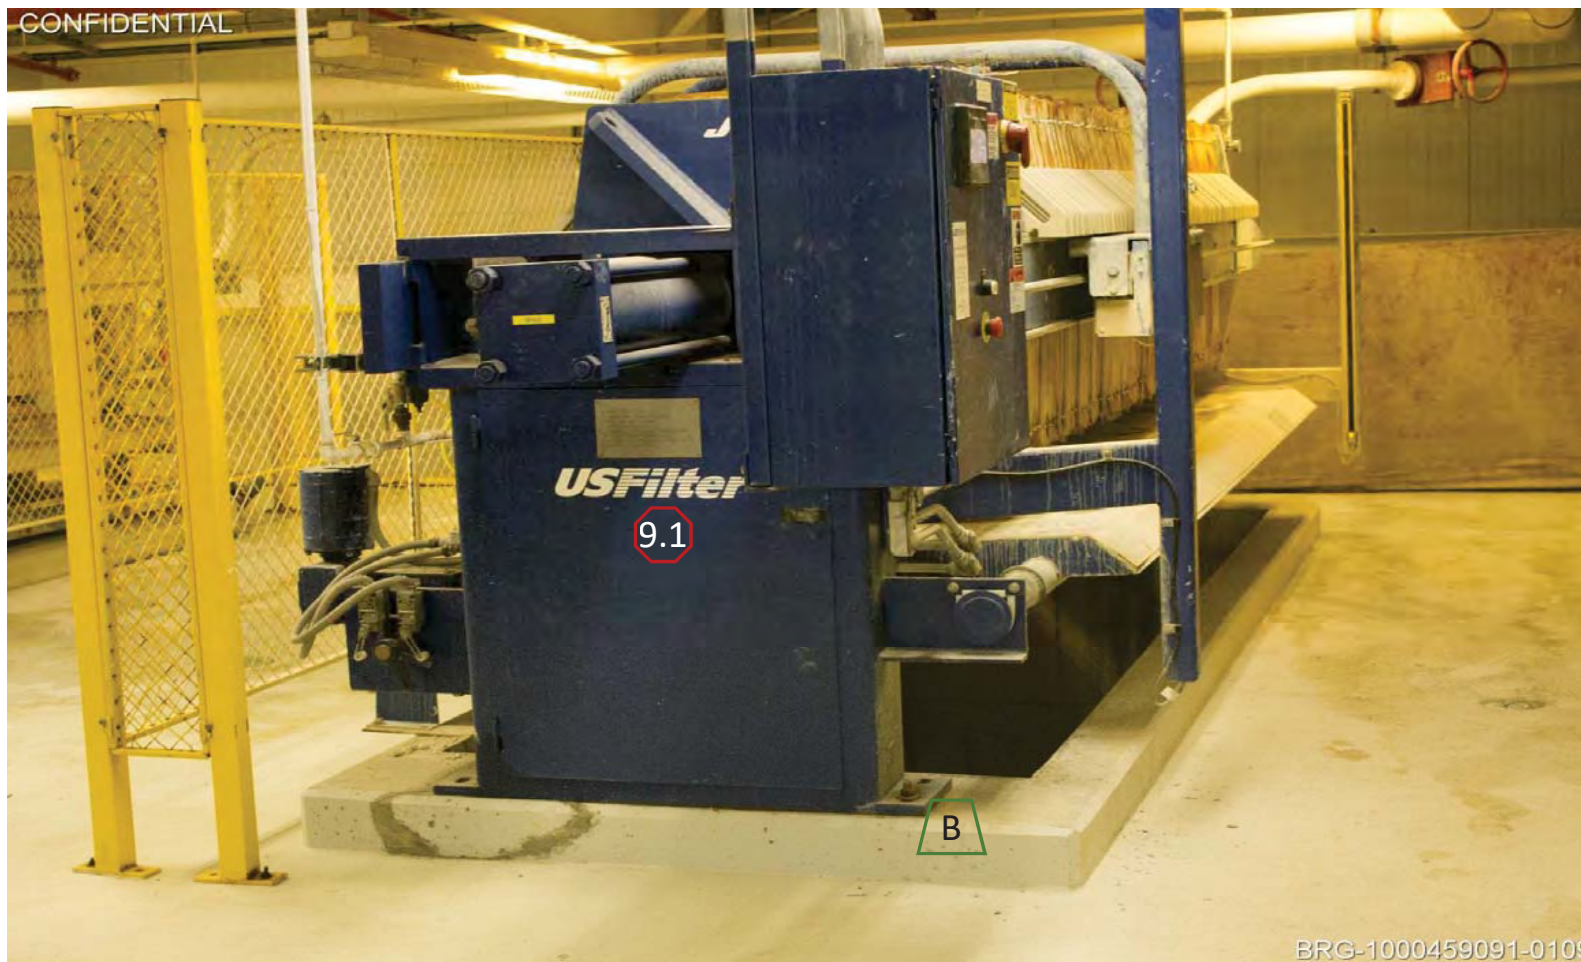
Picture 100045909-32 - WWT (Filter Presses)

Filter Presses

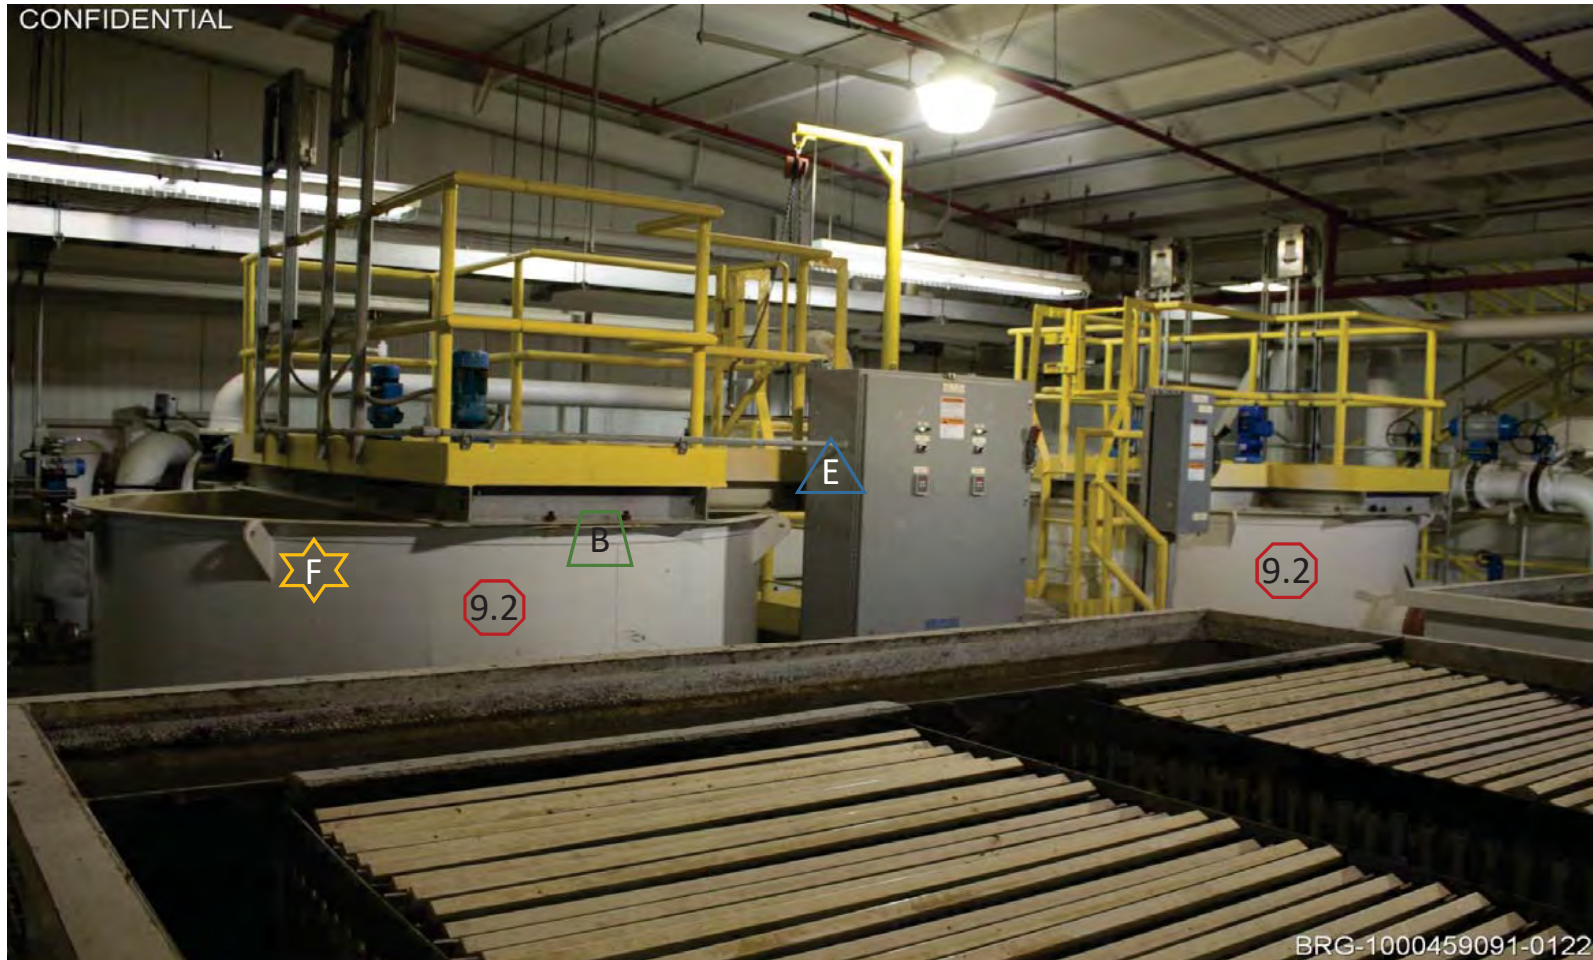
Picture 100045909-33 - WWT (Flocculation Tanks)

Lift points are welded to the top portion of each flocculation tank.

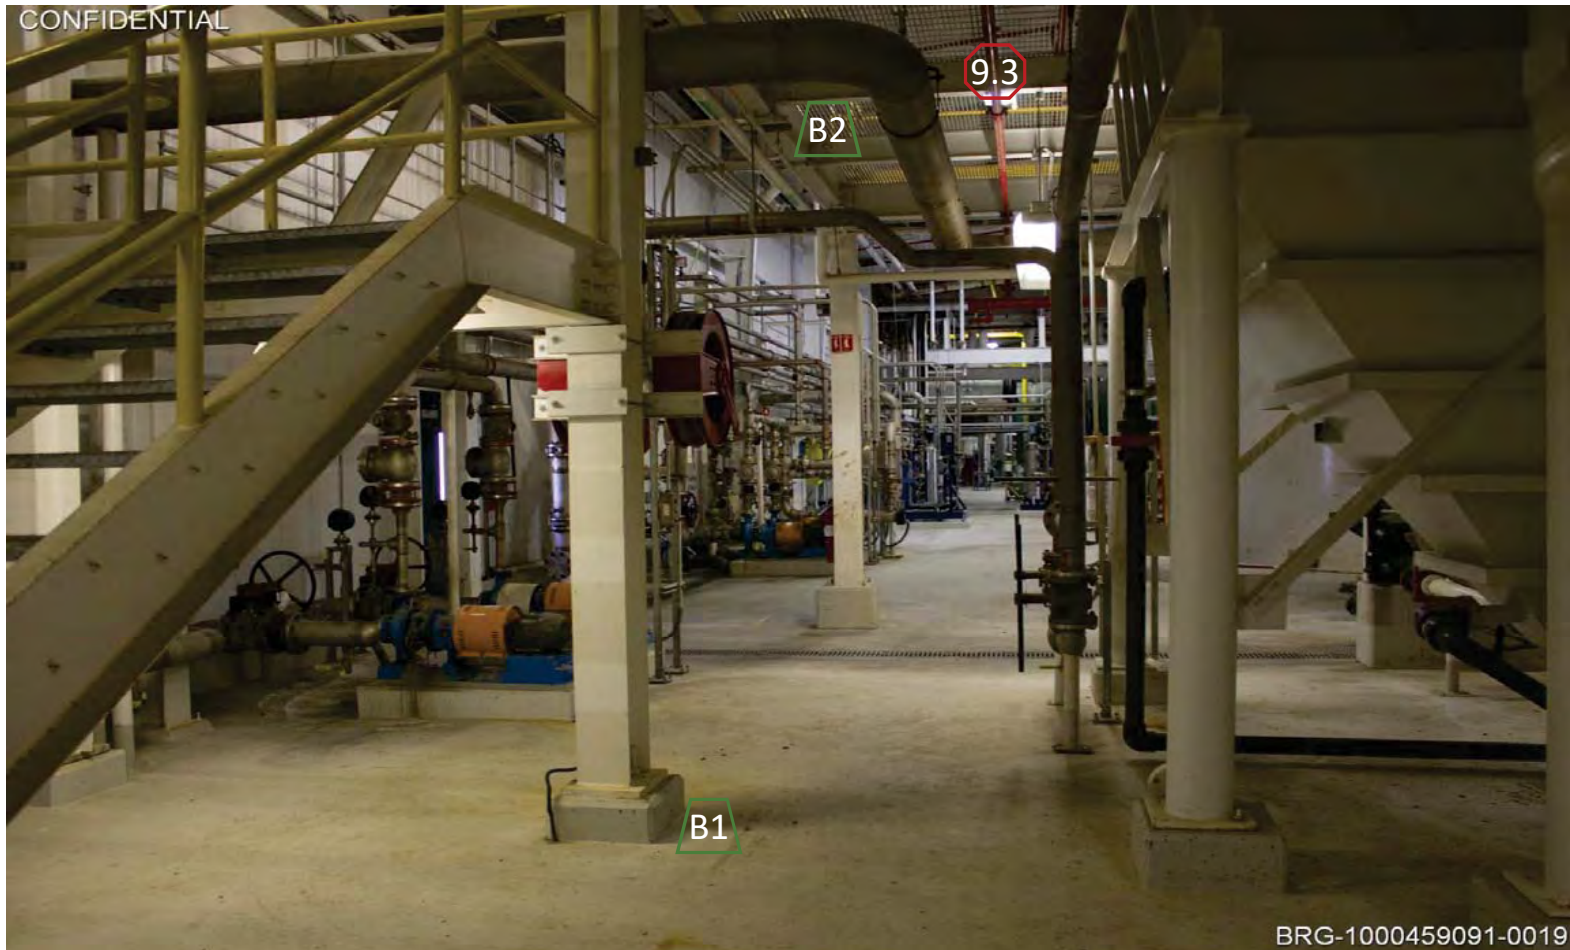
Picture 100045909-36 - WWT (Mezzanine)

The floor of the mezzanine is composed of grated steel decking.

The mezzanine structure is constructed out of steel beams which are connected with nut and bolt fasteners.

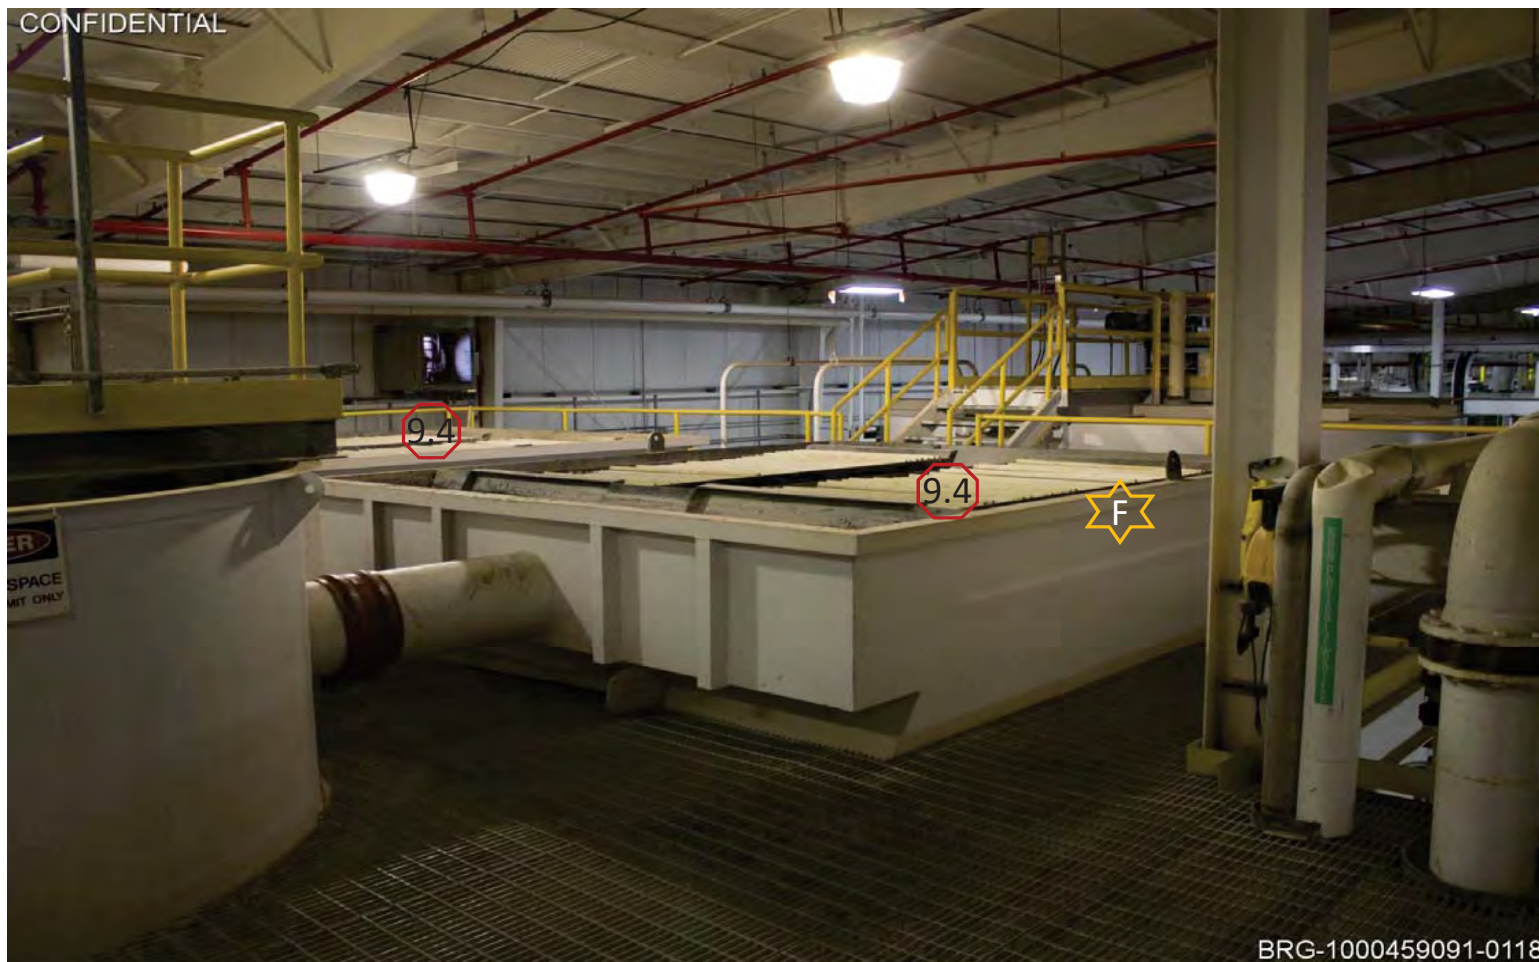
Picture 100045909-37 - WWT (Parallel Plate Clarifiers)

Parallel Plate Clarifiers

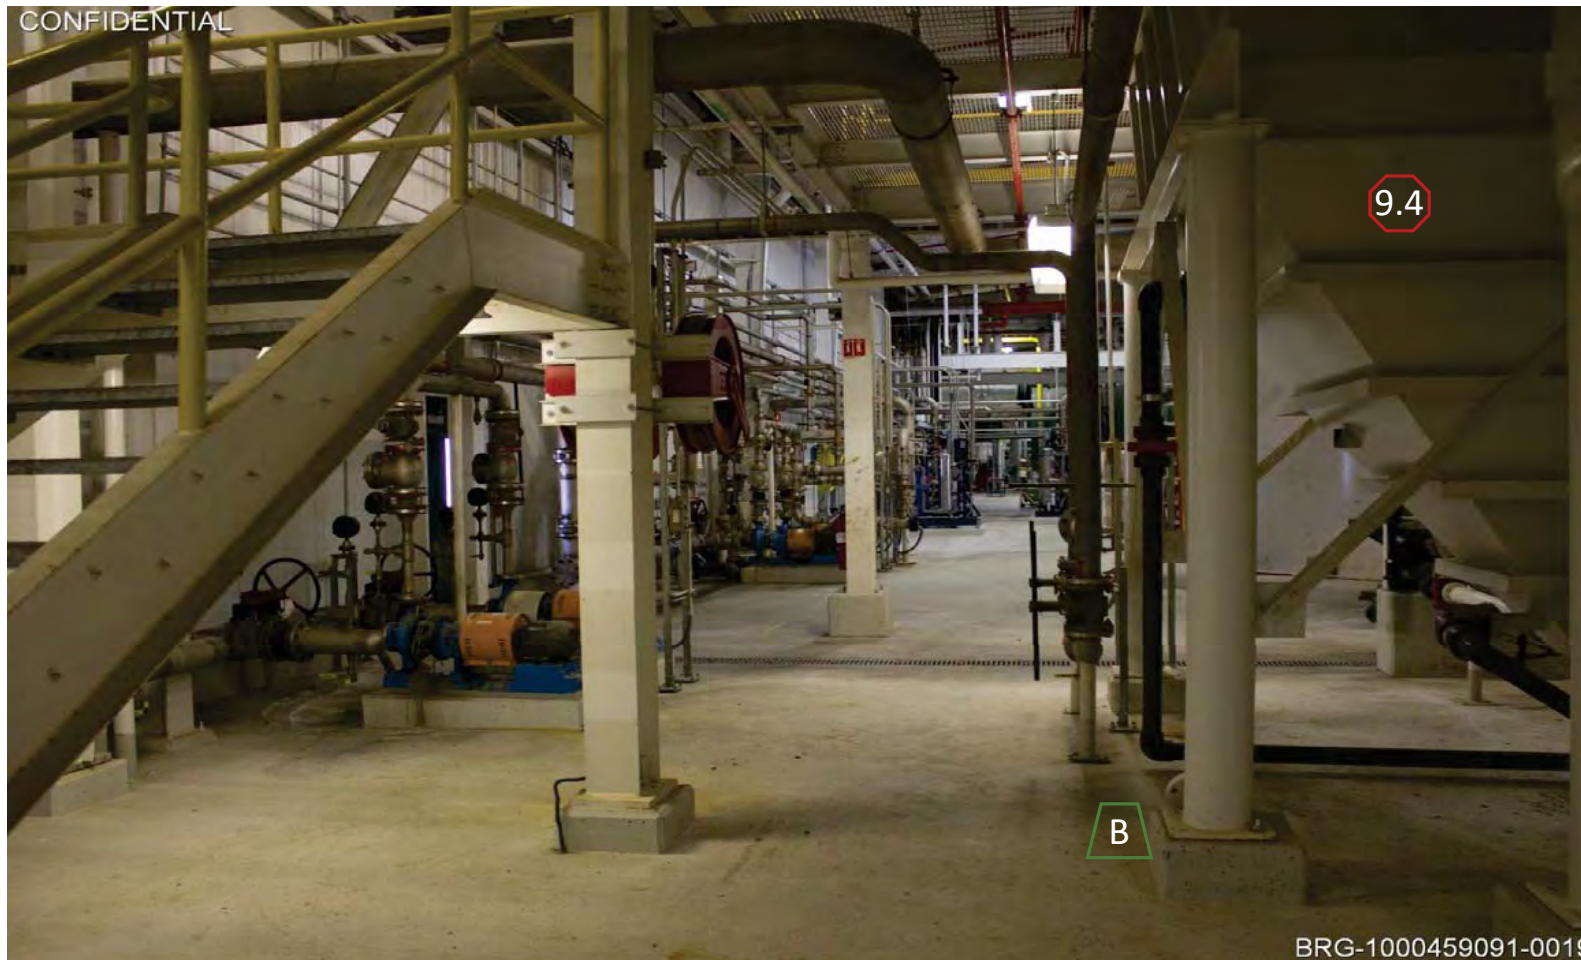
Picture 100045909-38 - WWT (Parallel Plate Clarifiers)

Each parallel plate clarifier has a set of two lift points welded to the top portion of the asset.
