**UNITED STATES BANKRUPTCY COURT
SOUTHERN DISTRICT OF NEW YORK**

MOTORS LIQUIDATION COMPANY, f/k/a
GENERAL MOTORS CORPORATION, *et al.*,

Plaintiff's Representative Assets Appendix

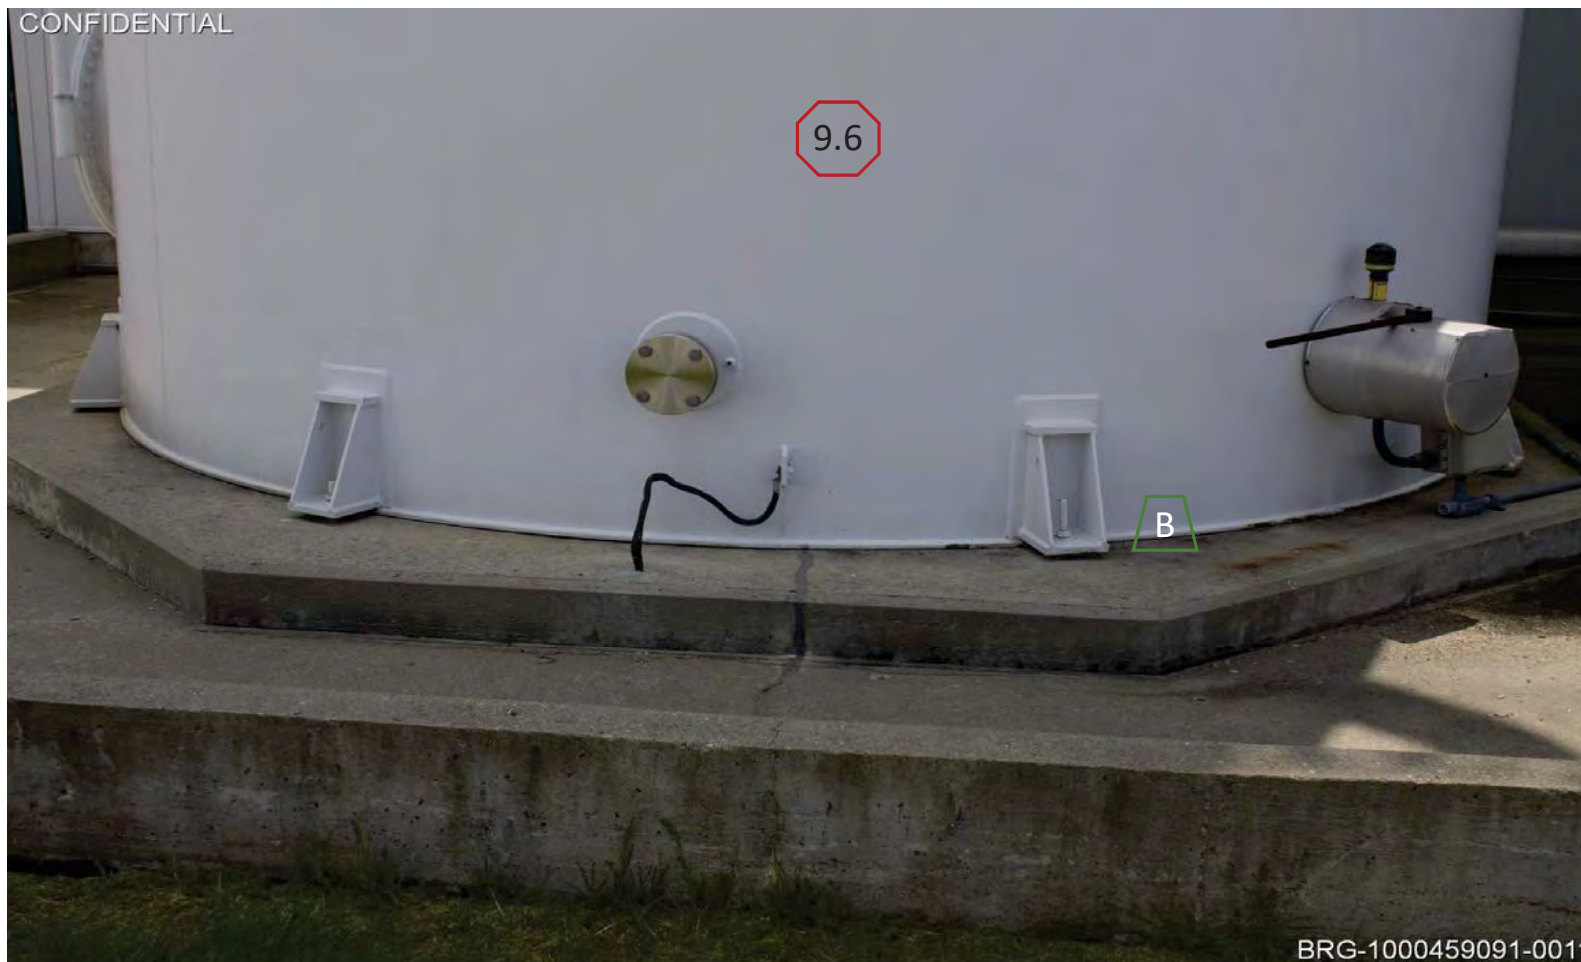
Picture 100045909-40 - WWT (ELPO Waste Tank Attachment)

An access platform is bolted to the top of the ELPO waste tanks.

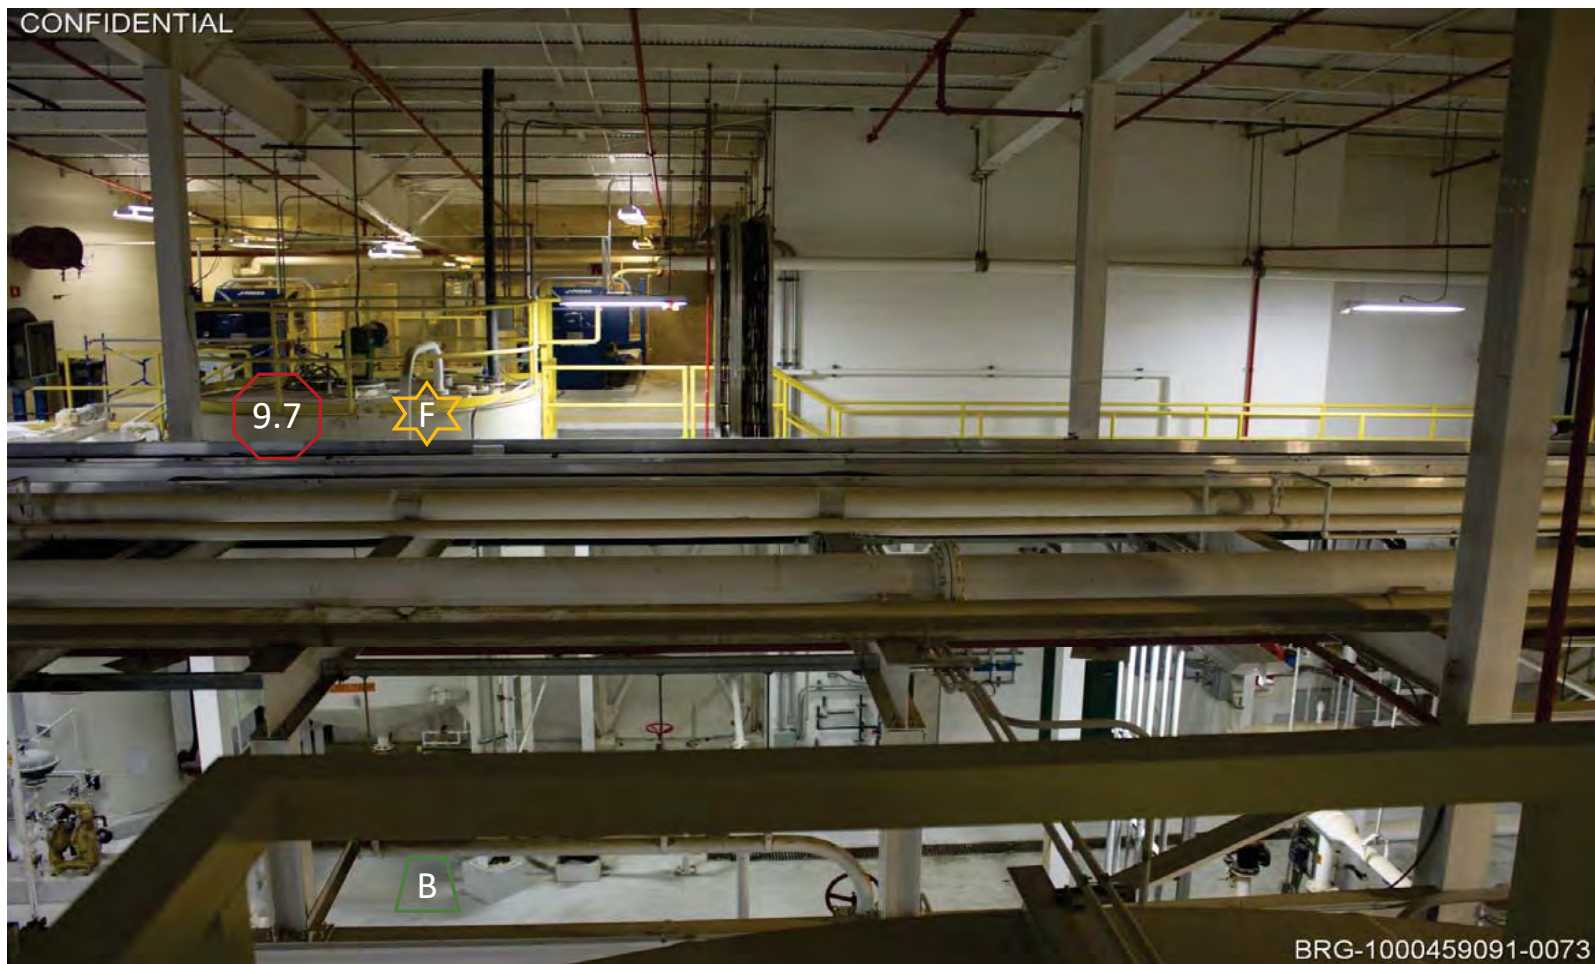
Picture 100045909-41- WWT (Sludge Conditioning Tank)

Sludge Conditioning Tank

The sludge conditioning tank is mounted on 8 inch footings and is attached with lag bolts.

The sludge conditioning tank has lift points welded to the top of the tank.

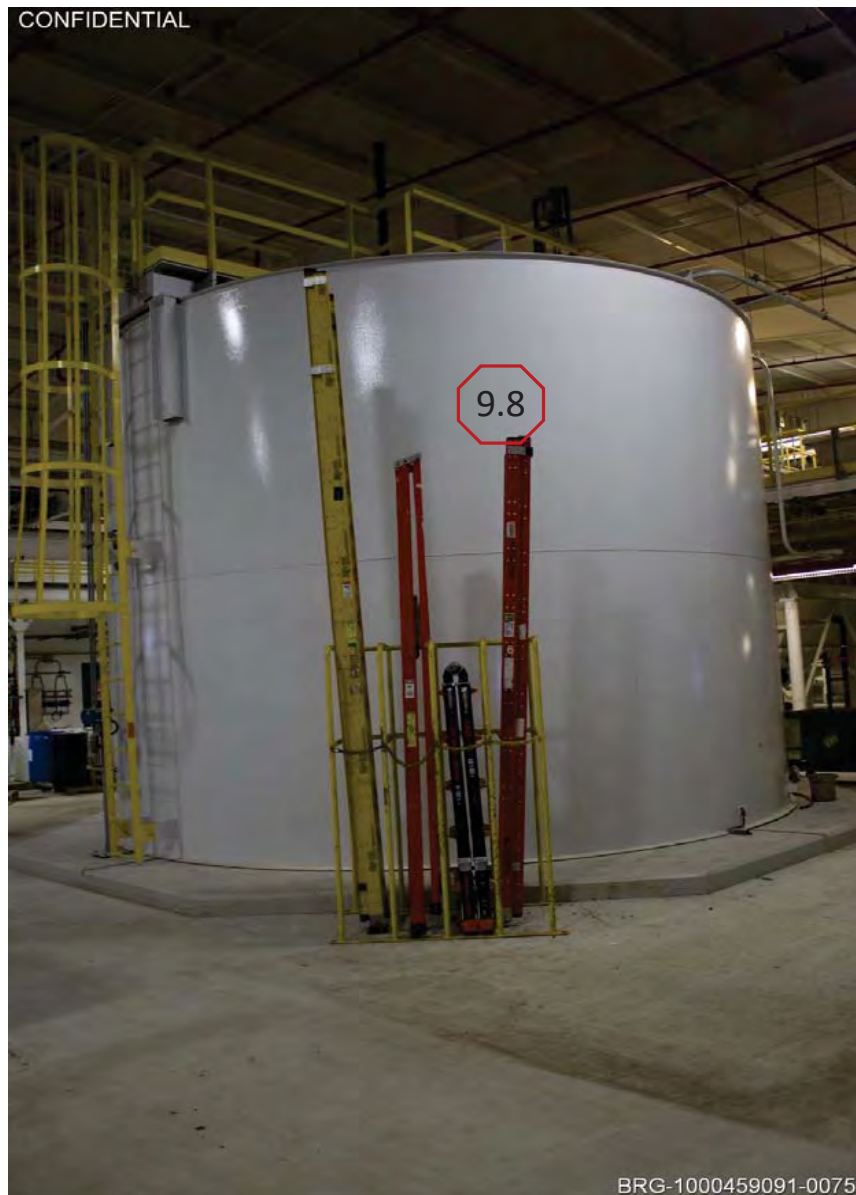
Picture 100045909-42 - WWT (Sludge Holding Tank)

Sludge Holding Tank

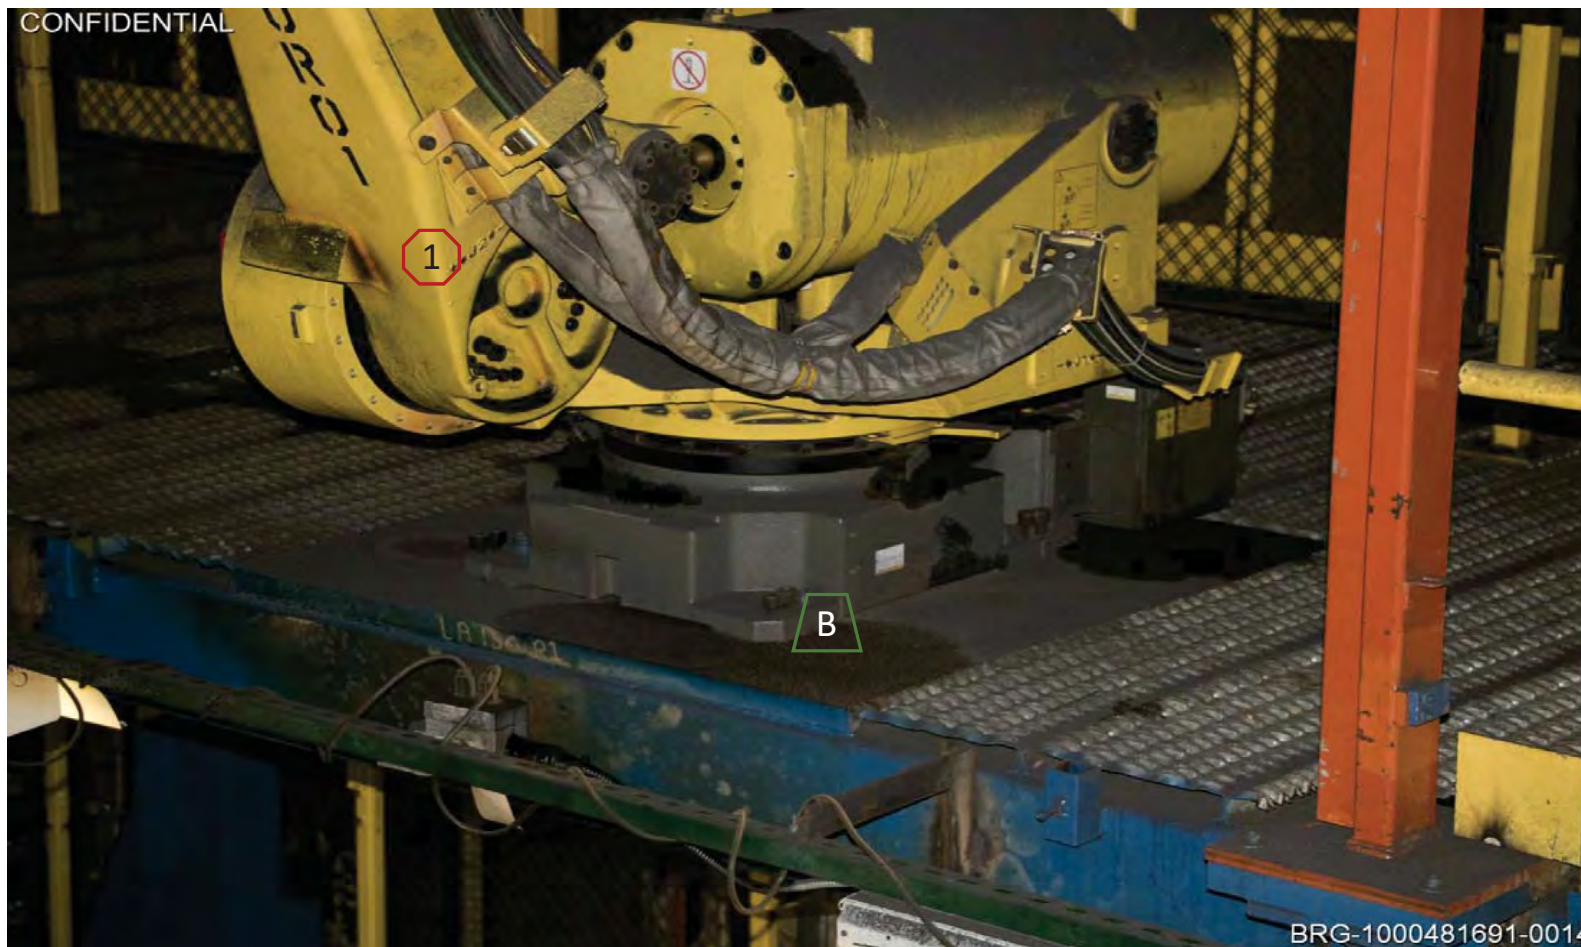
Picture 100048169-2 - Framing Robot

Electrical power and data are delivered to the framing robot through loose wiring and attached using quick disconnect fittings.

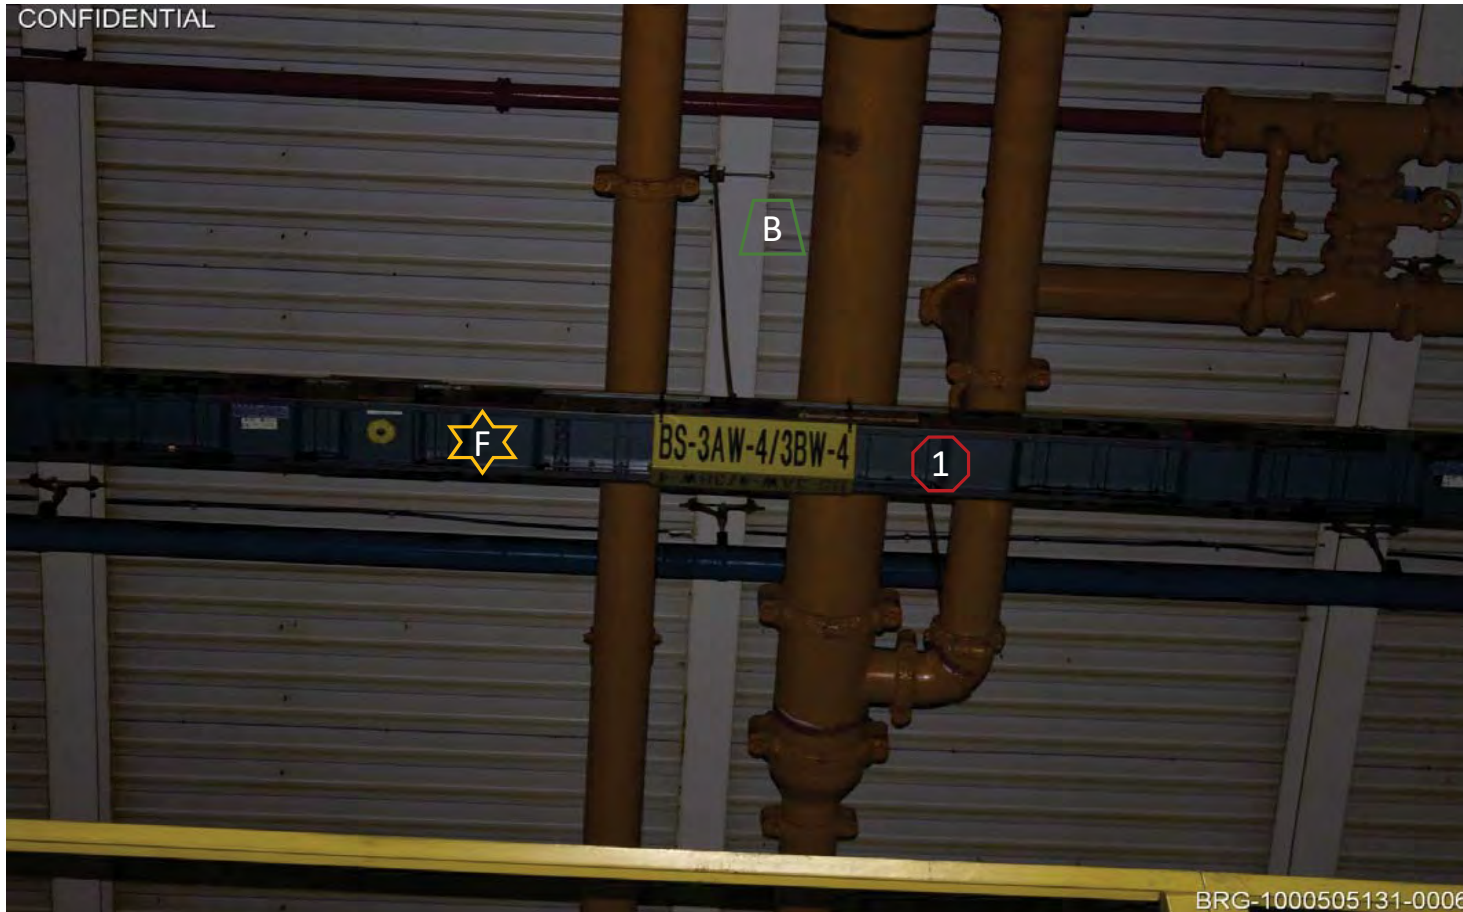
Picture 100050513-1 - Weld Bus Duct

The Weld Bus Duct is suspended from the ceiling using nut and bolt fasteners connected to I-beam clamps.

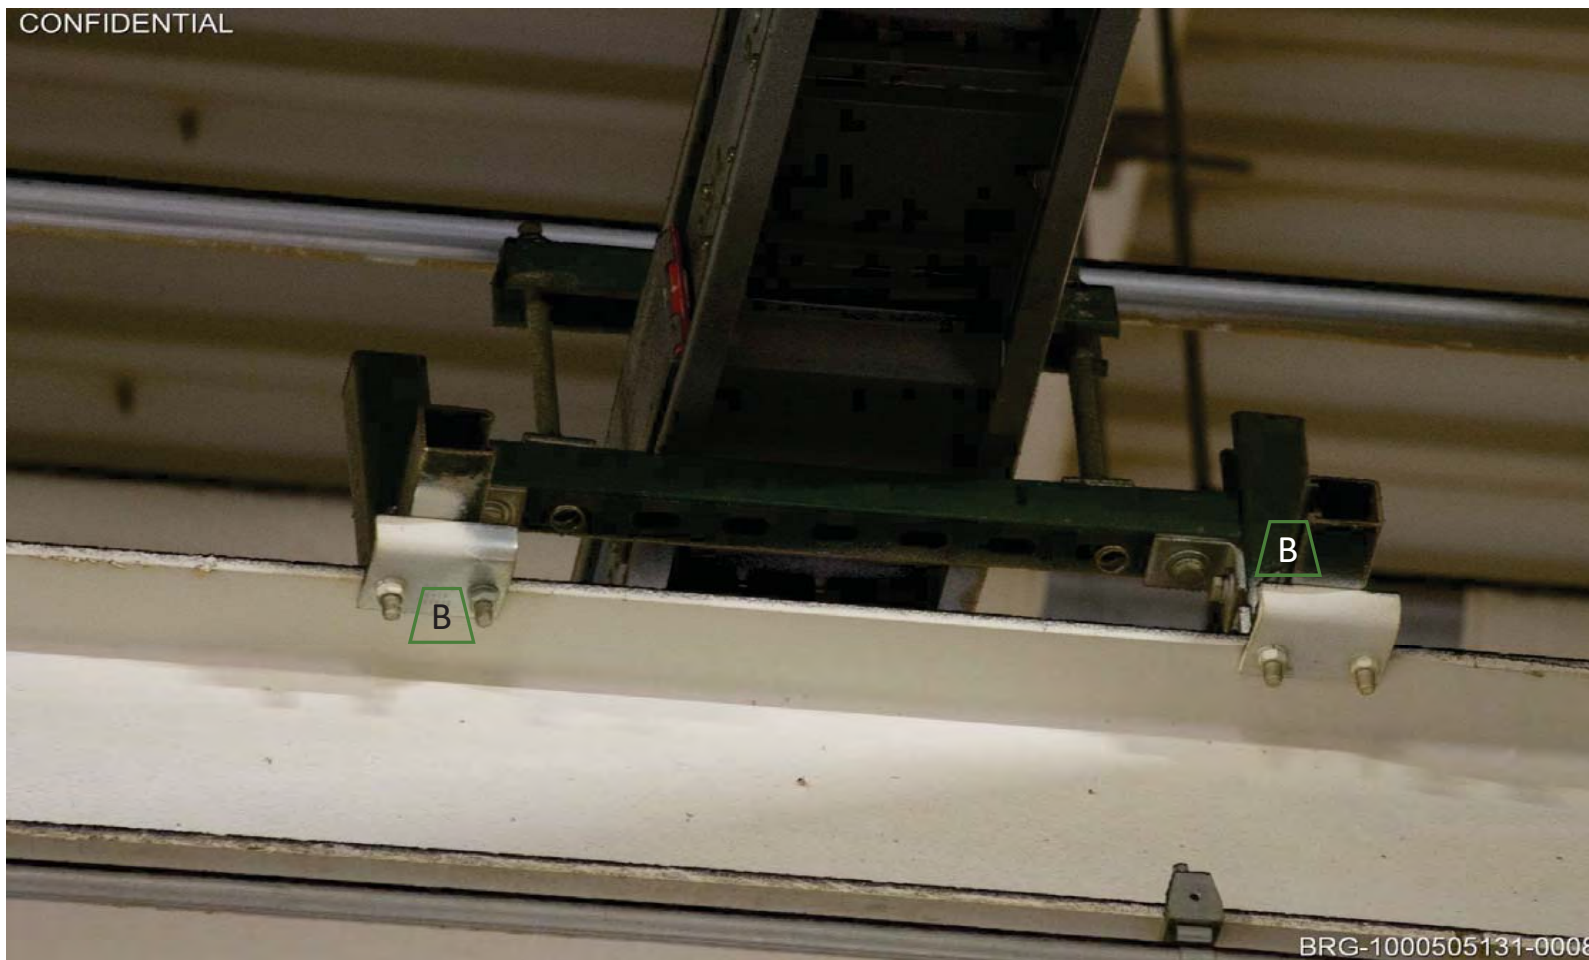
Picture 100050513-3 - Weld Bus Duct

The Weld Bus Duct is attached to the lower beam of a truss using a light steel framework attached with bolted beam clamps.

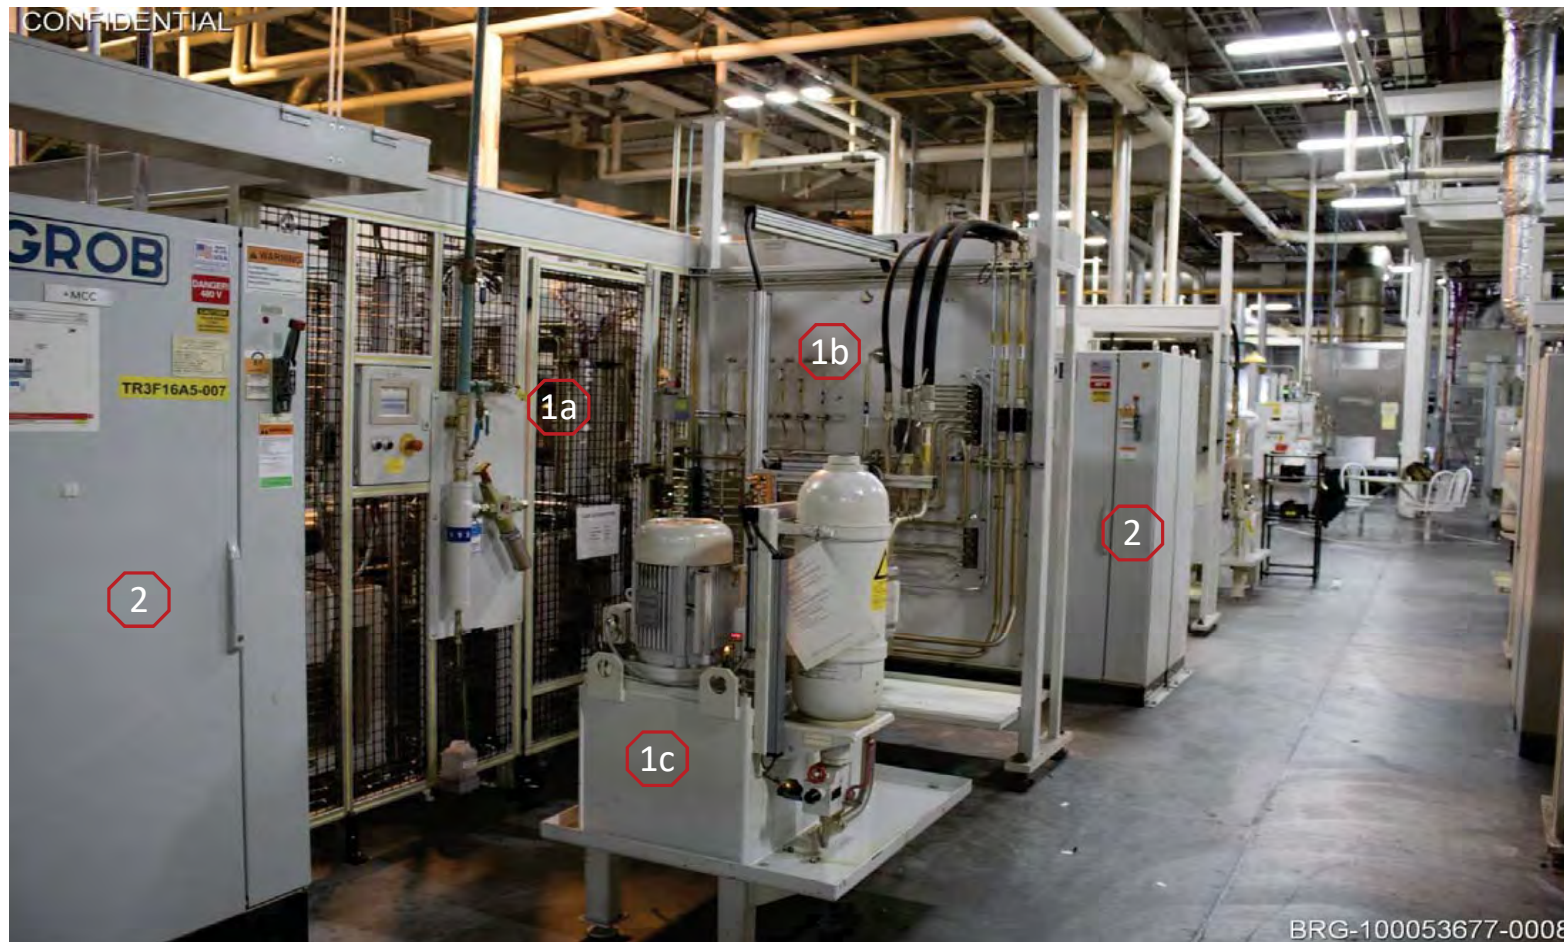
Picture 100053677-2 - Test Stands & Control

1a Test Stand Sub-Component A: Individual Test Stand (located inside the safety gate)

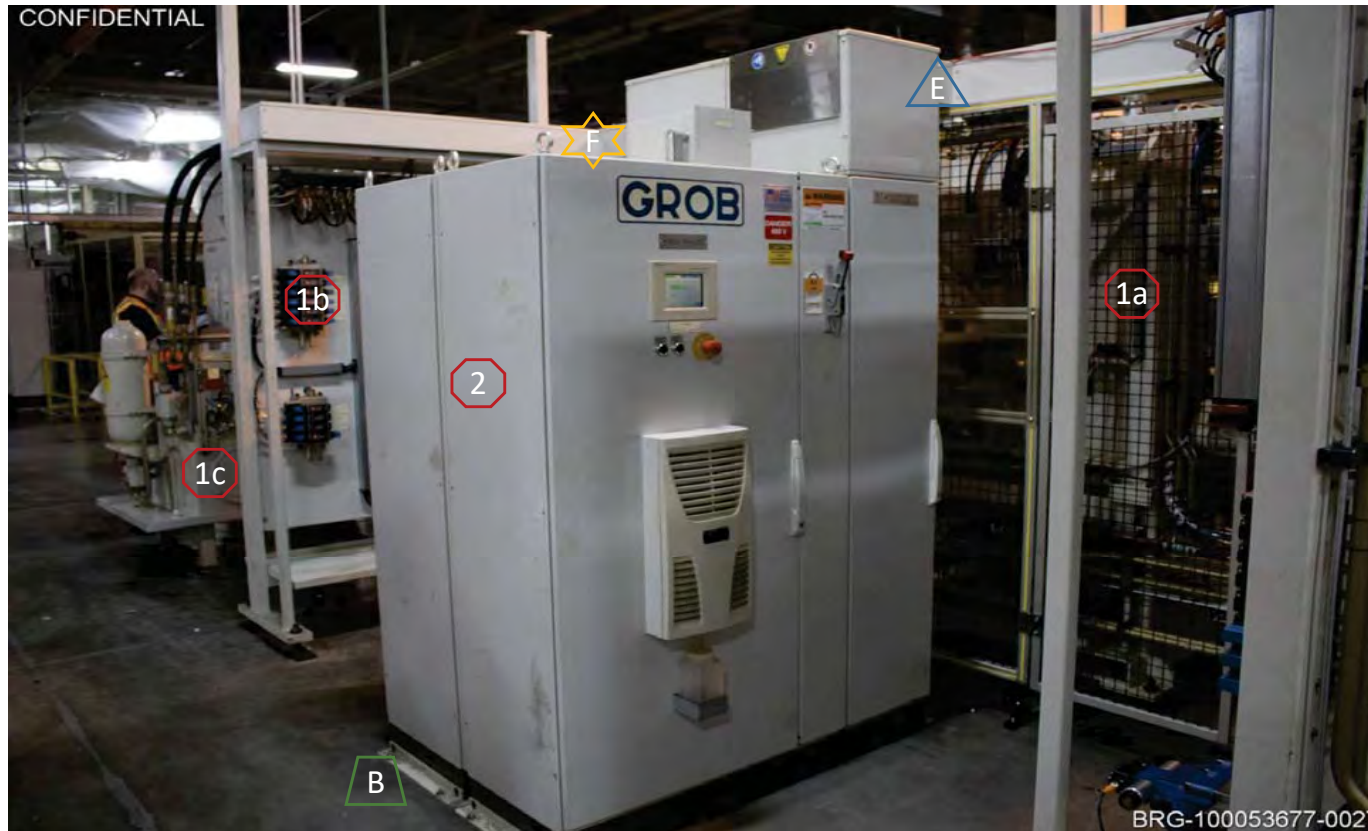
Picture 100053677-10 - Control Cabinets

Electric & data wiring is fed from the cabinet to the leak test components using enclosed, reconfigurable cable trays.

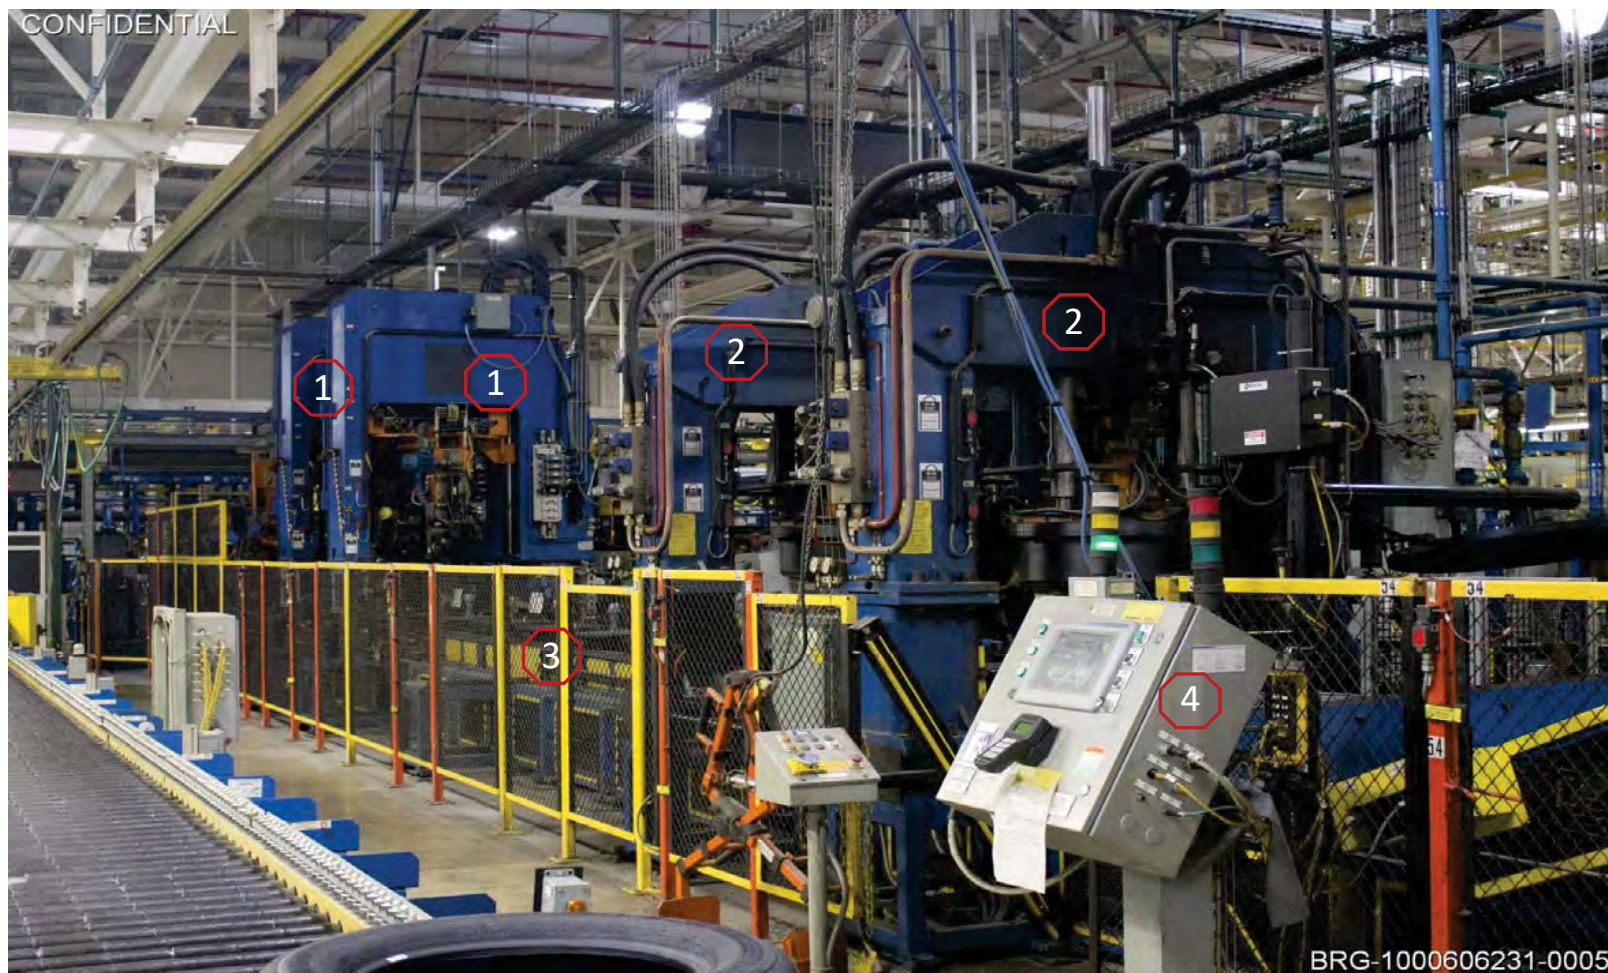
Picture 100060623-1 - Wheel Assembly Machine

1 Mounting Stations

2 Inflation Stations

4 HMI Control Panel

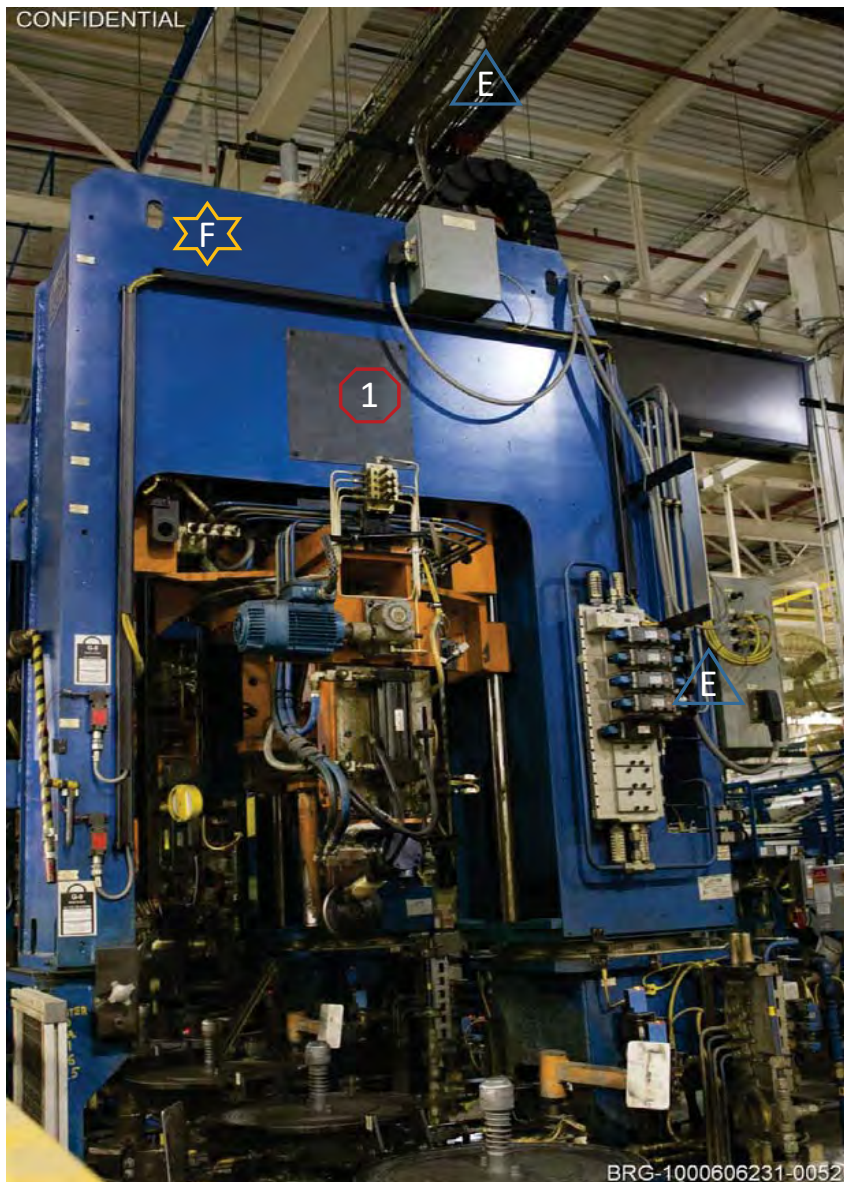
Picture 100060623-2 - Mounting Station

Electrical and data cabling are fed to the mounting station through loose wiring in overhead metal cable trays. The wiring also utilizes quick disconnect fittings.

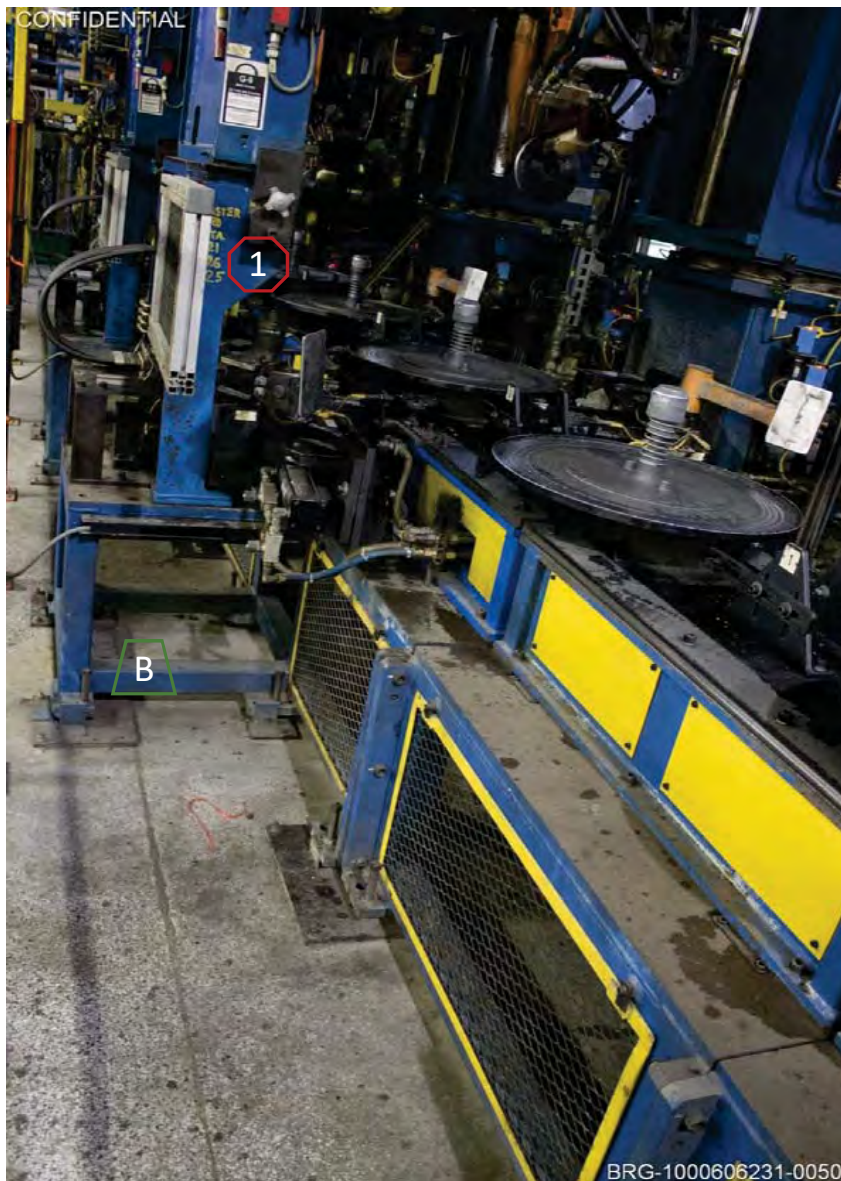
Picture 100060623-3 - Mounting Station (Attachment)

B The mounting station is attached to the building floor with lag bolts.

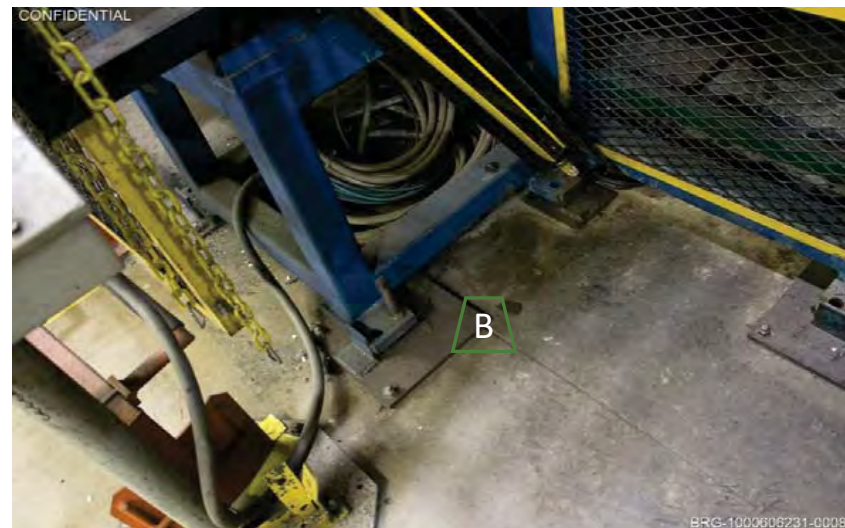
Picture 100060623-5 - Inflation Station (Attachment)

- B** The tire inflation station is attached to the building floor with lag bolts.
- E** Electrical power and data are fed to the components of the Wheel Assembly Machine by loose cabling contained in reconfigurable overhead cable trays
- 2** Inflation Stations

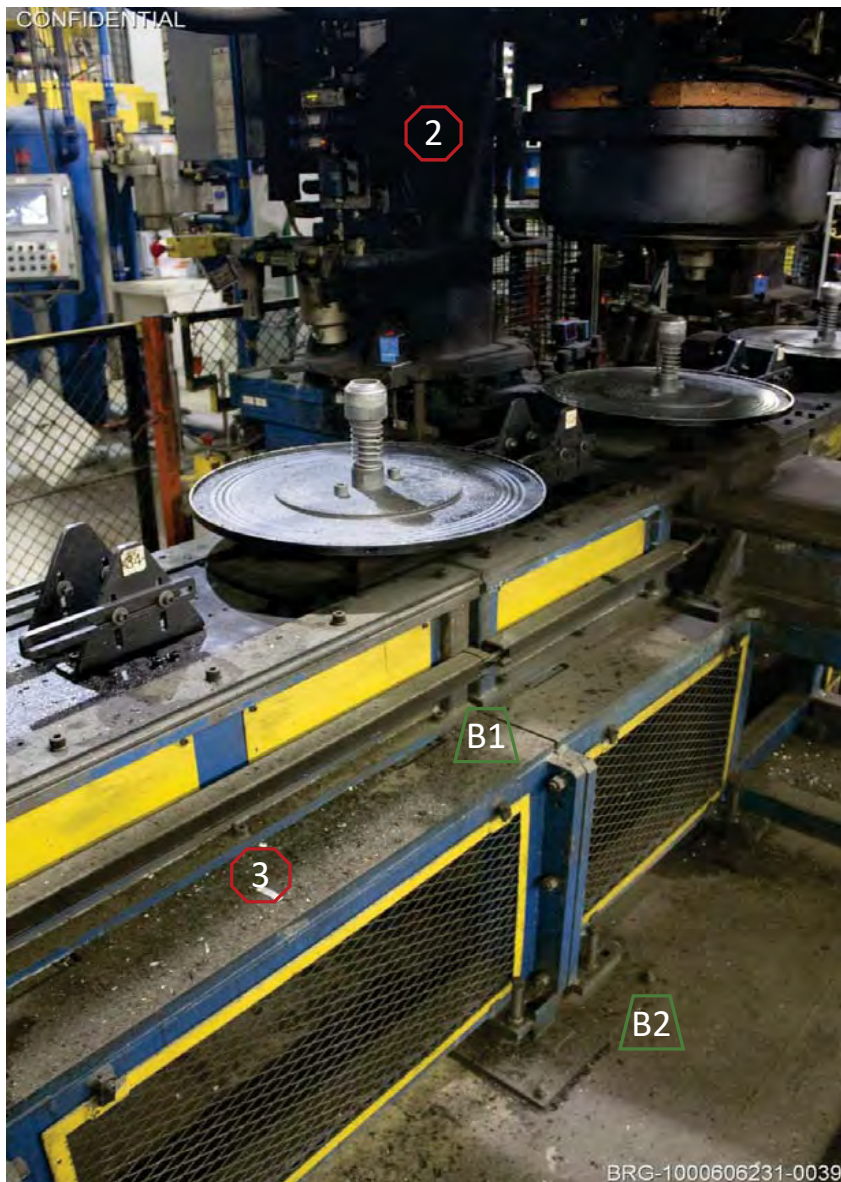
Picture 100060623-7 - Conveyor

- B1** The individual sections of conveyor are connected to each other with nut and bolt fasteners.
- B2** The conveyor is attached to the building floor with lag bolts.
- 2** Inflation Stations
- 3** Conveyor

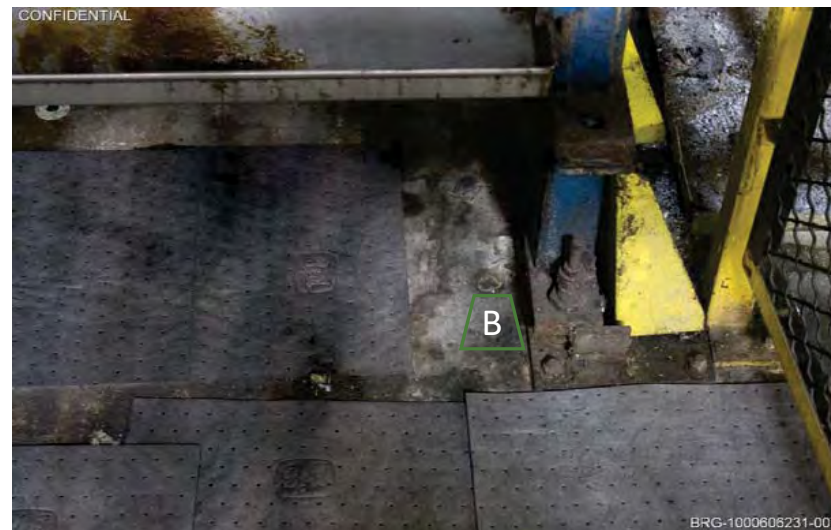
Picture 100060623-10 - Soaping Station (Attachment)

B The soaping station is attached to the building floor with lag bolts.

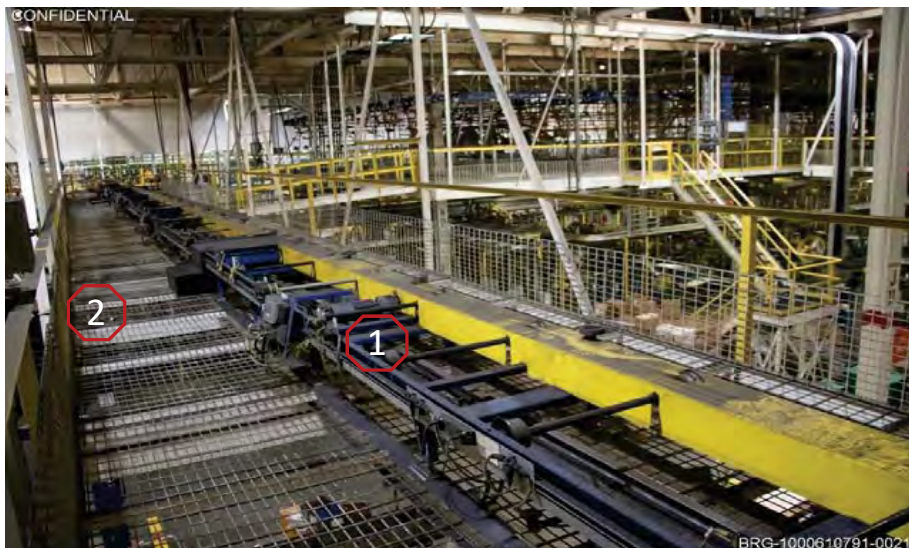
Picture 100061079-2 - Roller Bed Conveyor & Mezzanine

- 1 Roller Bed Conveyor modules
- 2 Mezzanine with metal wire grating floor

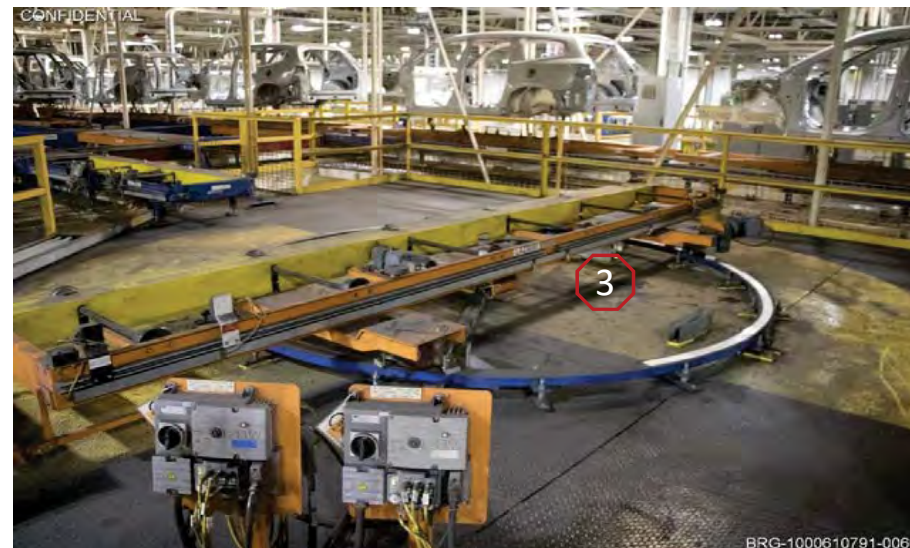
Picture 100061079-3 - Pivoting Unit

- 3 Pivoting Conveyor Unit on solid floor mezzanine section

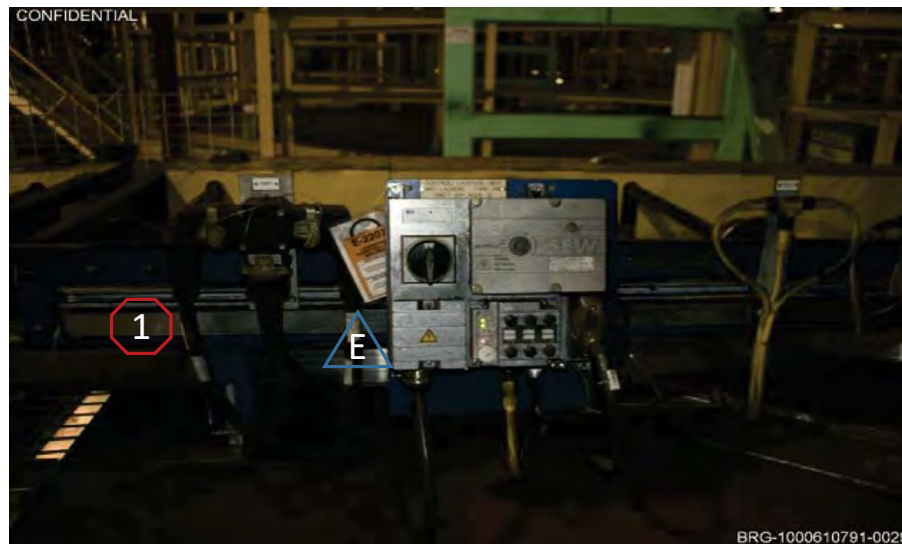
Picture 100061079-8 - Roller Bed Conveyor

B The roller bed conveyor is affixed to the mezzanine with bolted plates.

E All wiring to the roller bed conveyor is connected using quick disconnect plugs and sockets.

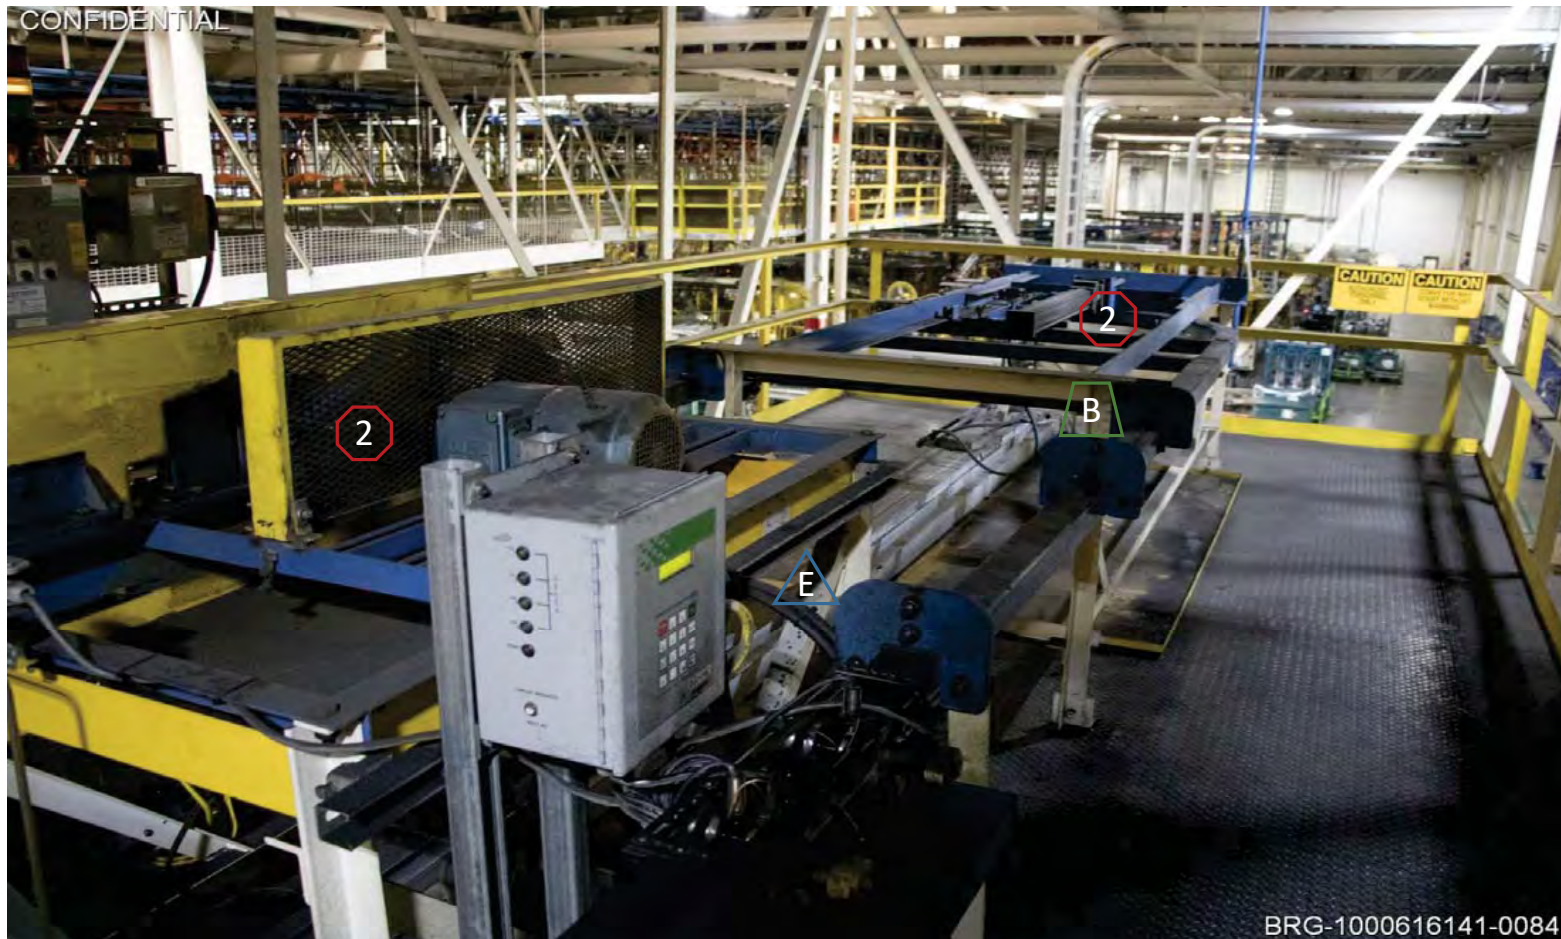
Picture 100061614-5 - Chain Drive (left) & Take-up Unit (background)

Sections of conveyor track are bolted to steel members which are suspended from roof trusses.

Electrical and data wiring are fed to the chain drive units through loose cabling. Quick disconnect fittings are used.

The take-up unit is attached to adjacent sections of conveyor track with nut and bolt fasteners.

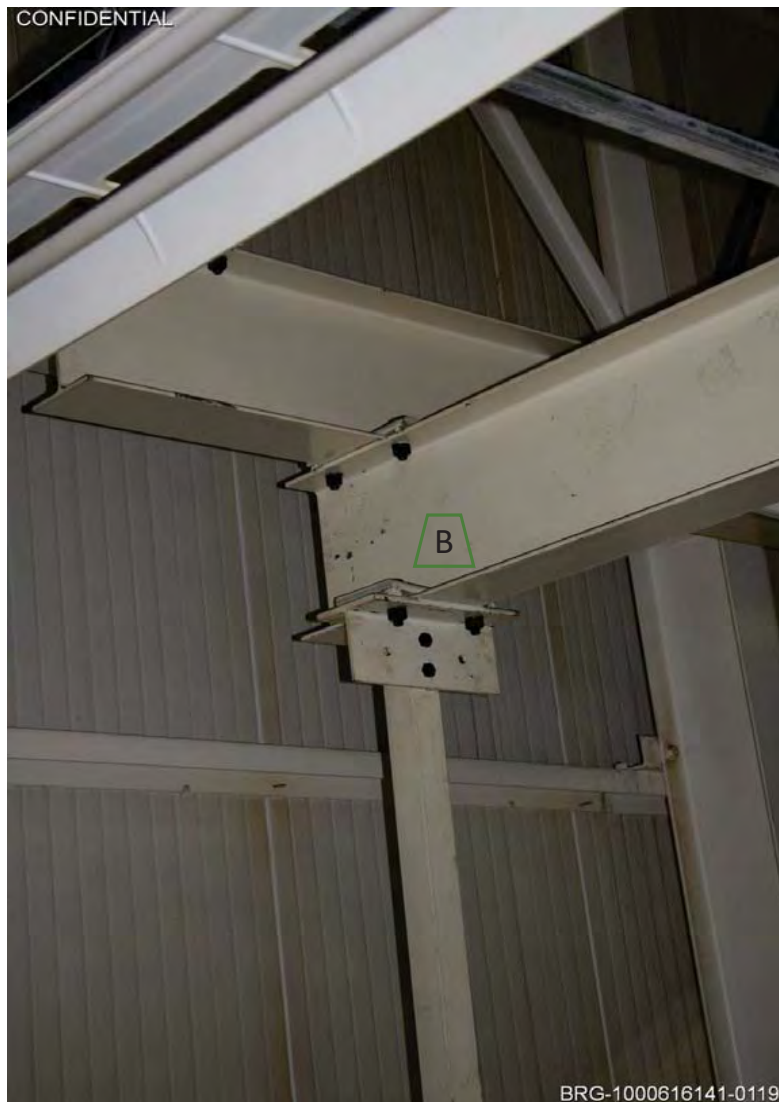
Picture 100061614-9 - Mezzanine (Truss Attachment)

The mezzanine is entirely suspended from the roof trusses by steel members attached to the building trusses with removable "clips", steel plates clamped around the top and underside of the bottom beam of the truss.

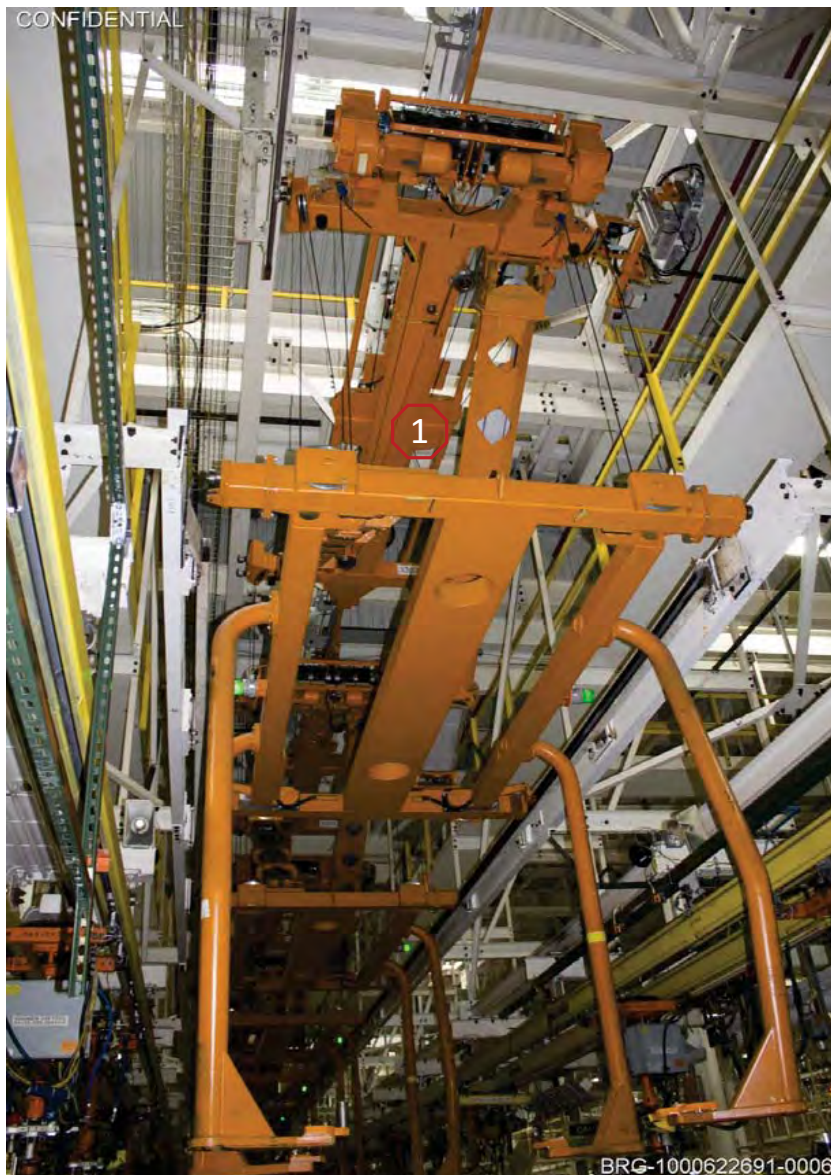
Picture 100062269-1 - Vertical Adjusting Carriers (Below)

- 1 Vertical Adjusting Carriers. Carrier at left is extended (lowered); carrier above is retracted (raised).
- 2 Wheeled Trolleys

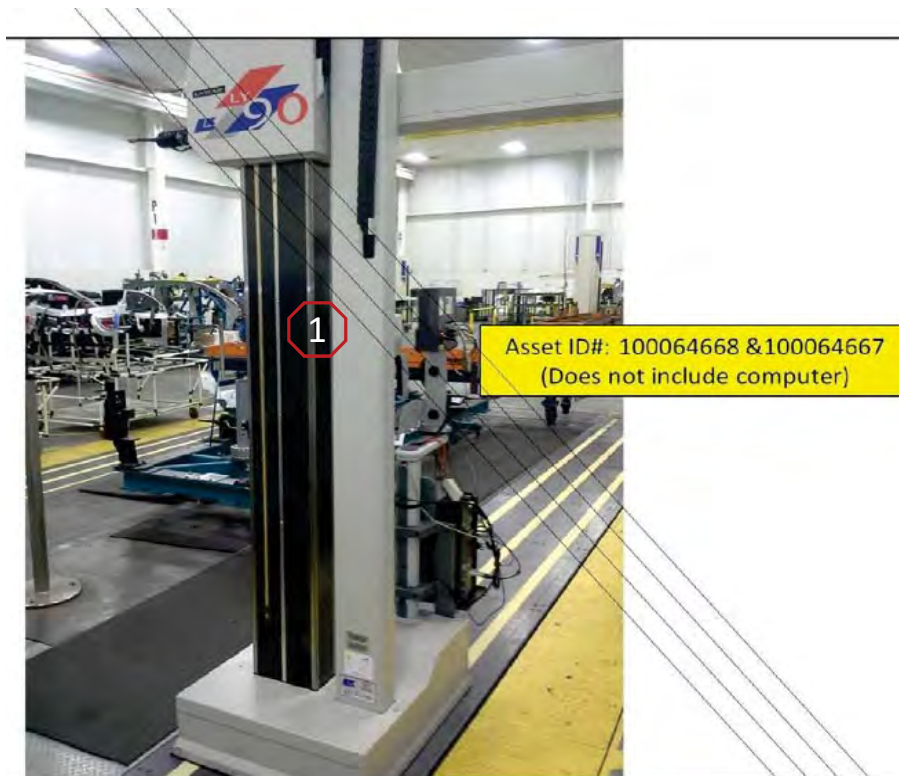
Picture 100064667-1 - BS CMM (Prior to Removal)

The BS CMM was located in the empty floor space shown above. The BS CMM has been removed without apparent damage to the realty. The concrete pit for the BS CMM was a separate asset; the pit was filled in after removal of the BS CMM.
