**UNITED STATES BANKRUPTCY COURT
SOUTHERN DISTRICT OF NEW YORK**

MOTORS LIQUIDATION COMPANY, f/k/a
GENERAL MOTORS CORPORATION, *et al.*,

Plaintiff's Representative Assets Appendix

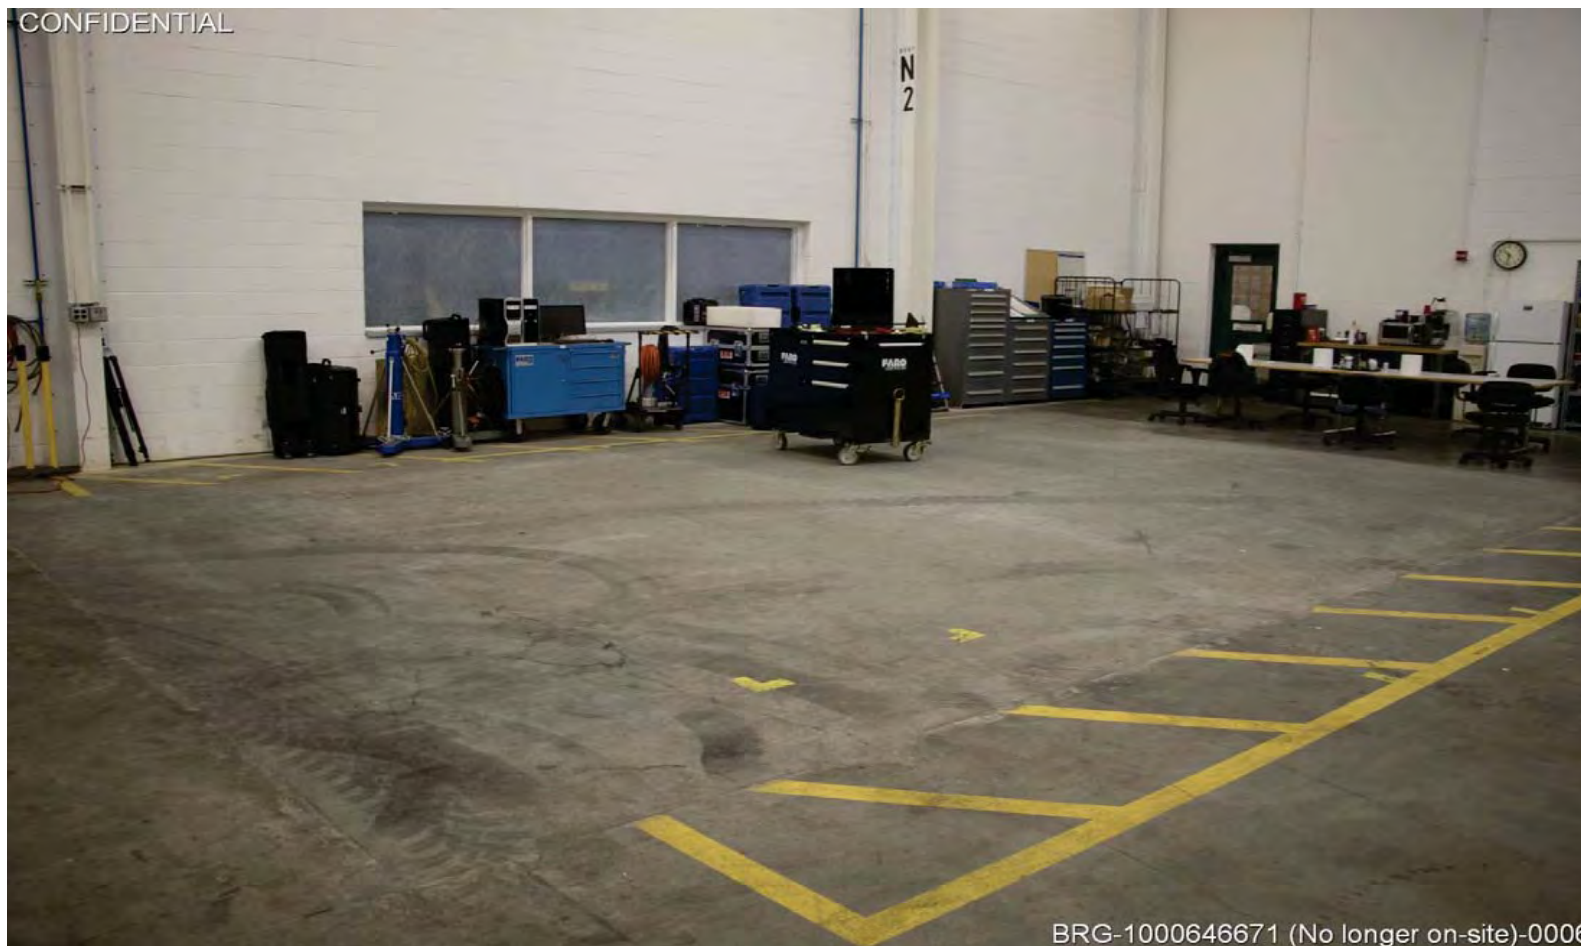
Picture 100064667-2 - BS CMM (Empty Area)

The above image of the BS CMM shows one of two measurement columns; the other, unseen column is to the left. The 8'x25' surface plate is behind the column.

The BS CMM was located in the empty floor space shown above. The BS CMM has been removed without apparent damage to the realty. The concrete pit for the BS CMM was a separate asset; the pit was filled in after removal of the BS CMM.

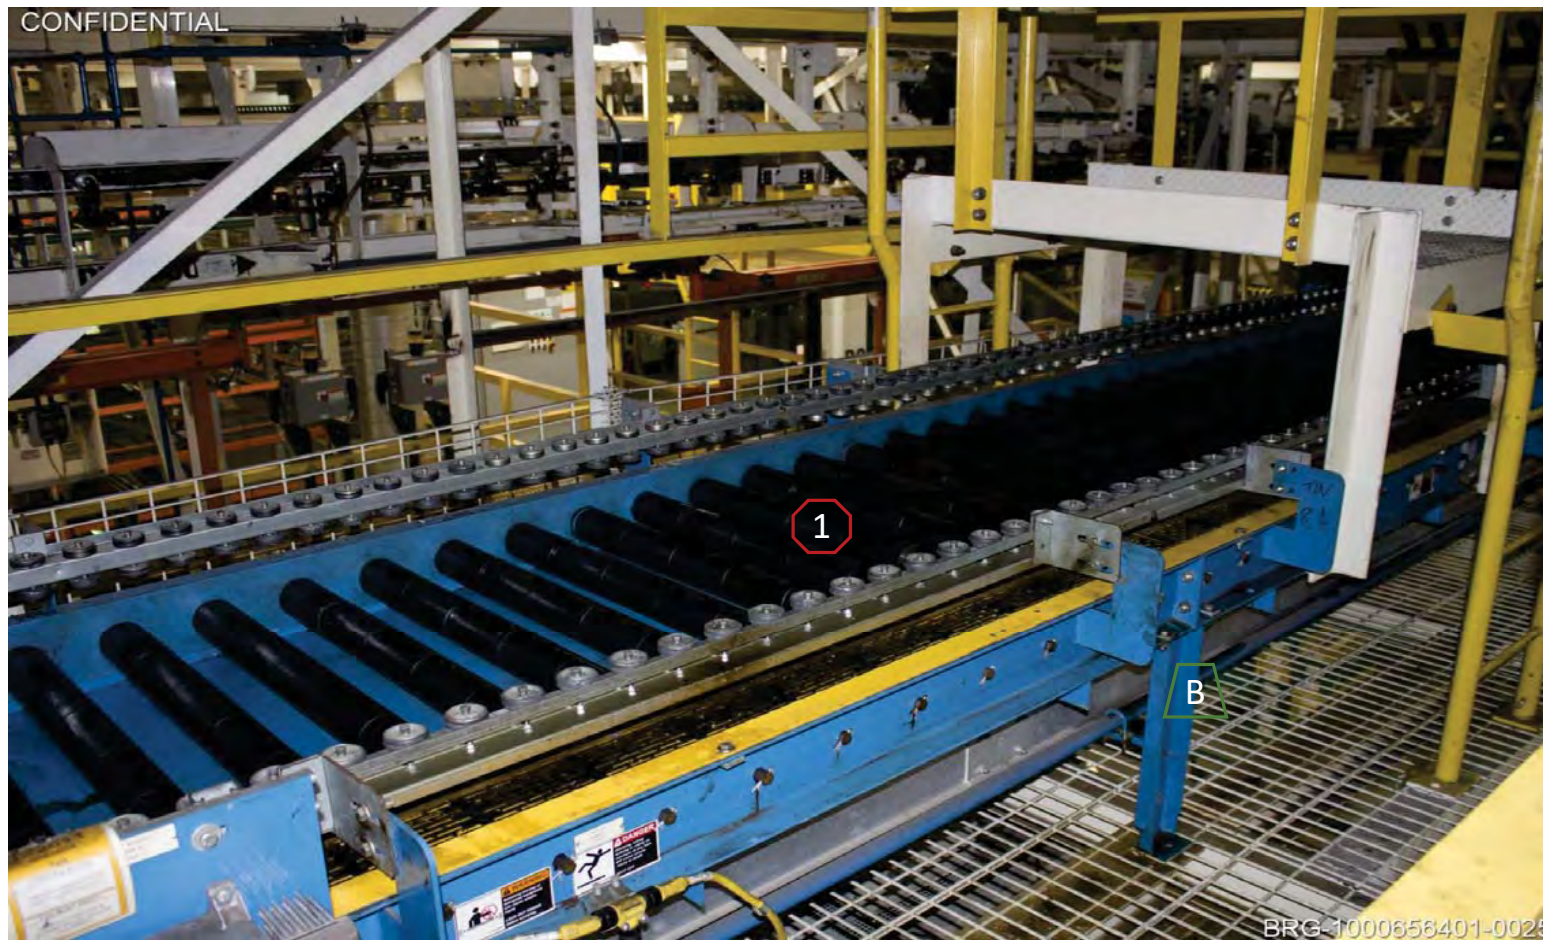
Picture 100065640-4 - Conveyor

Conveyor section with powered rolls.

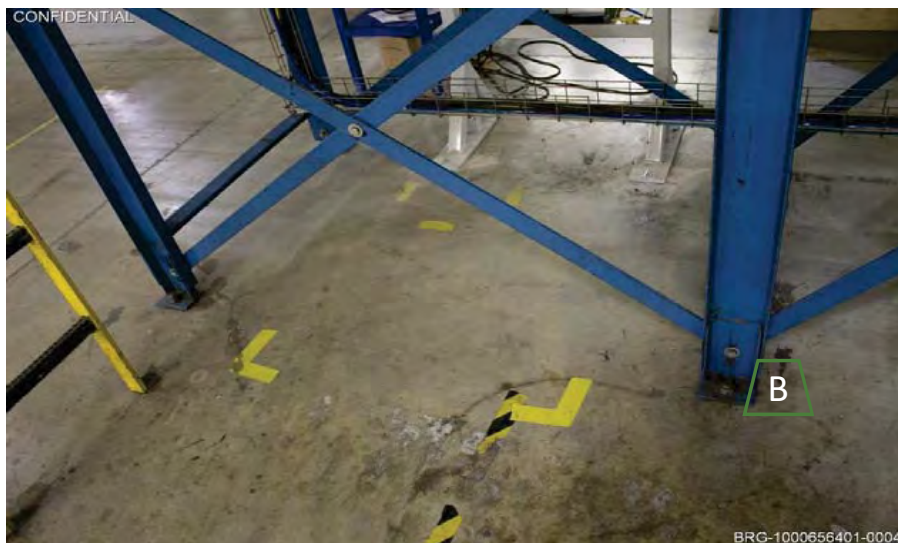
Picture 100065640-5 - Conveyor (Attachment)

Sections of conveyor are supported by adjustable height legs which are attached to the section frames with nut and bolt fasteners.

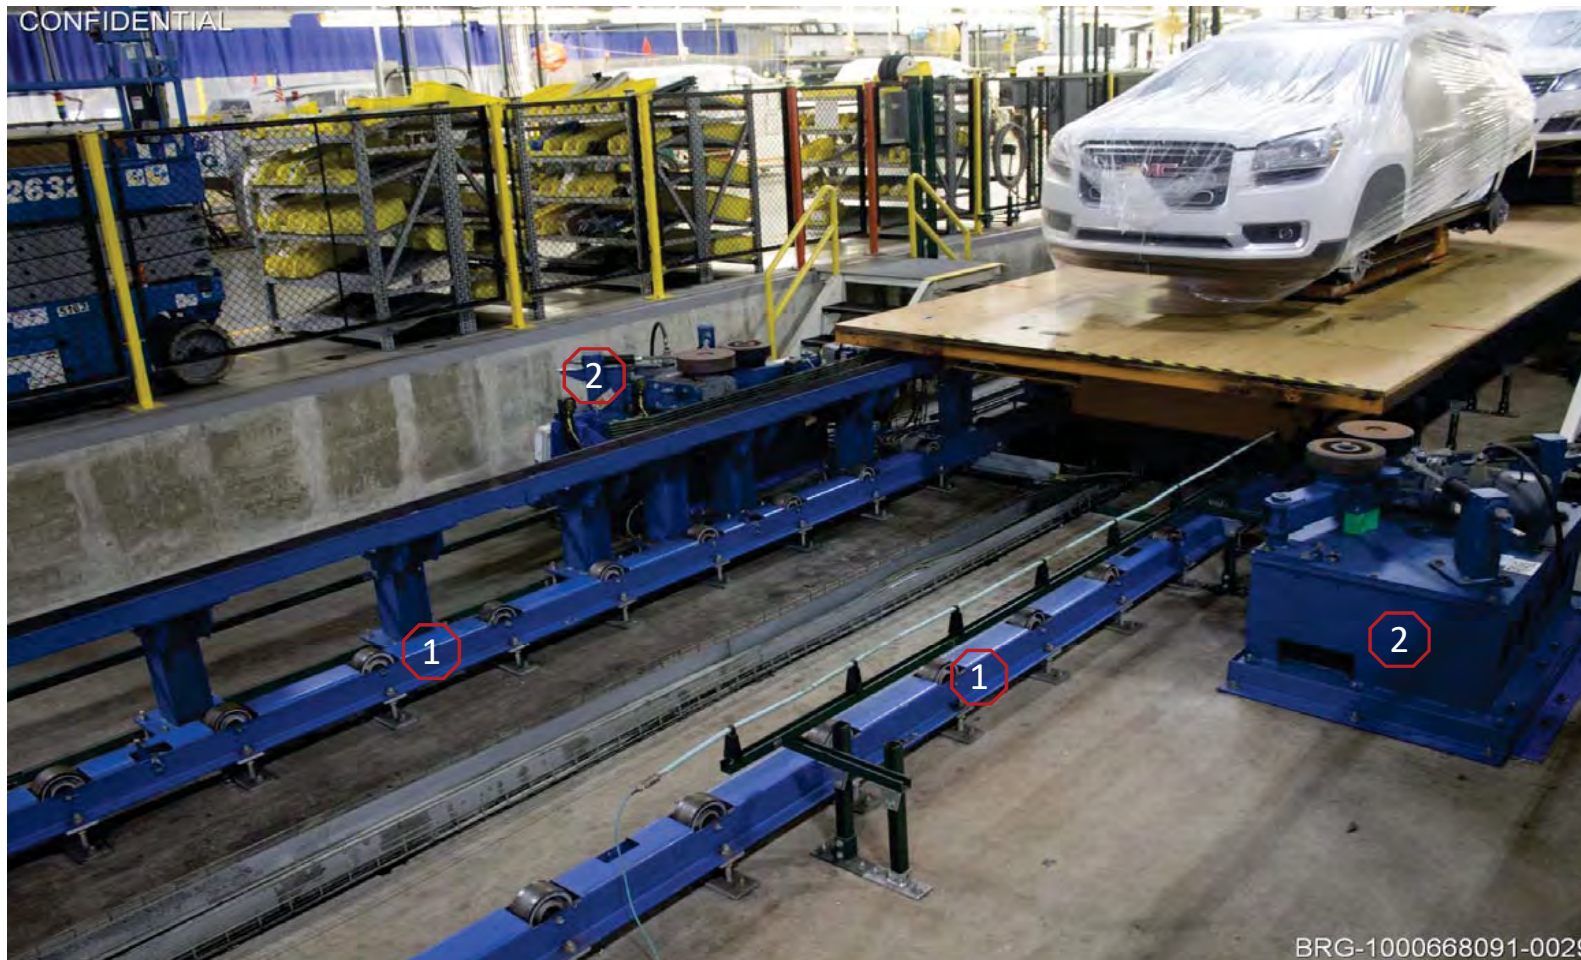
Picture 100066809-1 - Skillet Conveyor System

- 1** Left - Conveyor track with top mounted rollers and busbar mounted above. Right - Conveyor track with rollers.
- 2** Drive Rollers

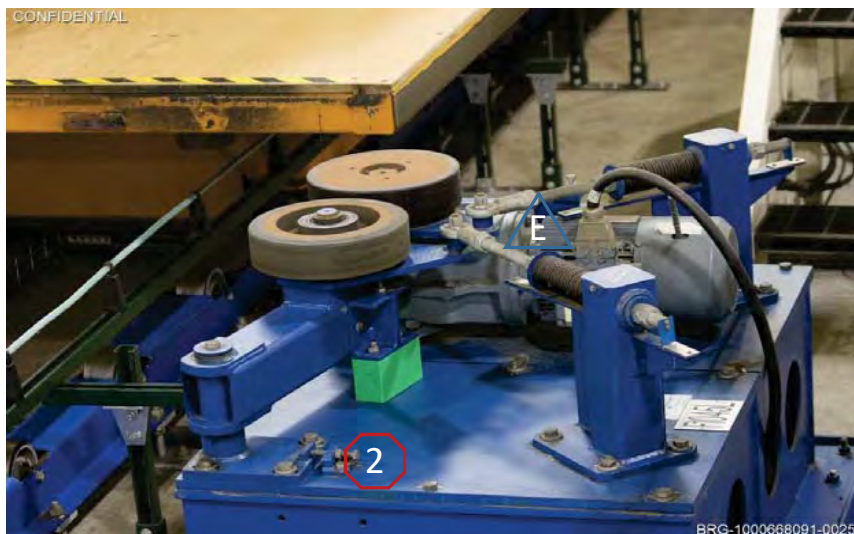
Picture 100066809-4 - Drive Roller

The drive roller is attached to the floor with lag bolts.

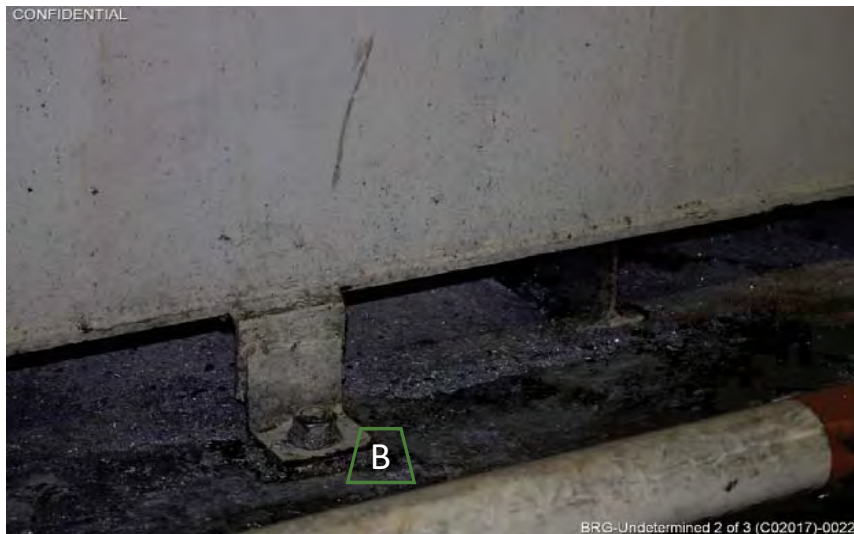
Picture 100070012-3 - Main Filtration Unit (Attachment)

The main filtration units are attached to the building floor with angle iron clips and lag bolts in several spots around their perimeters

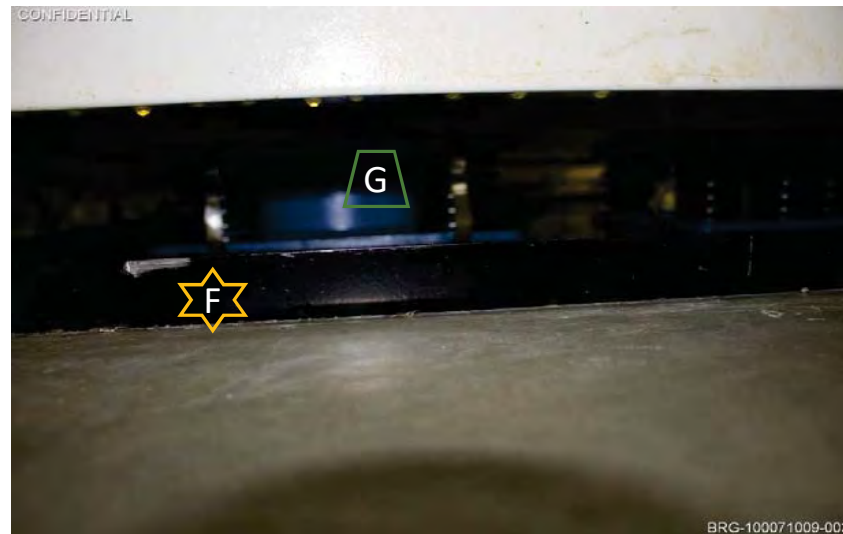
Picture 100071009-4 - CNC Gear Shaper

G The CNC Gear Shaper is mounted on a number of vibration isolation pads, which are in turn resting in a steel drip pan laid on the building floor.

F A steel drip pan laid on the floor contains fluids dripping from the CNC Gear Shaper.

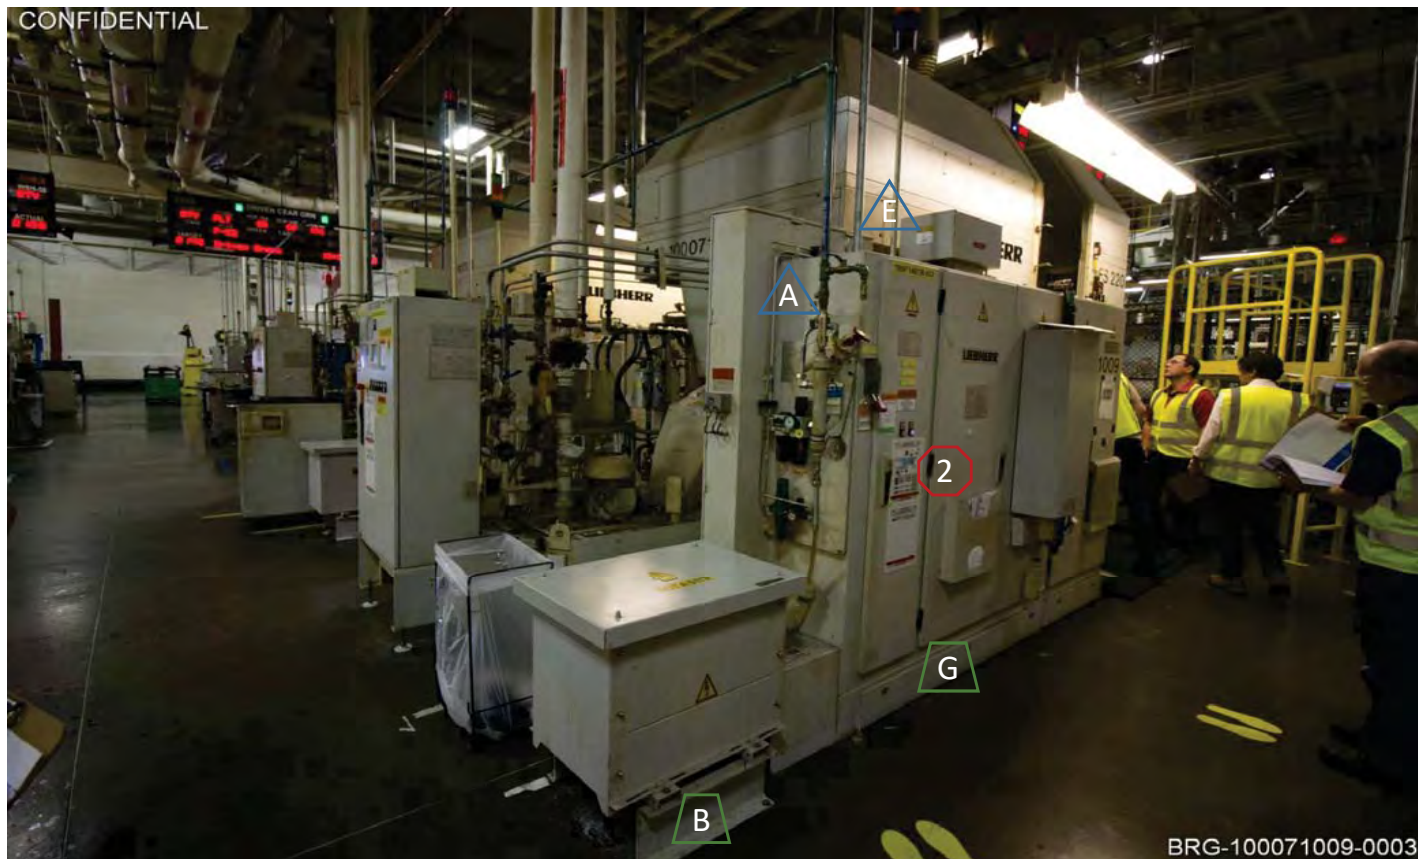
Picture 100071009-7 - HMI Control Panel

The HMI control panel is resting upon the floor with no evident fasteners.

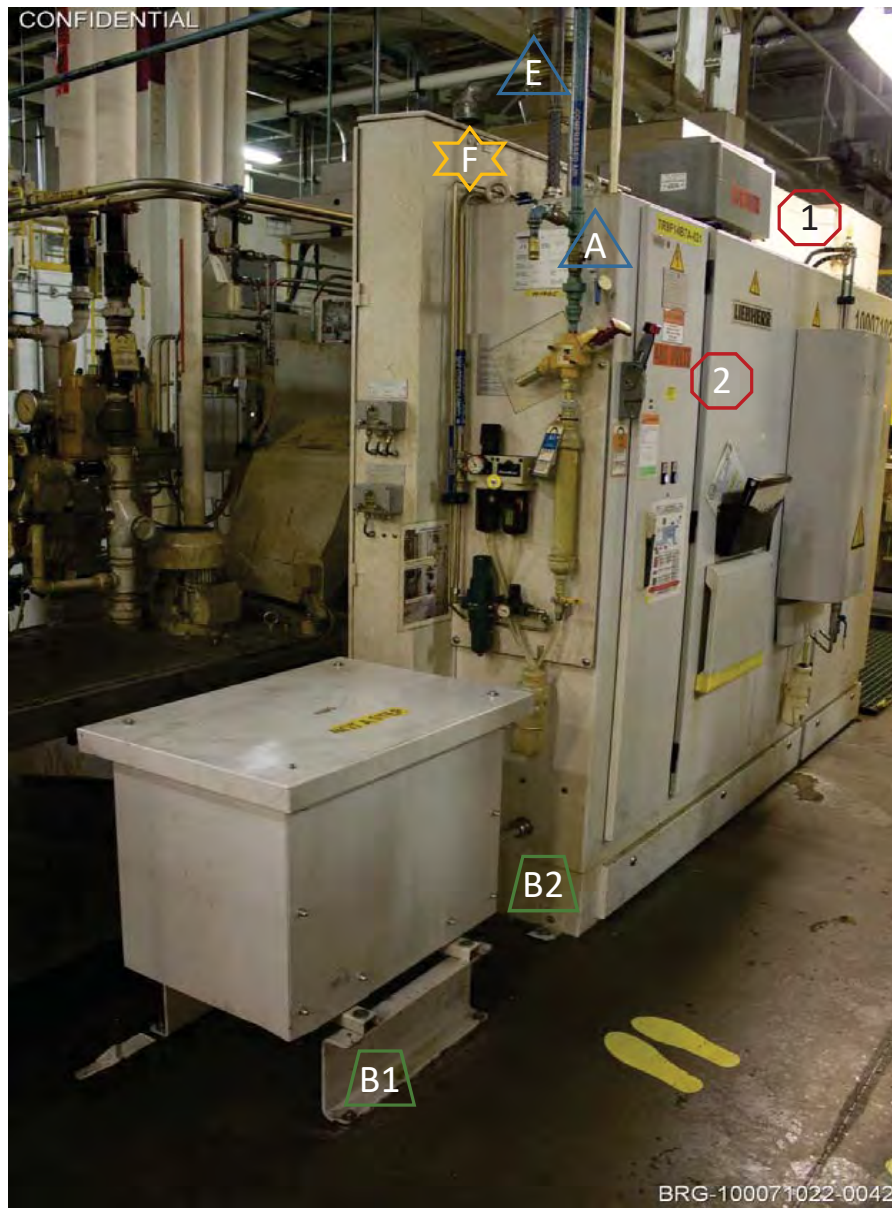
Picture 100071022-13 - Standalone Control Cabinet

- A** Compressed air is supplied from an overhead main header pipe.
- E** Electricity is supplied from an overhead removable bus plug via loose cabling.
- B1** Channel steel supporting a small transformer that feeds the control cabinet is affixed to the floor with lag bolts.
- B2** L-brackets are affixed to the floor using lag bolts.
- F** Top mounted eye-hooks for lifting the control cabinet. Mounted on four corners.
- 1** Gear Hobbing Machine
- 2** Standalone Control Cabinet

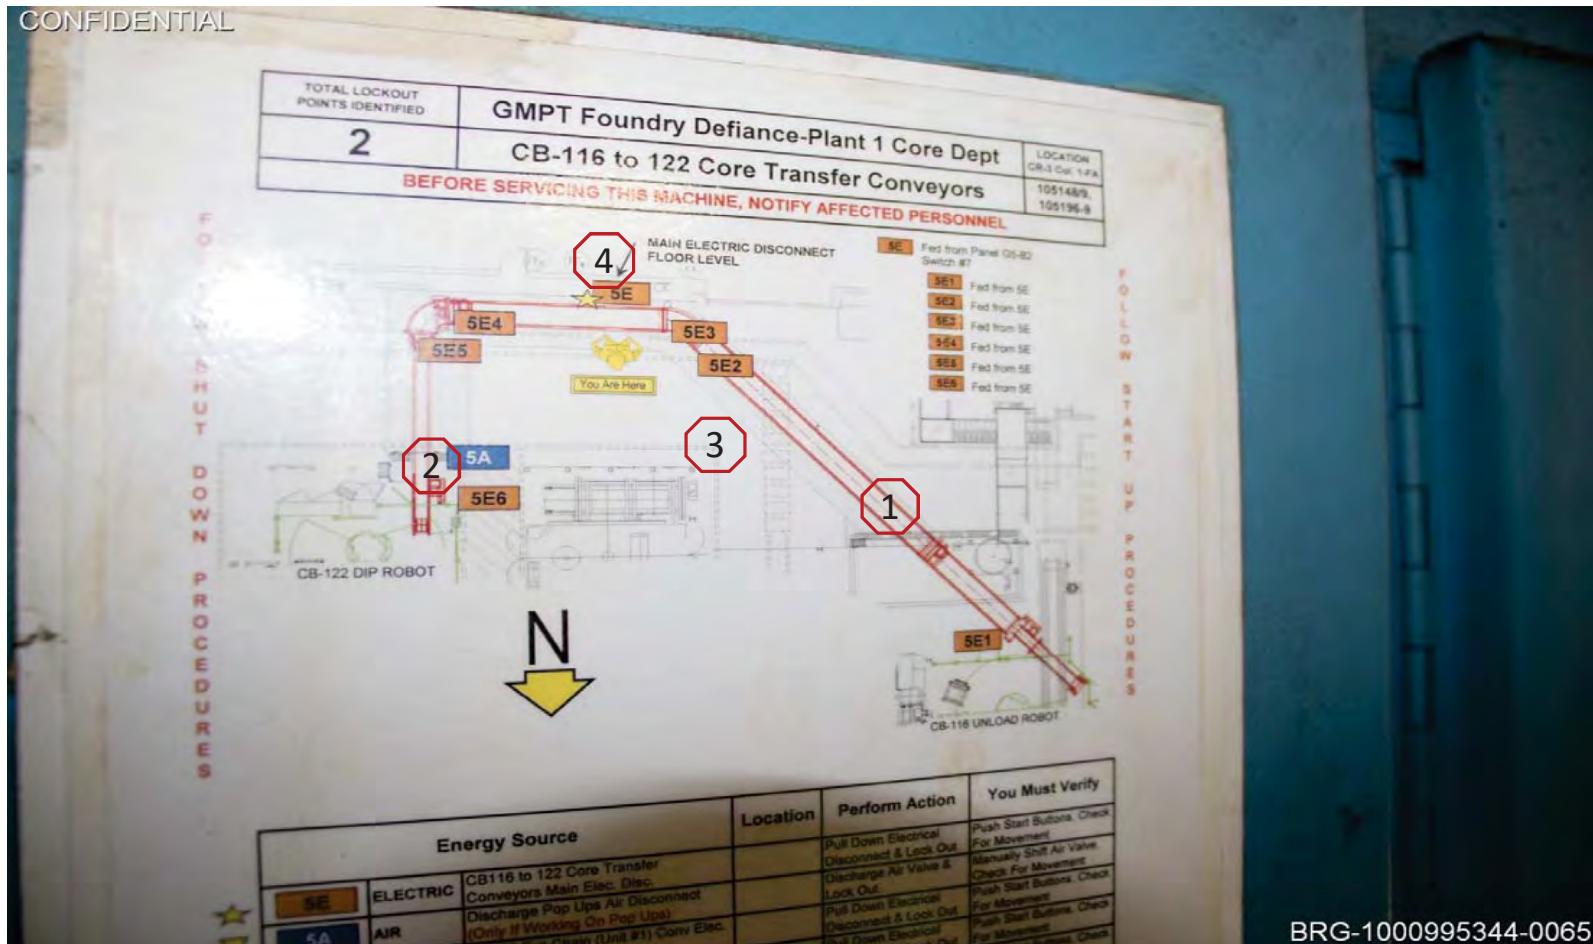
Picture 100095344-1 - Asset Diagram & Layout

- 1** Belt Conveyor
- 2** Chain-on-Edge Conveyor
- 3** Mezzanine
- 4** Control Panel (at floor level)

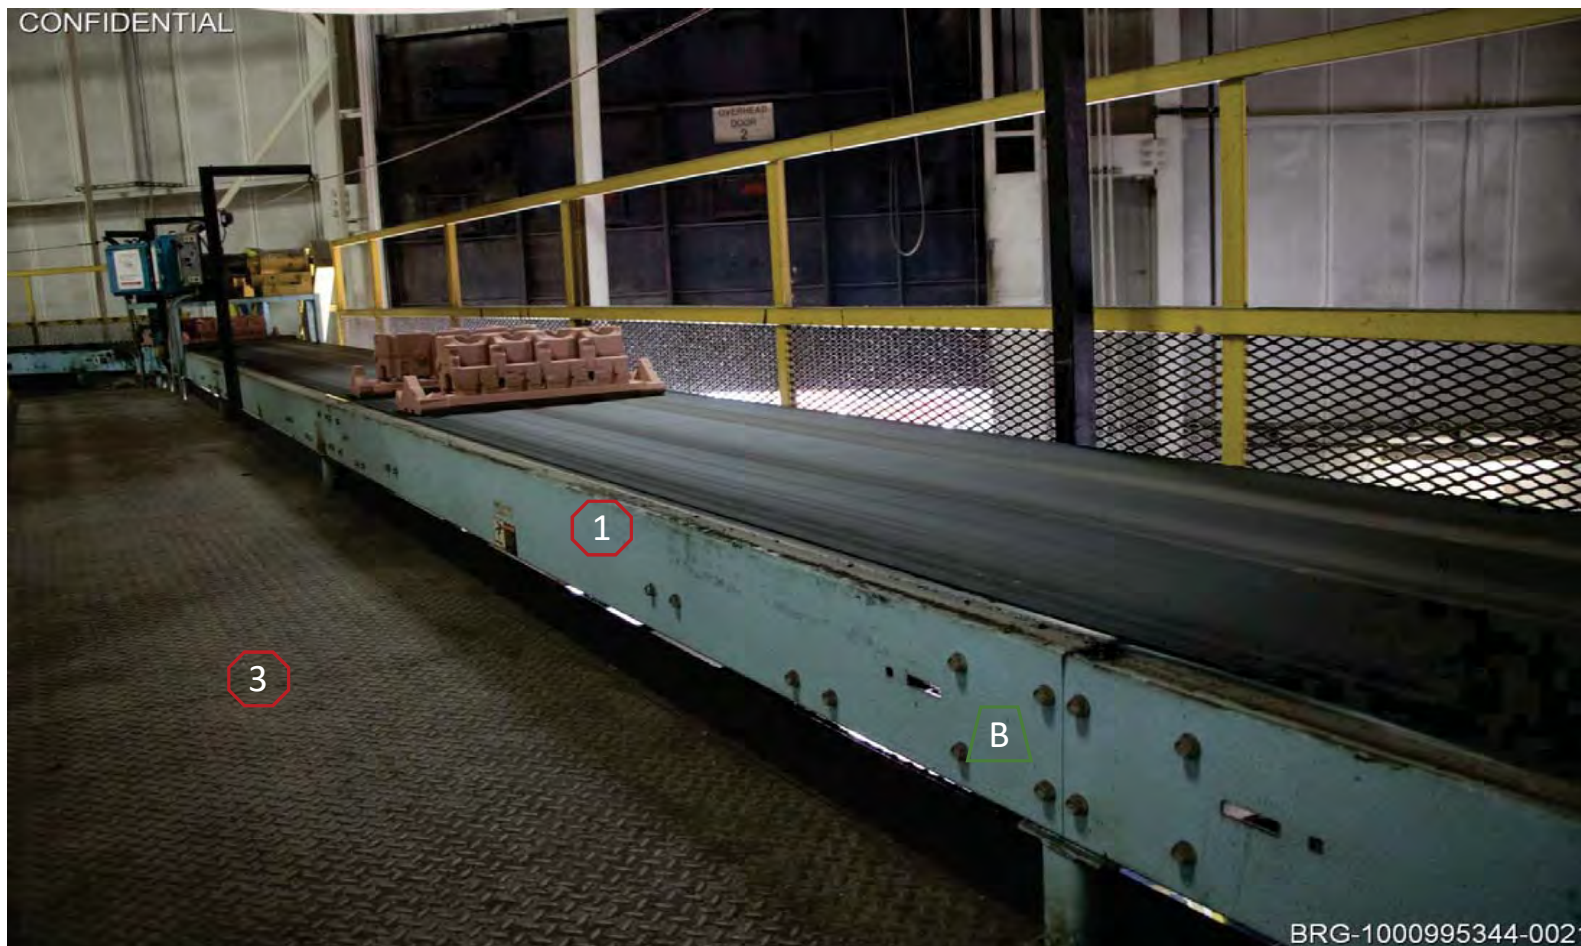
Picture 100095344-5 - Belt Conveyor

1 Belt Conveyor

3 Mezzanine

B The belt conveyor is assembled out of 15 foot long sections which are bolted together.

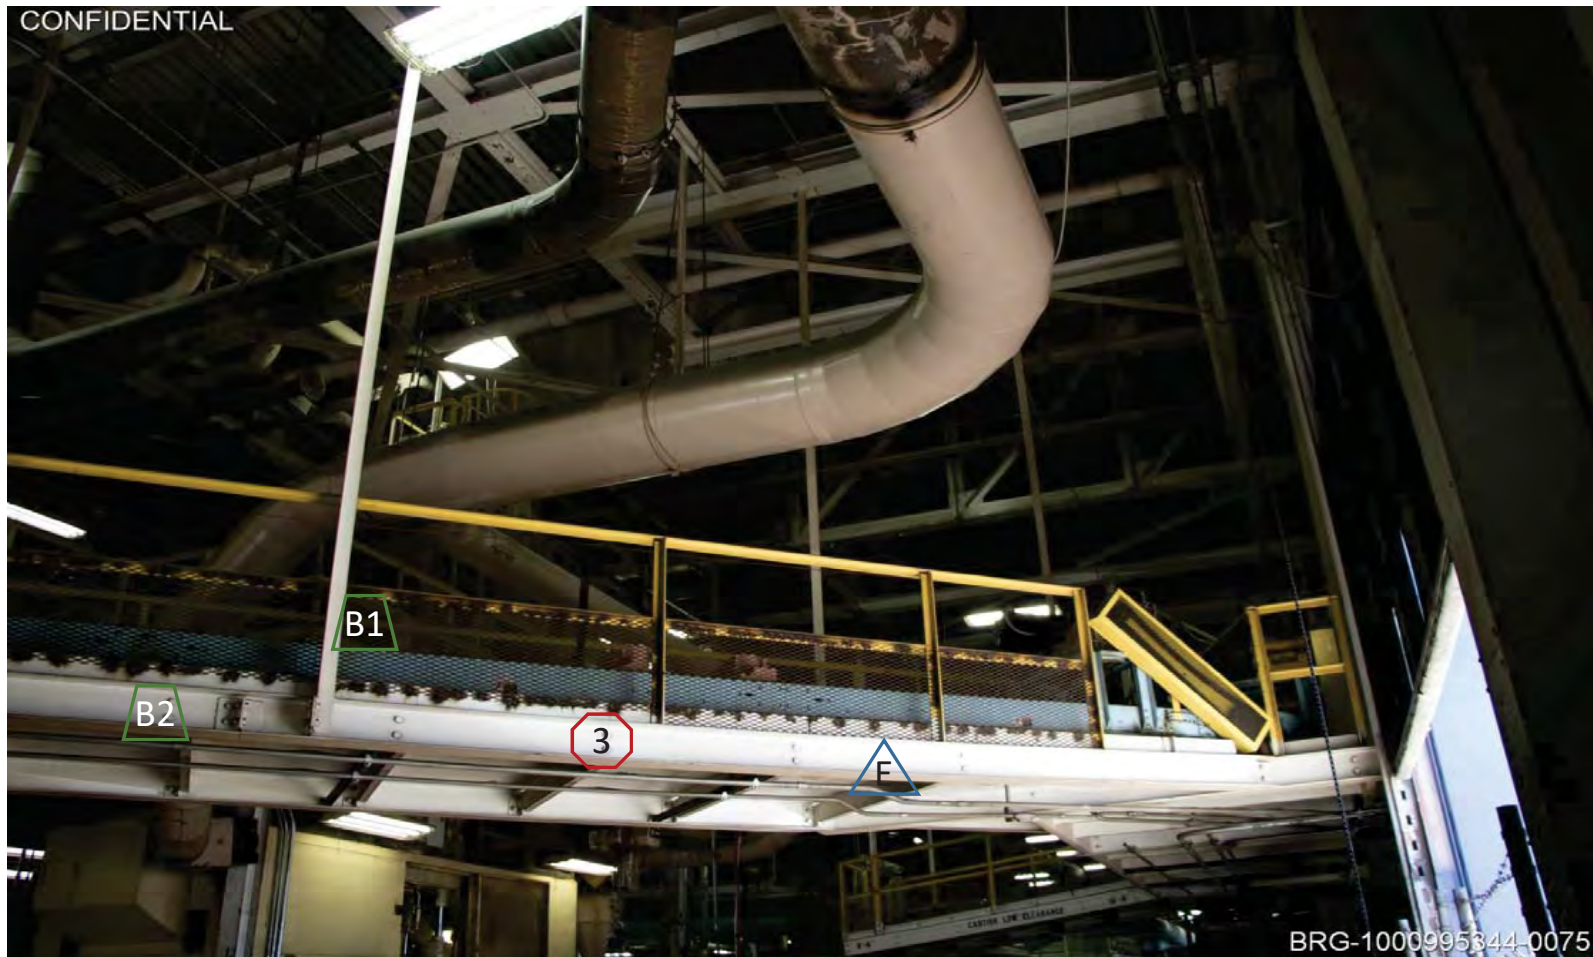
Picture 100095344-9 - Mezzanine

B1 The mezzanine is suspended from the building trusses with angle iron members which are attached to the mezzanine with bolts.

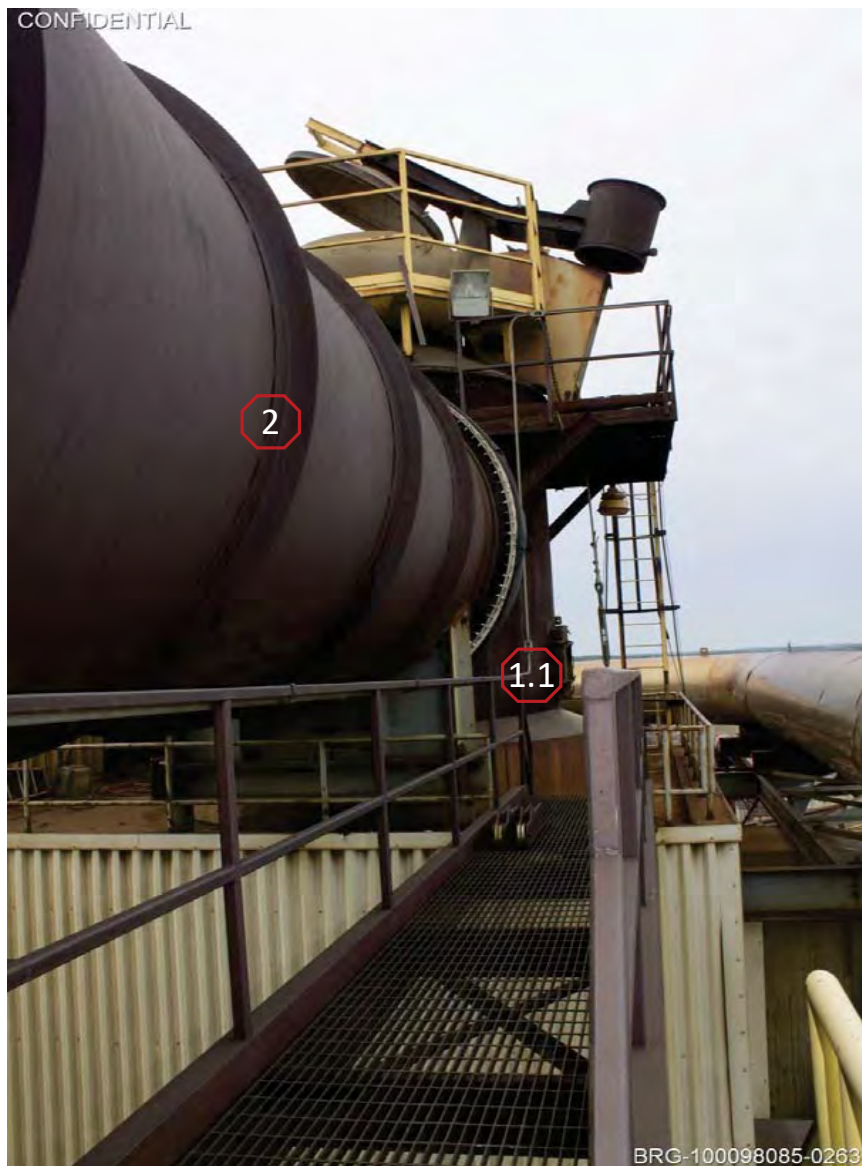
Picture 100098085-2 - Crossover Duct and Thermal Oxidizer

| 1 Thermal oxidizer vessel | 3 Heat recuperator vessel | 5 Scrubber vessel |
| 2 Crossover duct | 4 Turbine Blower (Hot blast) | 6 Induction draft fan |

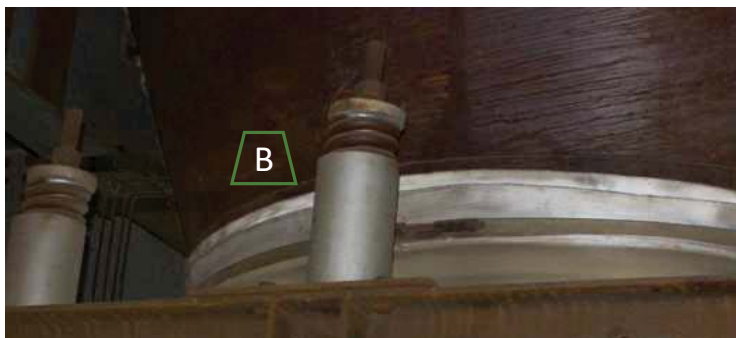
Picture 100098085-5 - Close up of Coil Spring Supports

Weight of recuperator vessel is suspended by coil springs and steel framework. Vessel cannot be attached to building due to heat expansion.

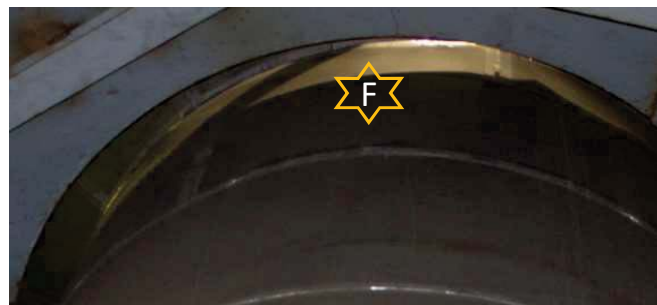
Picture 100098085-7 - Close up of Floor Opening

Vessel is installed through floor openings without attachment to accommodate heat expansion.

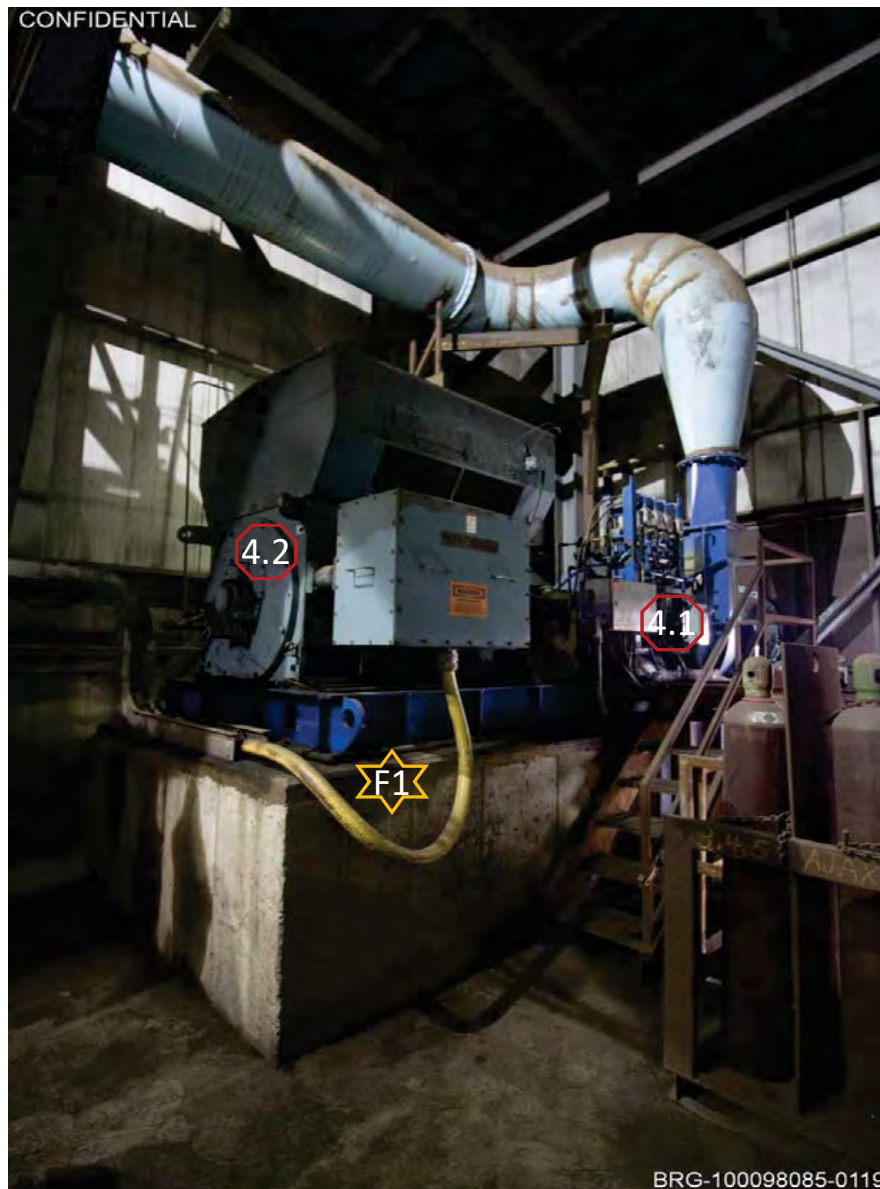
Picture 100098085-8 - Hot Blast Turbine Blower

- 4.1 Turbine blower with top exiting duct to cupola tuyeres.
- 4.2 1,800 horsepower motor, skid mounted as a unit with blower on concrete pier.
- 4.3 Bridge crane with wire rope hoist (separate asset), capable of traveling over turbine blower.
- F1 Lifting eyes integrated into blower/motor skid for installation/deinstallation use.
- F2 Floor opening to ground level below allows for removing turbine blower without damage to realty

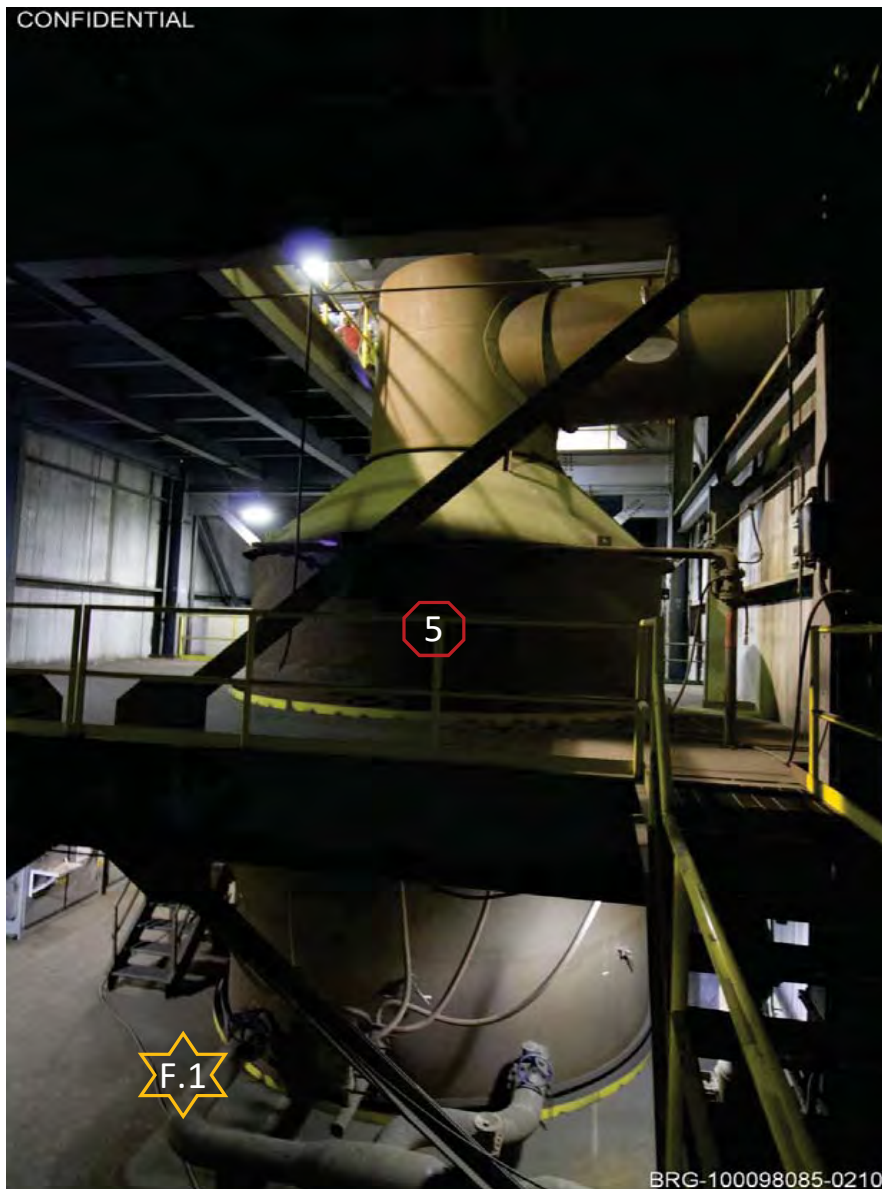
Picture 100098085-10 - Scrubber Vessel (Upper Section)

F.2 Upper building framework prevents removal without damage to building or vessel. No roof opening is provided.

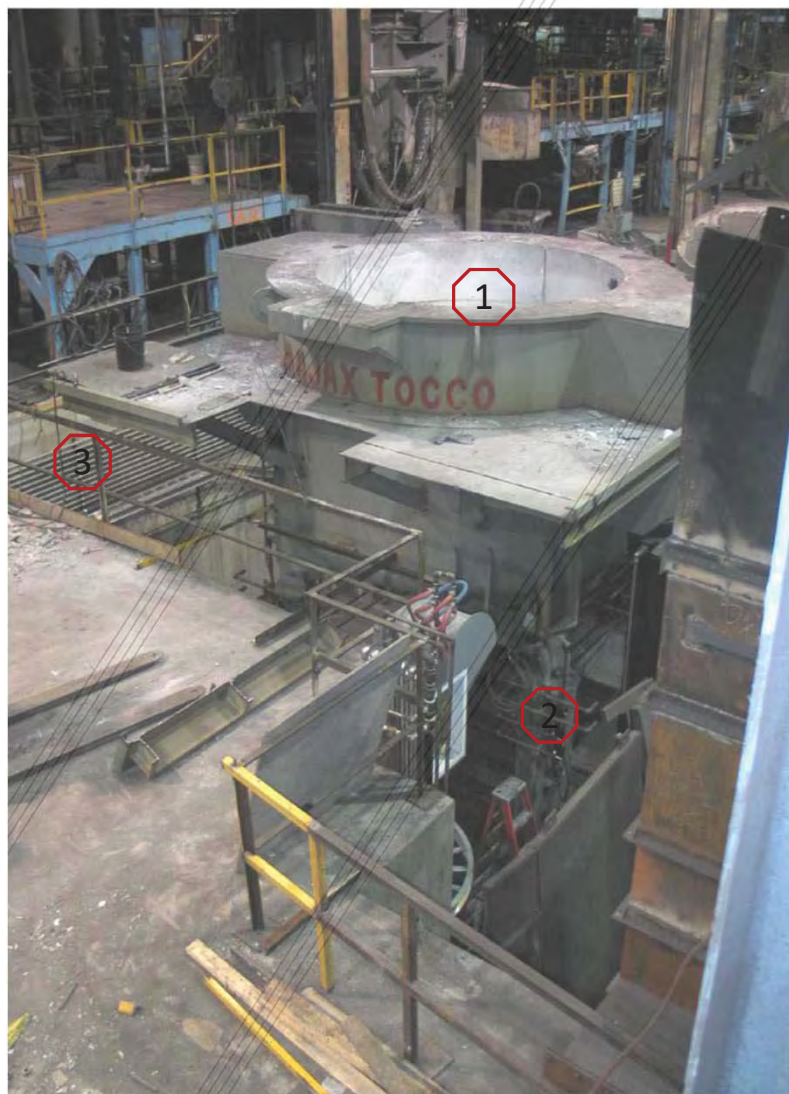
1 Vertical Channel Holding Furnace (lid has been removed)

2 Pit

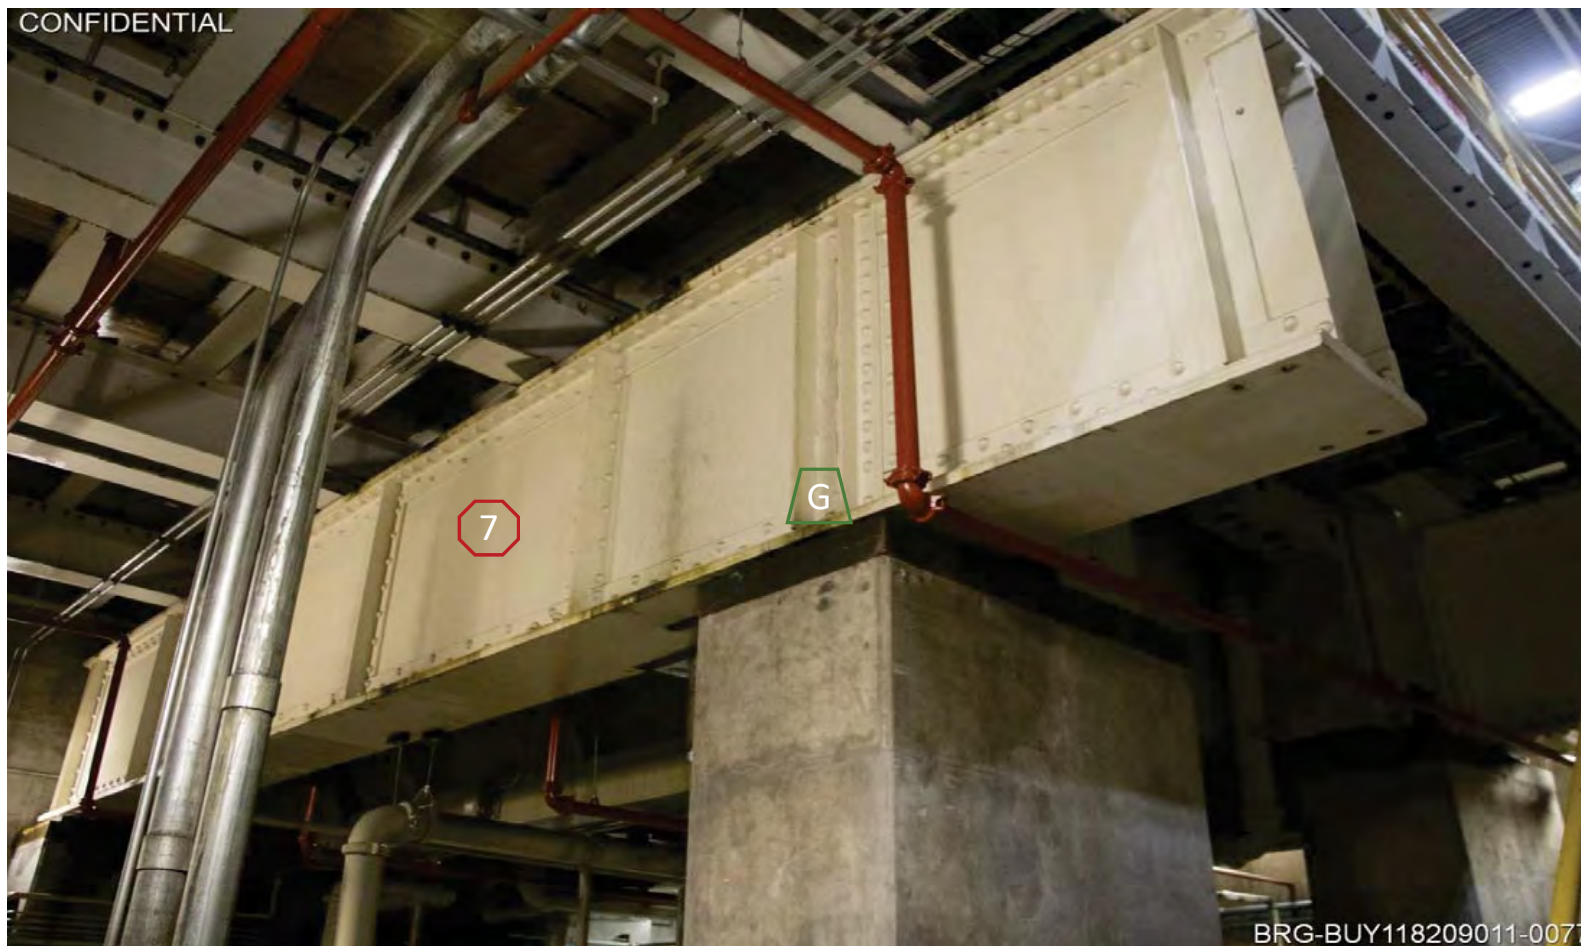
Picture BUY11820901-4 - Press Beams

7 Press Beam

B The four corners of the press bed are secured to concrete piers with bolts that attach to threaded rod embedded in the pier.

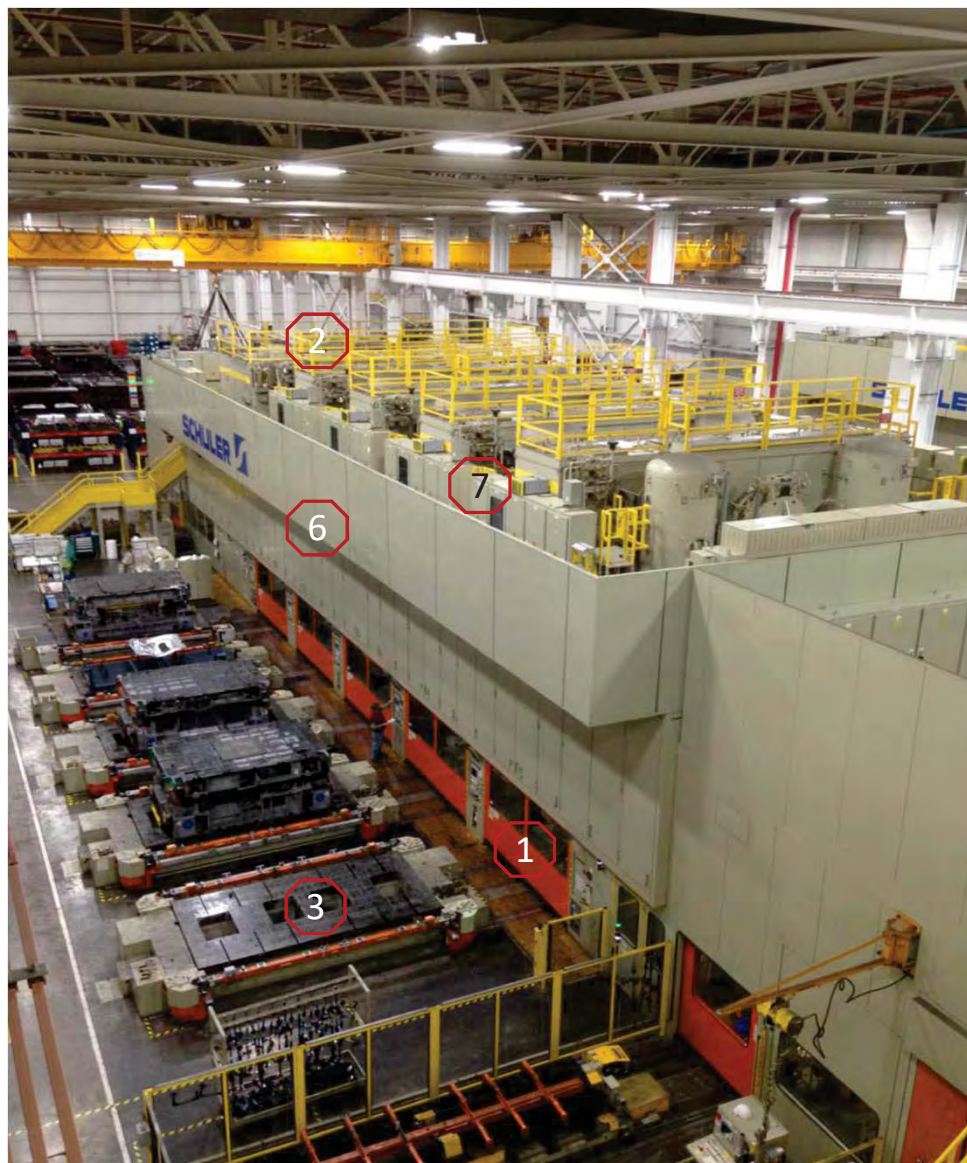
Picture BUYR503469FA-1 - Schuler Transfer Press

- 1 Individual Press Stations (not pictured, inside enclosure)
- 2 Topside Main Drive
- 3 Rolling Die Bolsters
- 4 Crossbar Transfer Units (not pictured, inside enclosure)
- 5 Hydraulic Power Units (not pictured, in basement)
- 6 Noise Reduction Enclosure
- 7 Electrical and Control Cabinets (at floor, top, and basement levels)

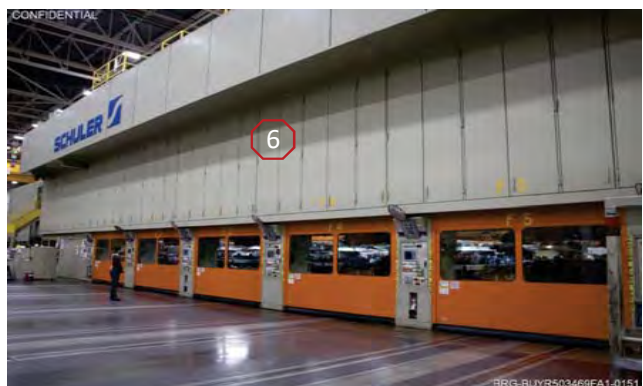
Picture BUYR503469FA-2 - Schuler Transfer Press

- 6 Noise Reduction Enclosure

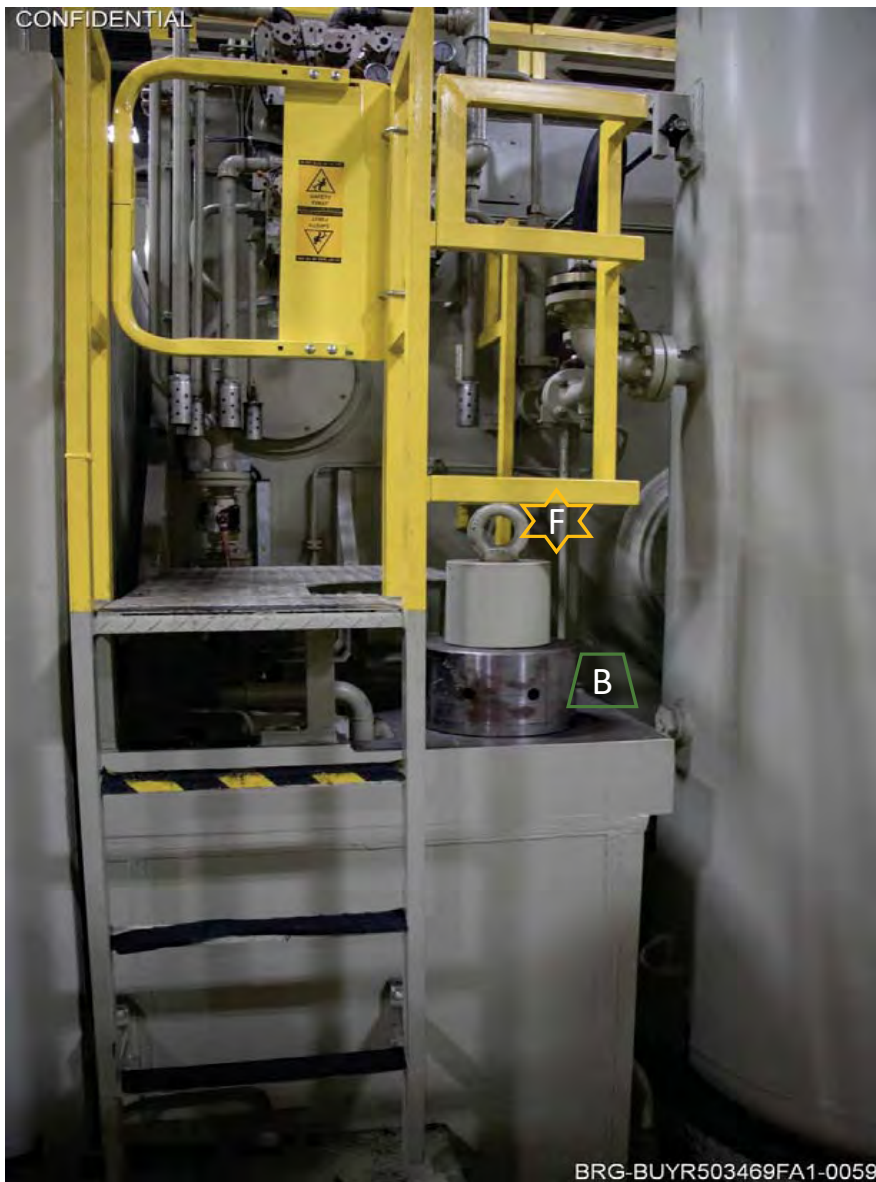
Bottom nuts of the tie rods are shown. The tie rod runs up through the press structure and is fastened by an additional nut on the press crown. Removing these bolts allows the structural components of the press to be dismantled.
