**UNITED STATES BANKRUPTCY COURT
SOUTHERN DISTRICT OF NEW YORK**

MOTORS LIQUIDATION COMPANY, f/k/a
GENERAL MOTORS CORPORATION, *et al.*,

Plaintiff's Representative Assets Appendix

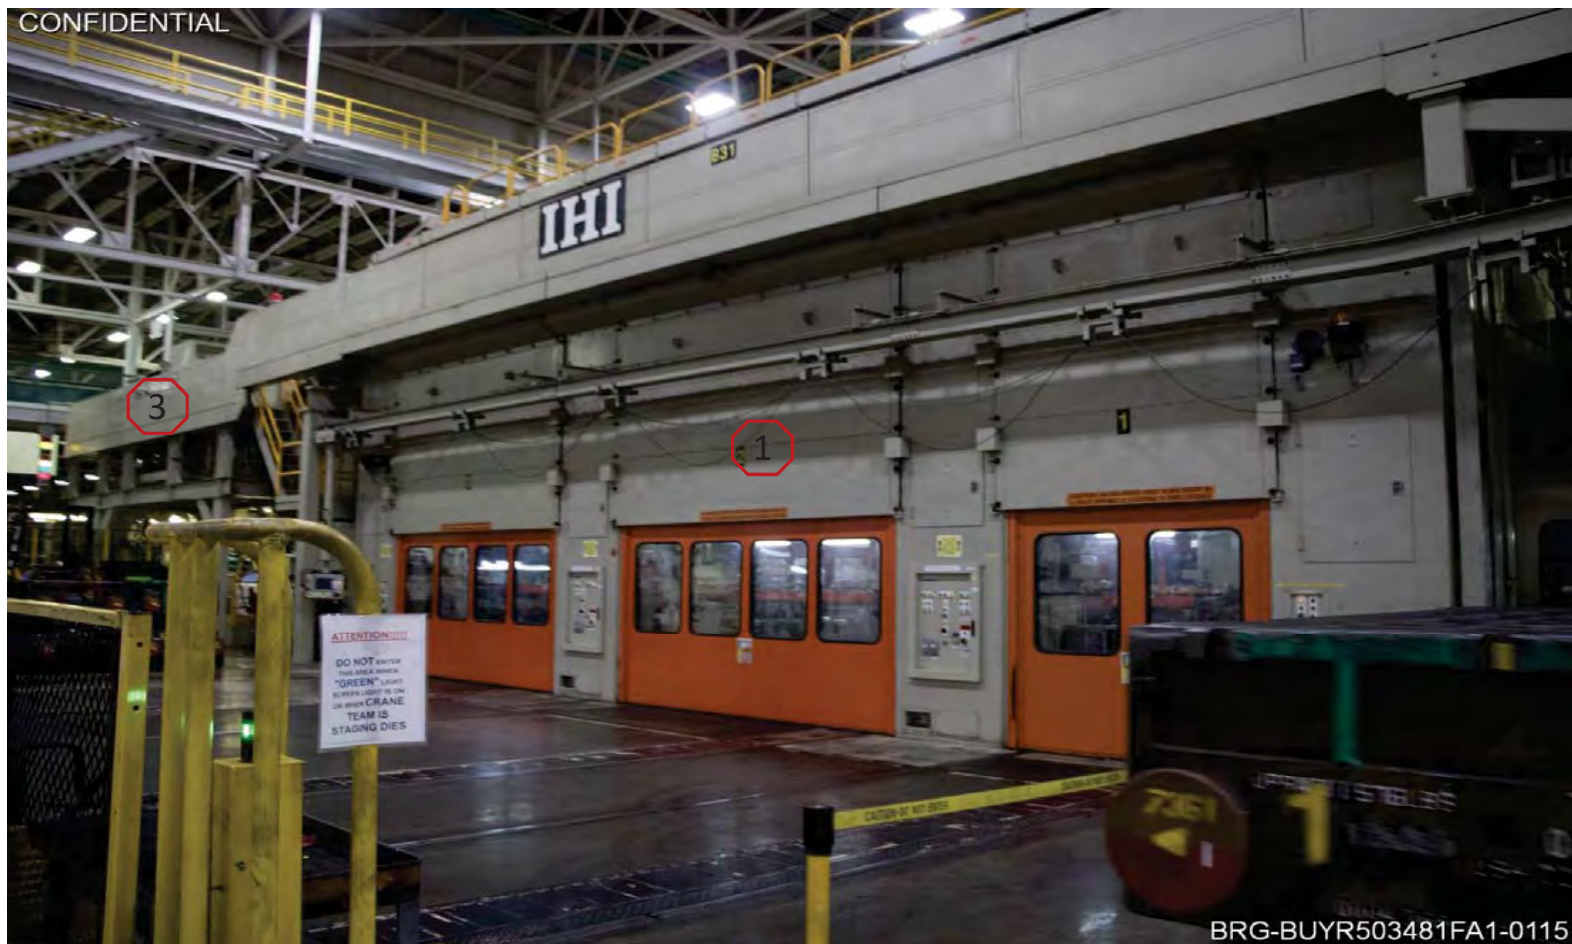
Picture BUYR503481FA-1 - B3-5 Transfer Press

End of Line ("EOL") system removes stampings and loads them into carts.

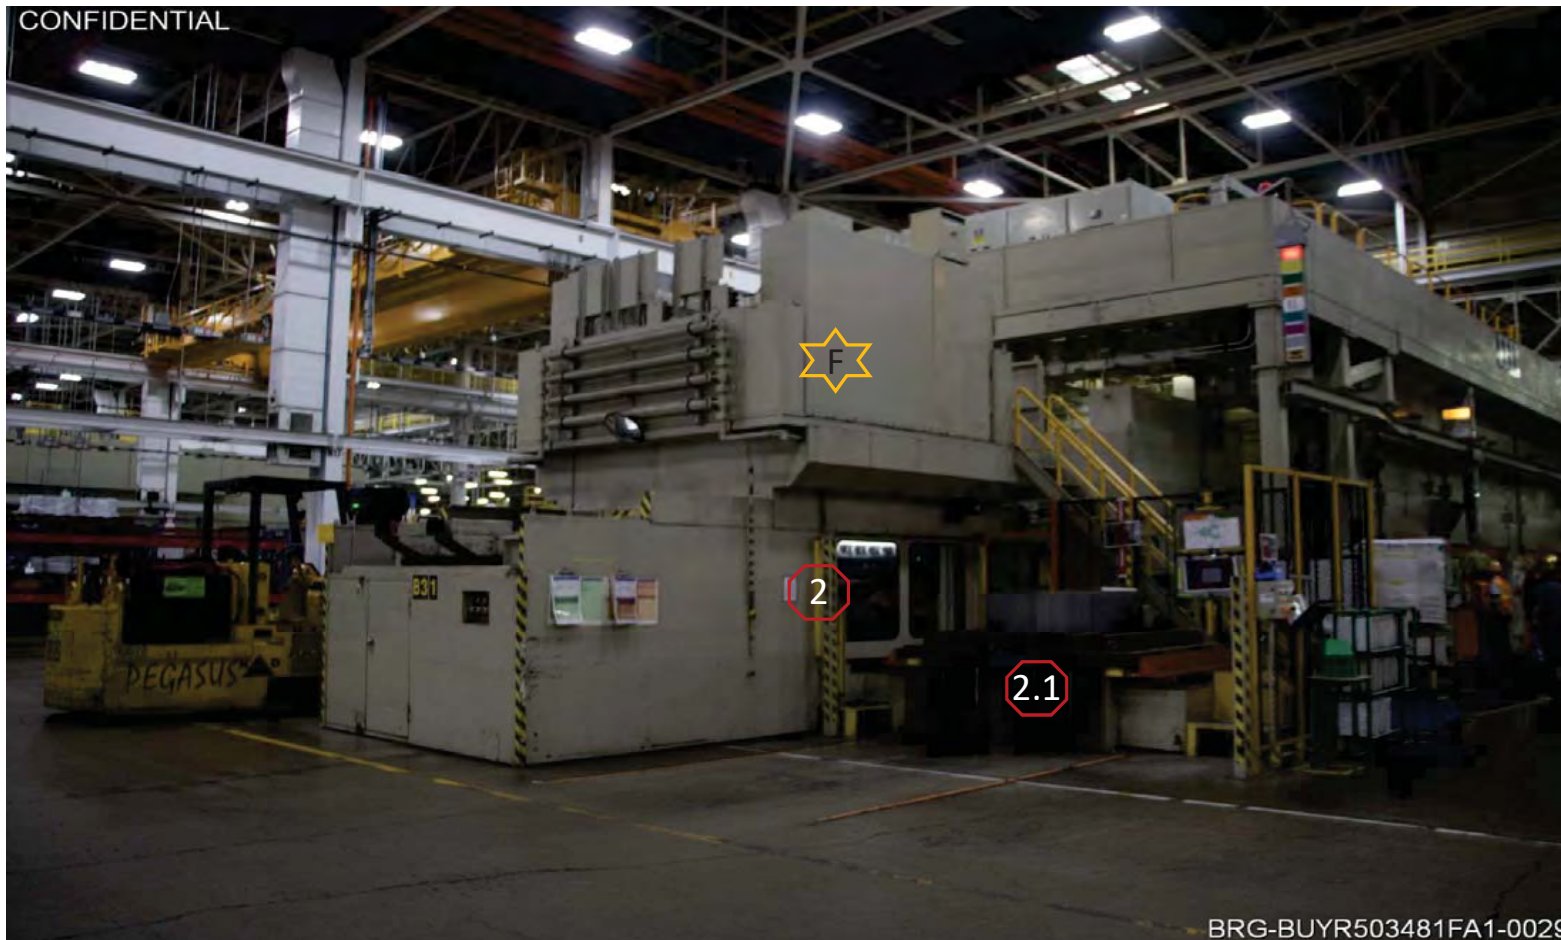
Picture BUYR503481FA-2 - Press Destacker/feeder System

Control cabinets mounted on roof of destacker/feeder.

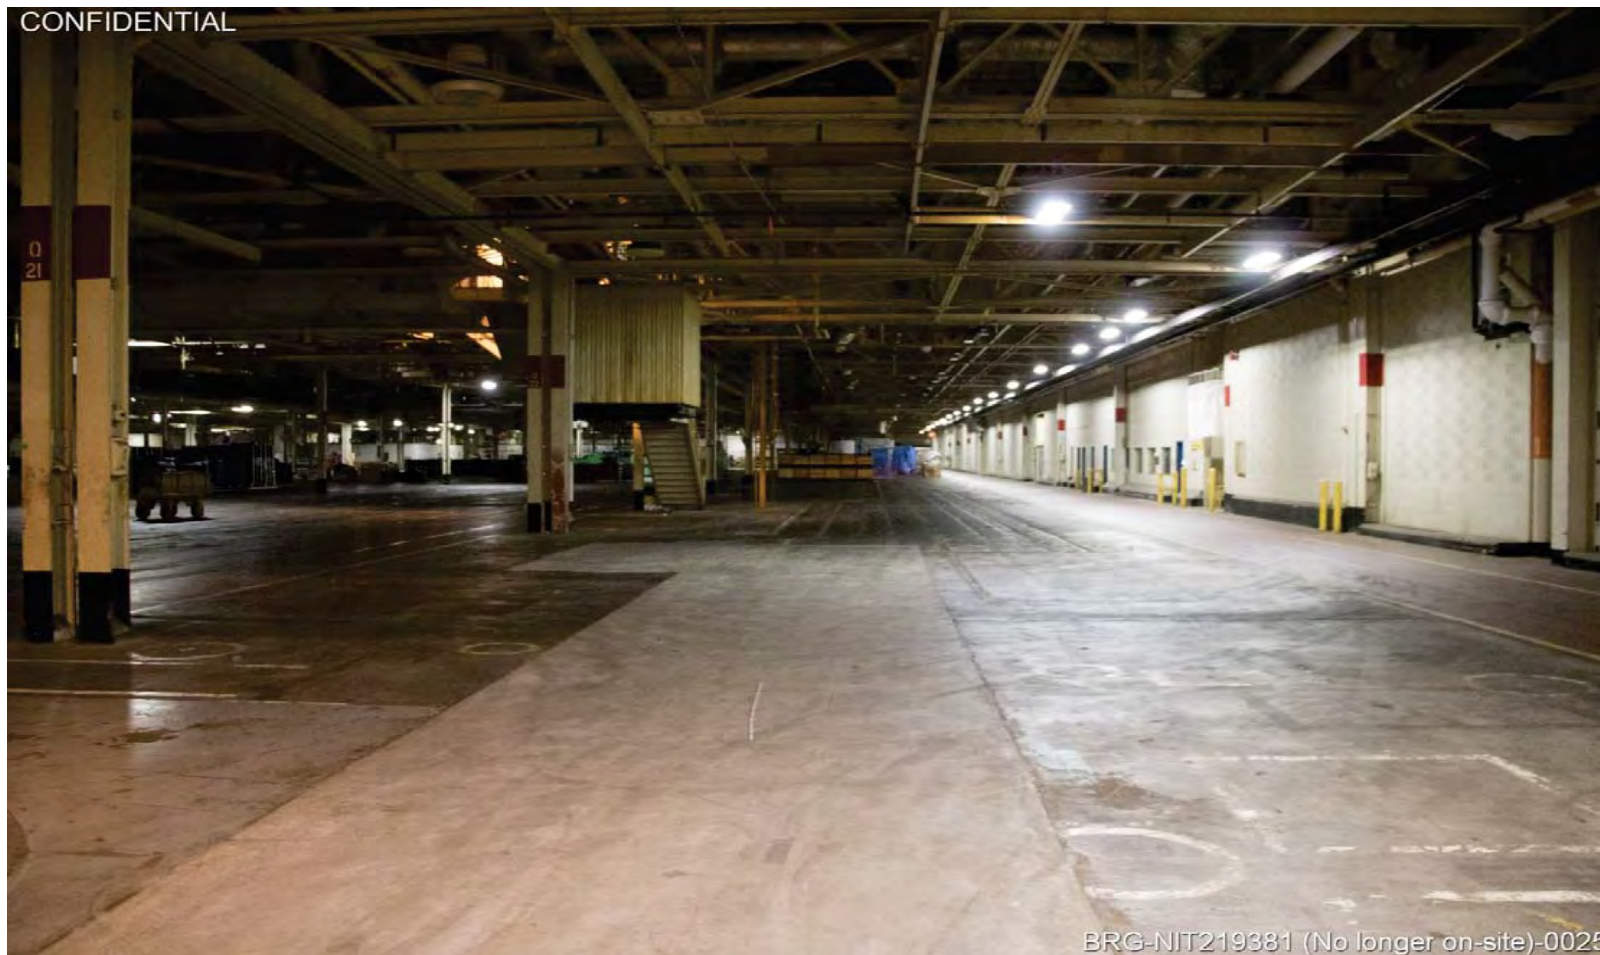
Picture NIT219381-1 - 4 Speed Build Line (Empty Area)

This empty area formerly housed the 4 Speed Build Line, which had been removed prior to the May 2016 inspection. The 4 Speed Build Line was comprised of assembly equipment, conveyors, other related assets, and all of the necessary utilities required for operation of the line.

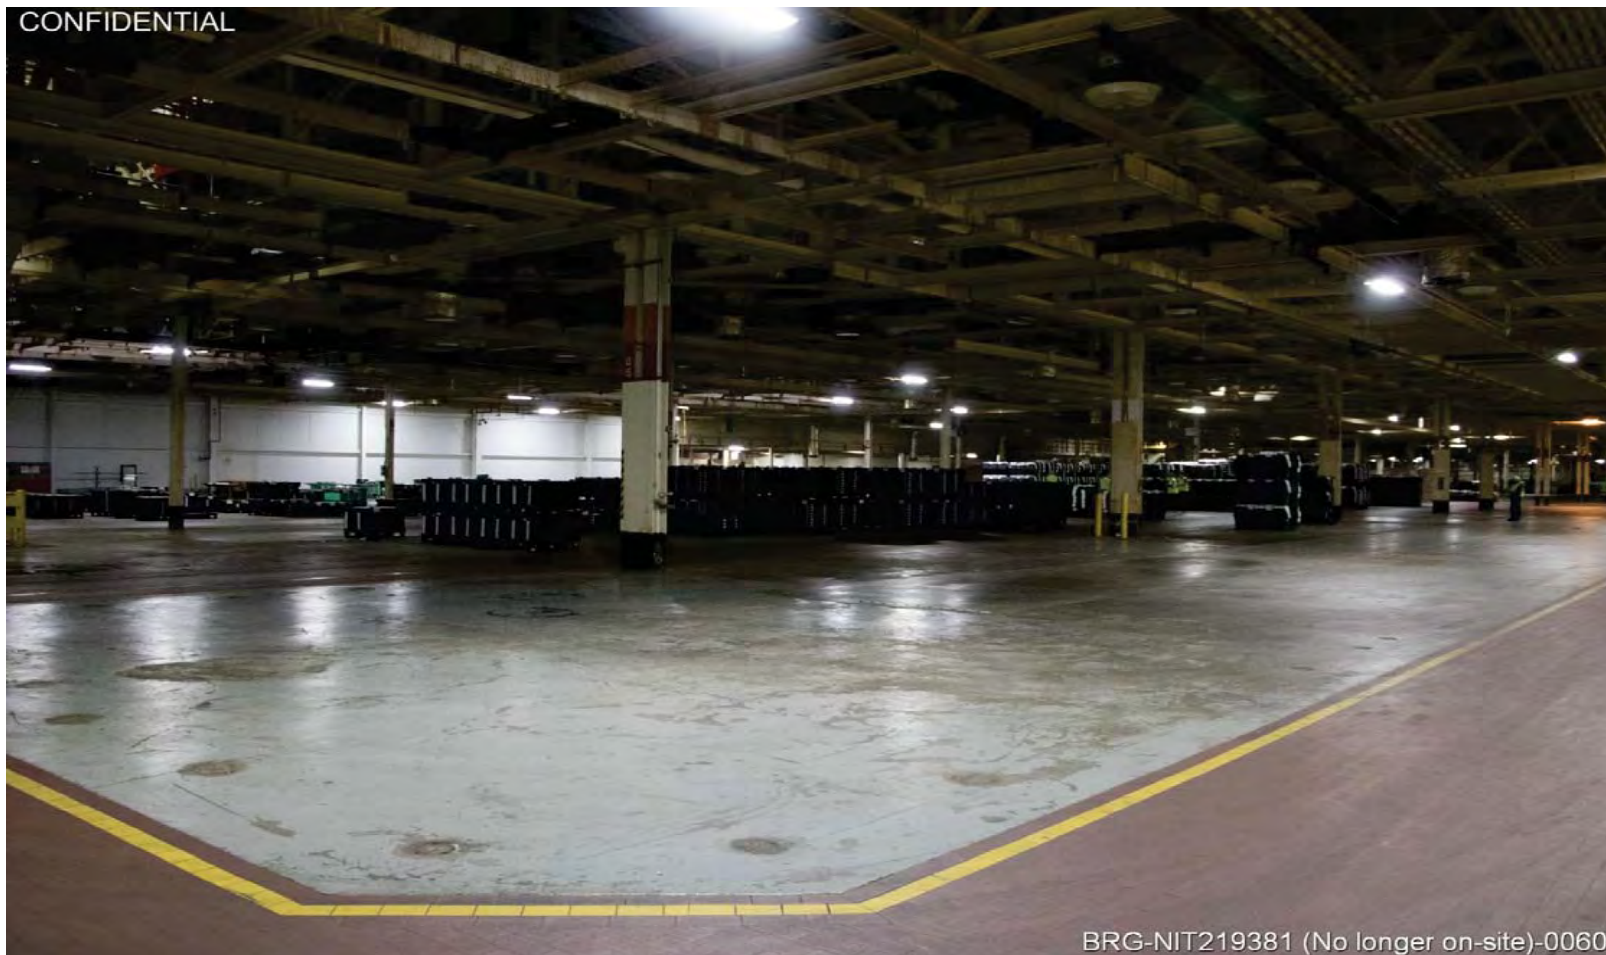
Picture NIT219381-2 - 4 Speed Build Line (Empty Area)

All components of the 4 Speed Build Line, including any connections to utilities such as electricity, compressed air, chilled water, and ventilation, have been removed with minimal evidence of their previous installation. No damage to the building was observed during the inspection.

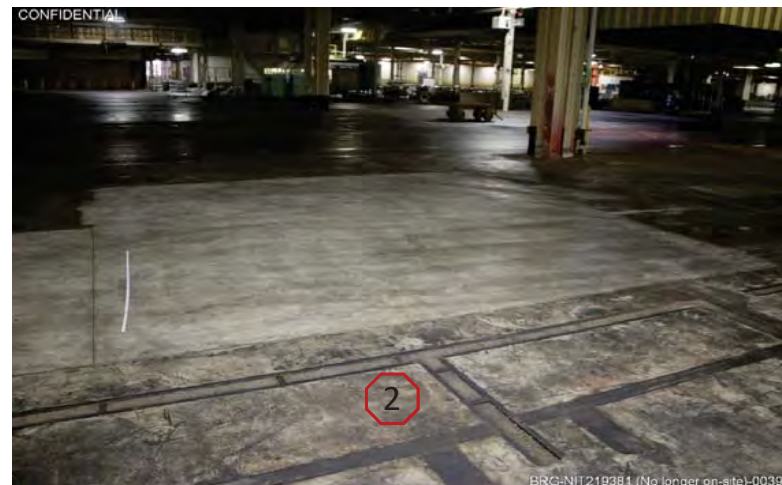
Picture NIT219381-4 - Trench

- 1 The pit for the 4 Speed Build Line has been filled in with concrete so that all floor space is level with the surrounding building floor. The pit for the build line was capitalized under Asset ID NIT219381A, separate from the 4 Speed Build Line asset.
- 2 A trench in the 4 Speed Build Line area has been filled with concrete so that it is level with the surrounding building floor.

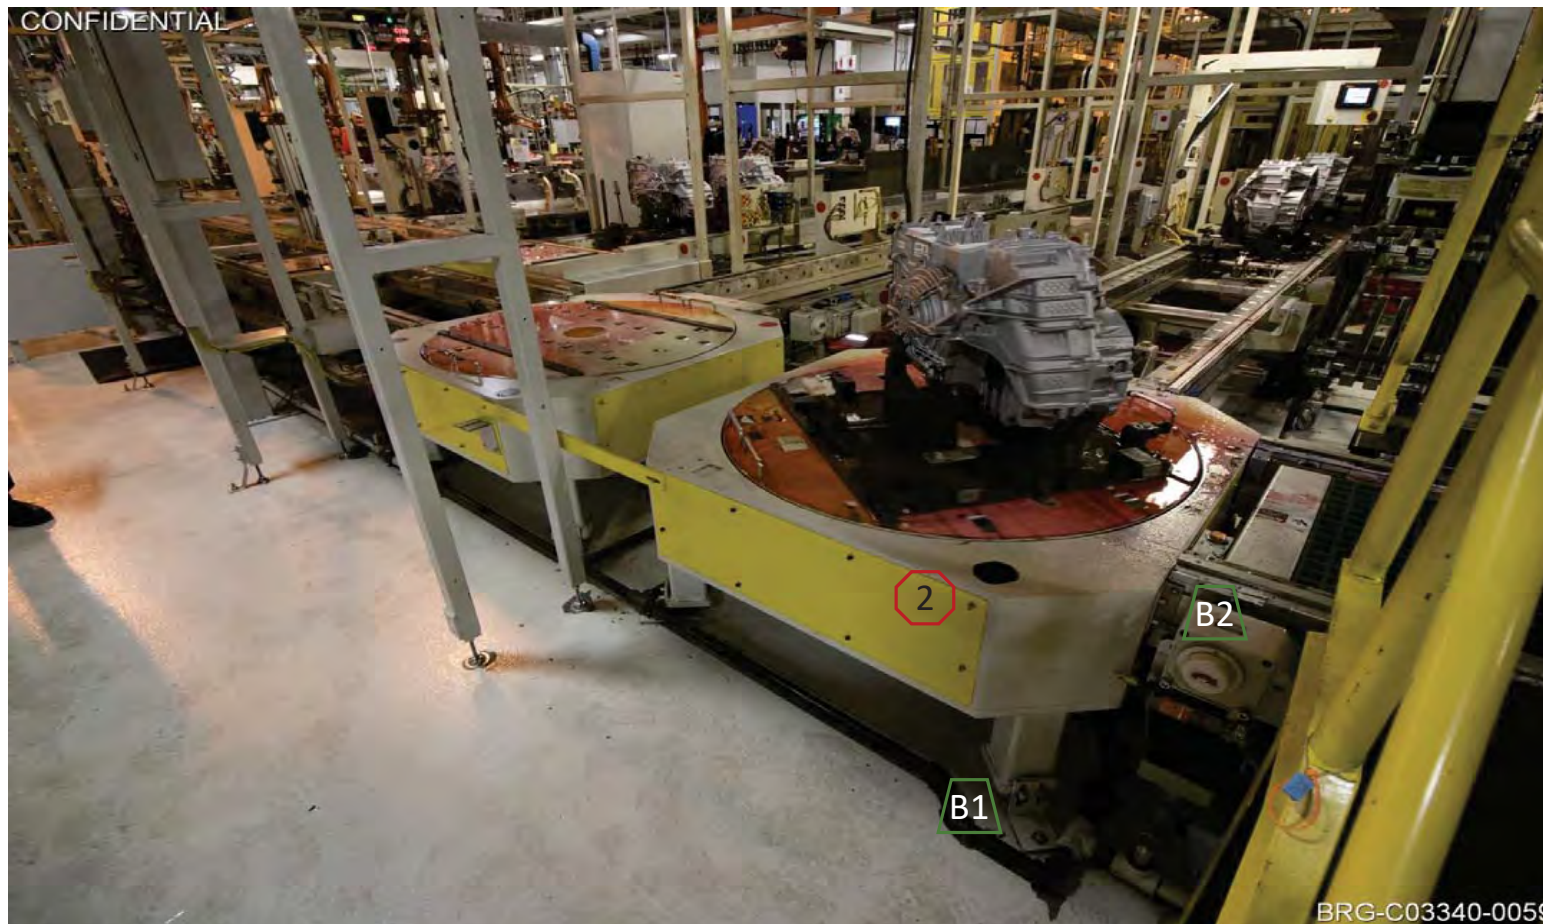
Picture NITC03340-4 - Rotary Table

B1 The rotary table is secured to the building floor with lag bolts.

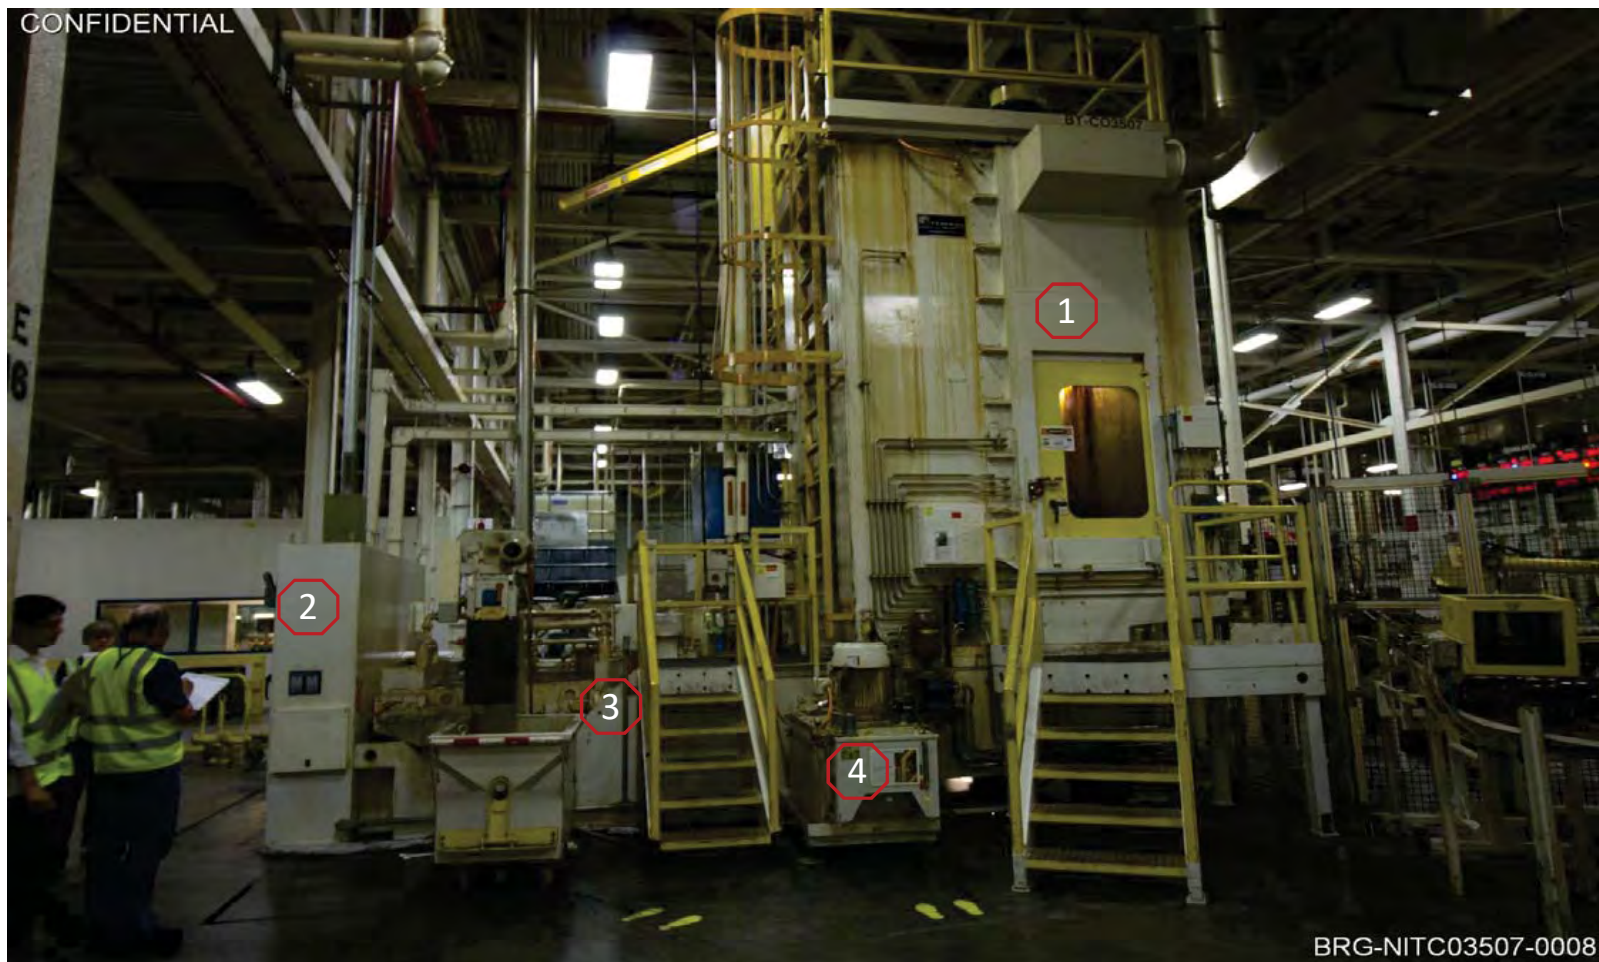
Picture NITC03507-2 - Helical Broaching Machine

| 1 Helical Broach | 3 Chip Conveyor and Filtration System |
| 2 Standalone Control and Electrical Cabinet | 4 Hydraulic Power Pack |

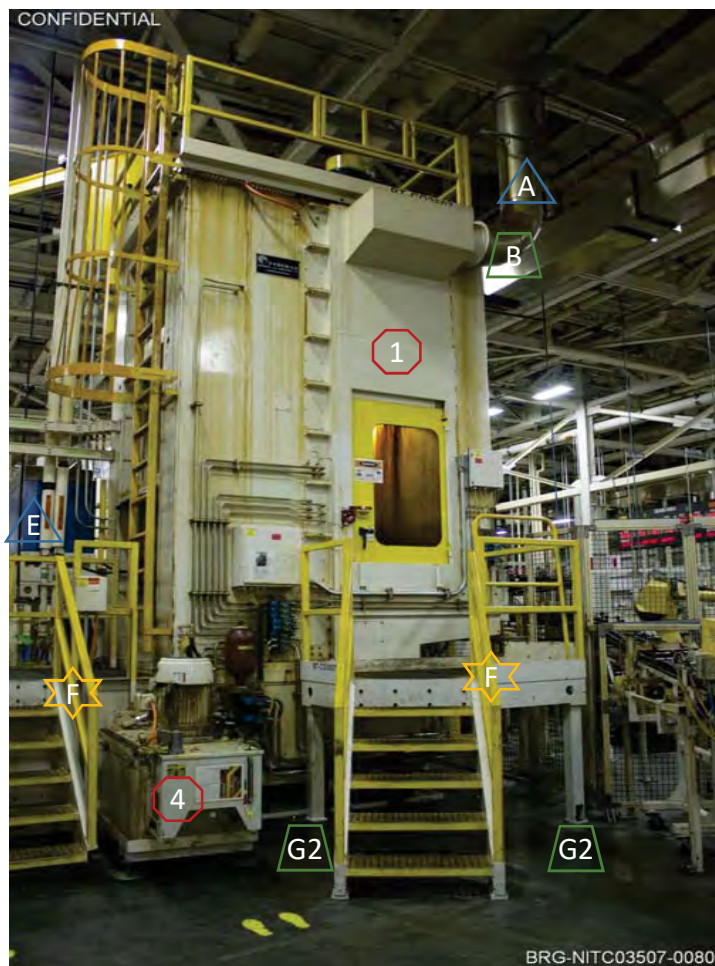
Picture NITC03507-3 - Helical Broach

- G1** Adjustable leveling pads are bolted to the base of the Helical Broach and rest on a drip pan under the machine. The drip pan lays on the building floor. The Helical Broach is not affixed to the building floor in any other way.
- G2** The supporting legs of the modular platforms rest on the building floor with leveling bolts.
- 1** Helical Broach

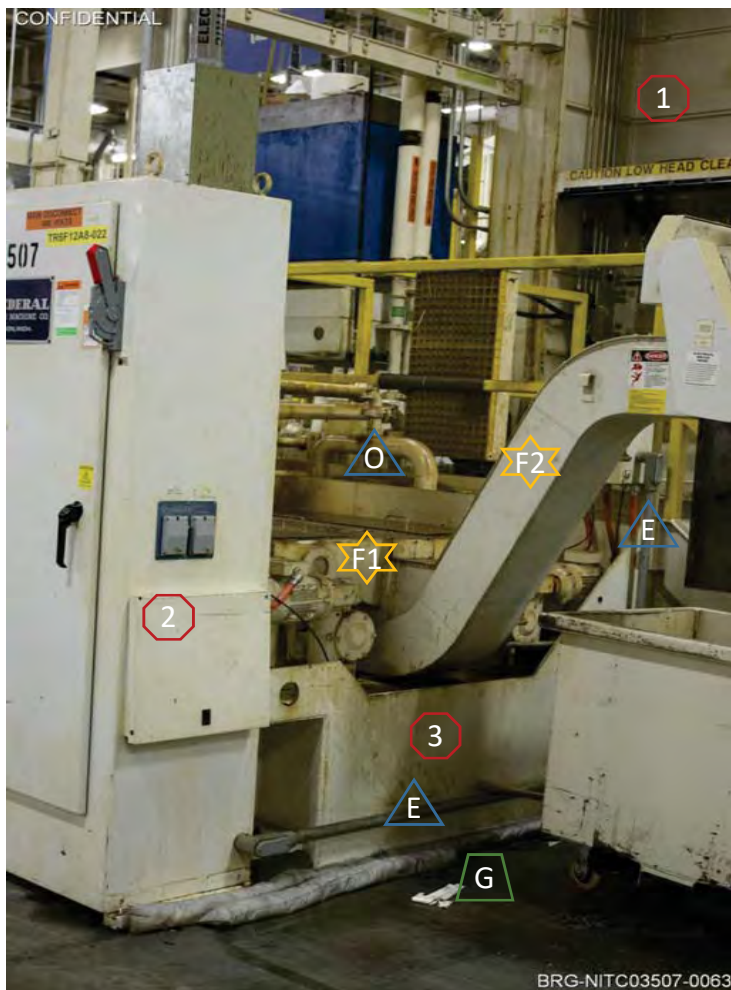
Picture NITC03507-8 - Filtration System (Right Side)

- E** Electric & data wiring is fed from the control cabinet using conduit.
- O** Pipe connects the filtration system to the Helical Broach to recycle cutting oil.
- G** The chip conveyor and filtration system rests on the building floor. The system is not affixed to the building floor in any other way.
- F1** The oil pipe is attached to the filtration system with a flanged joint that is bolted together.
- F2** Different sections of the oil piping are connected by quick disconnect compression fittings.
- 1** Helical Broach
- 2** Standalone Control and Electrical Cabinet
- 3** Chip Conveyor and Filtration System

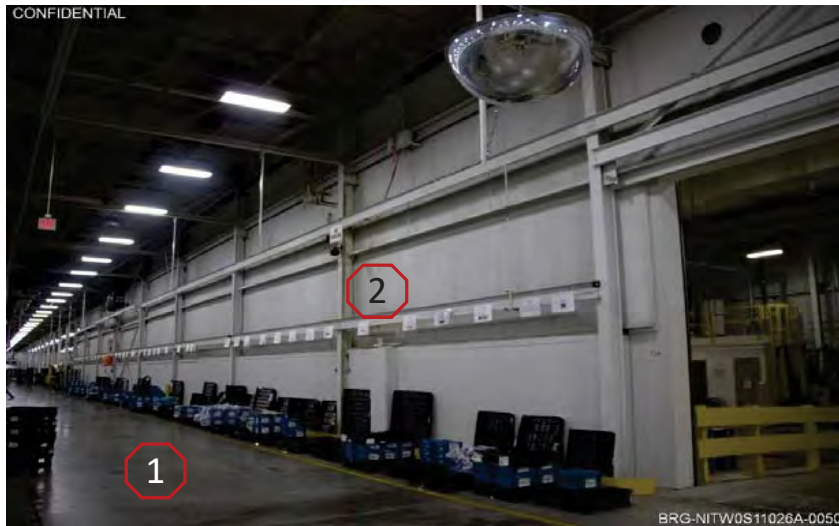
Picture NITW0S11026A-2 - Courtyard Enclosure

- 1 Epoxy Coated Concrete Floor
- 2 Structural Steel Framing

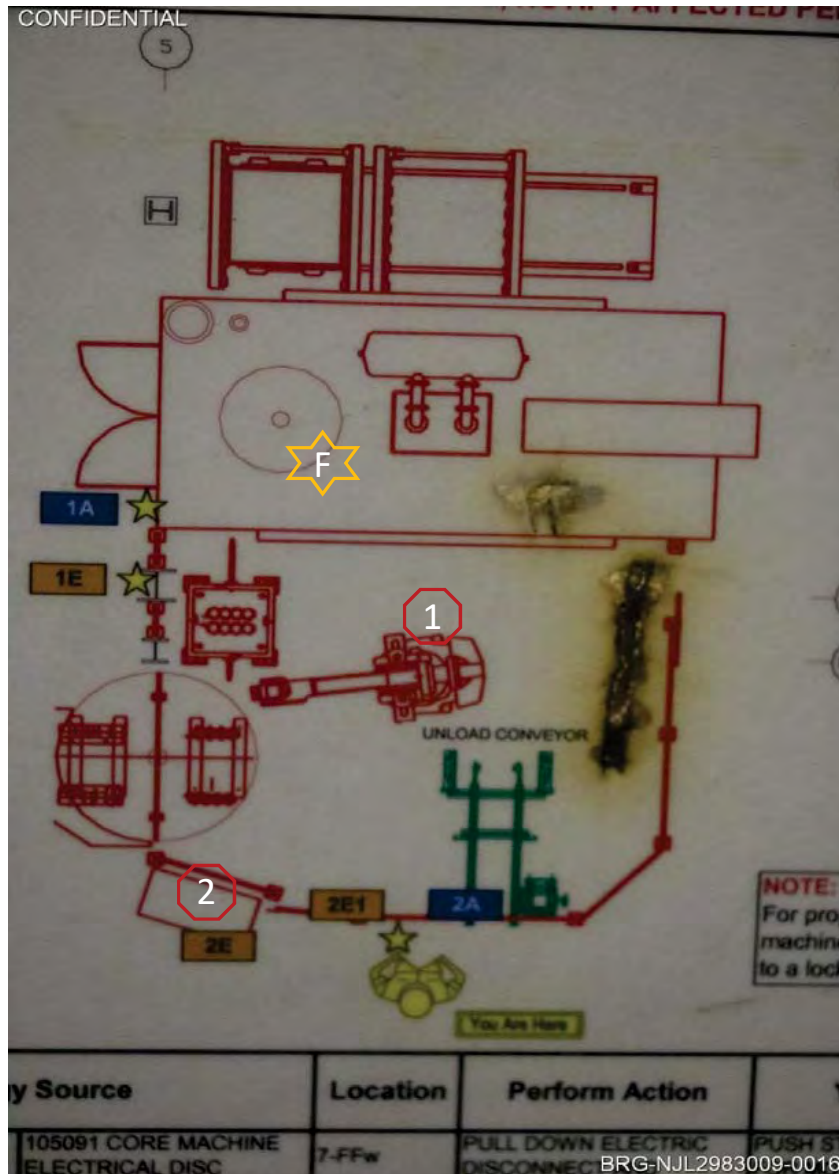
Picture NJL2983009-1 - Asset Diagram

1 Robot inside cell fencing. Lorimendi core machine is shown above robot.

F Lorimendi core machine has separate asset tag

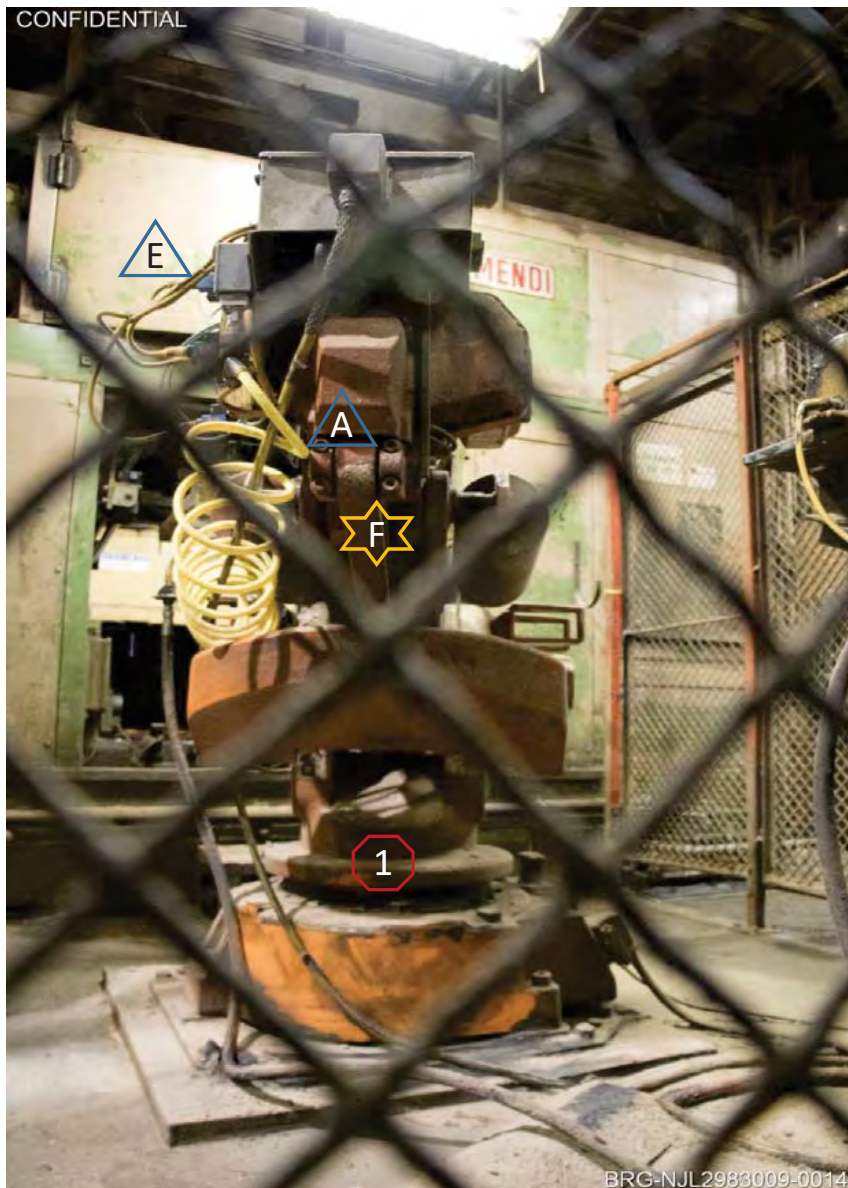
Picture NJL2983009-2 - Robot

Electrical power and data are fed to the robot via loose cable; certain cable utilizes quick disconnect fittings.

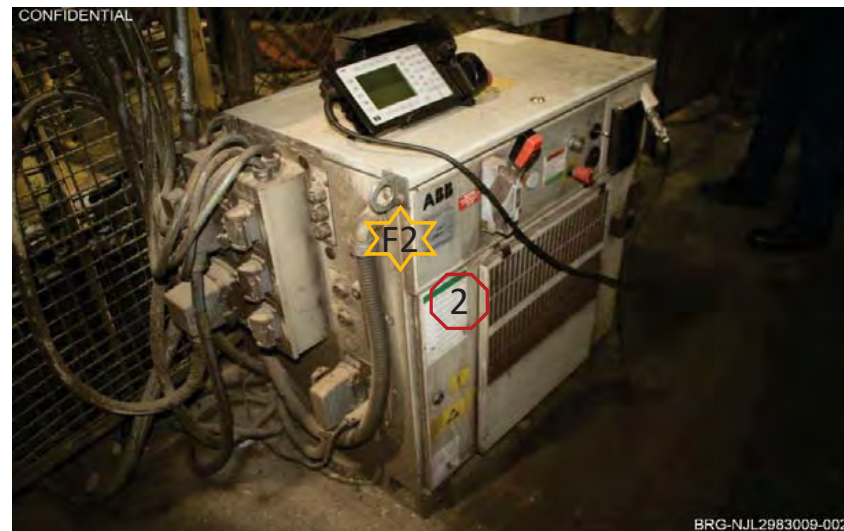
Picture NJL2983009-5 - Controller

Electrical power and data are connected to the controller by loose cable with quick disconnect fittings.

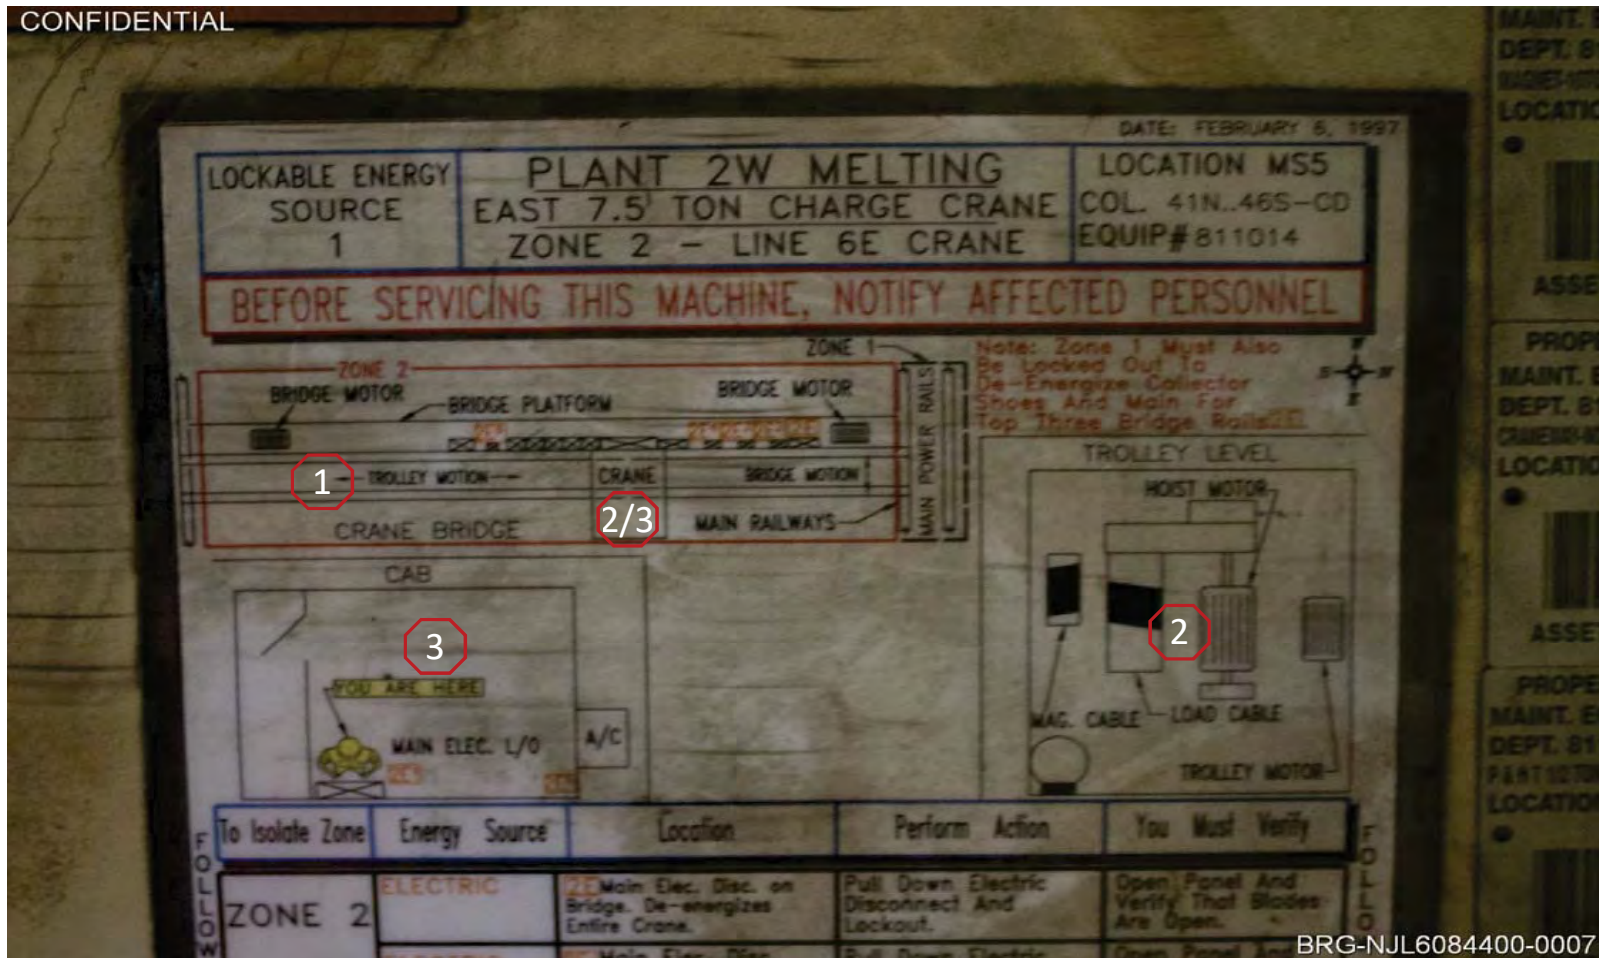
Picture NJL6084400-1 - Asset Diagram & Layout

- 1 Double Girder Bridge
- 2 Electric Wire Rope Hoist
- 3 Control Cab

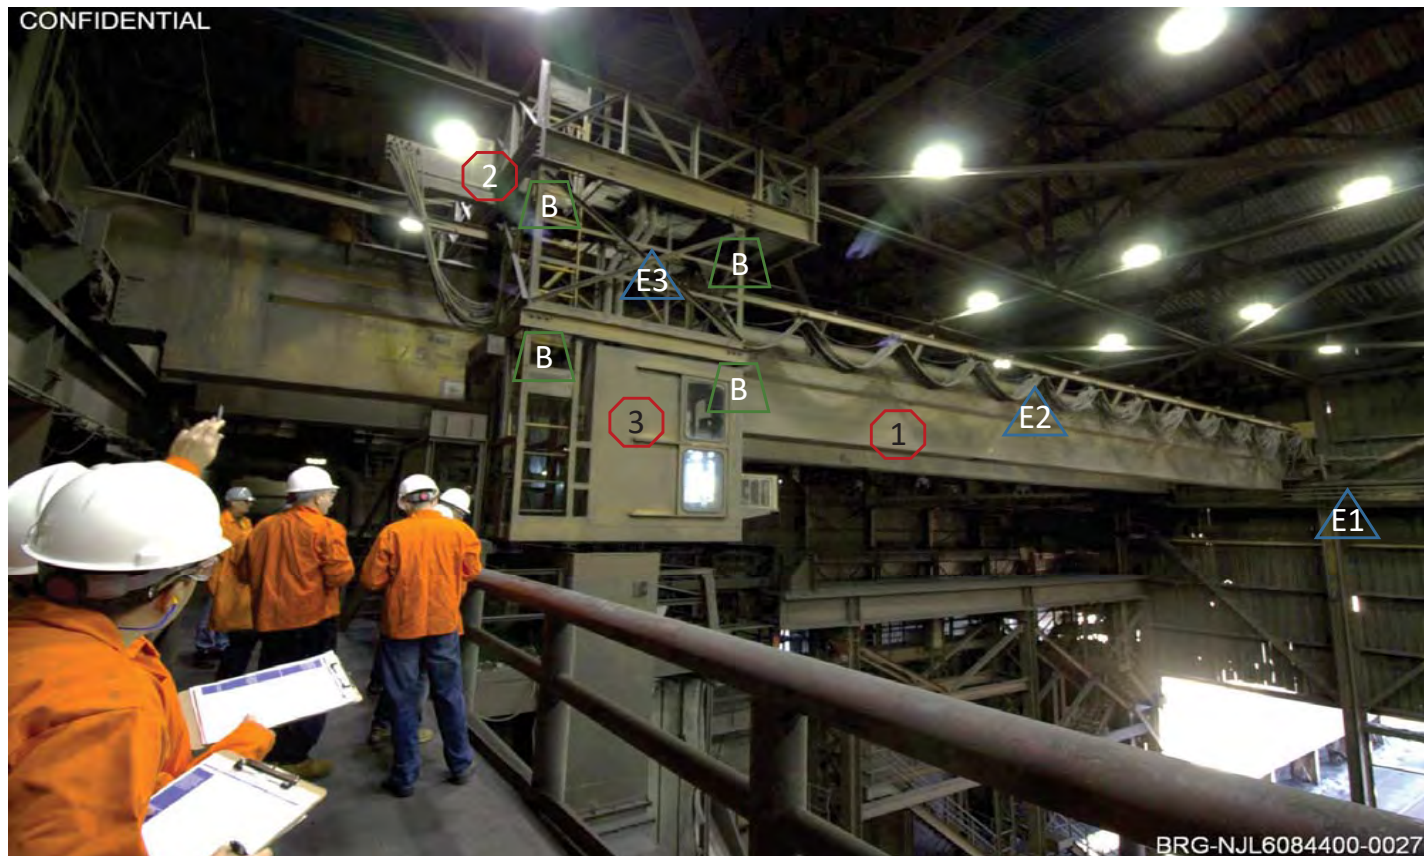
Picture NJL6084400-3 - Charger Crane (Back)

Trolley with Electric Wire Rope
Hoist
